Flow Measurement Using Magnetic Meters in Large Underground Cooling Water Pipelines

Abstract—This paper outlines the basic installation and operation of magnetic inductive flow velocity sensors on large underground cooling water pipelines. Research on the effects of cathodic protection as well as into other factors that might influence the overall performance of the meter is presented in this paper. The experiments were carried out on an immersion type magnetic meter specially used for flow measurement of cooling water pipeline. An attempt has been made in this paper to outline guidelines that can ensure accurate measurement related to immersion type magnetic meters on underground pipelines.

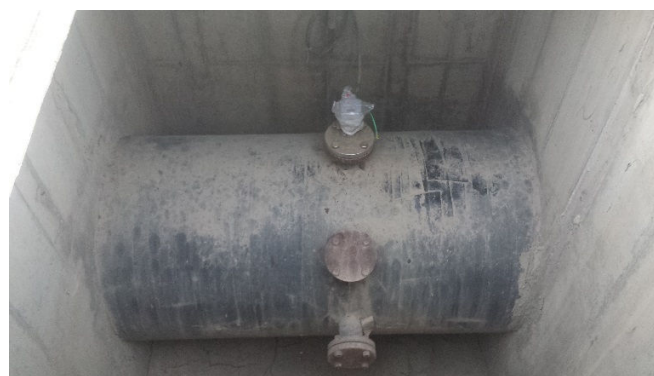
As shown in Fig. 7 the transmitter is top mounted and thus naturally the possibility of air bubbles flowing on the top portion of the pipe might pose a problem. As the sensor has both electrodes and magnetic field generating coils in very close proximity, large air bubbles passing in front of the sensor will change the magnetic inductance of the liquid and hence change the flow value.

Furthermore this phenomenon is made worse because of the much smaller area over which the magnetic field is able to pass through compared to the much larger pipe and to further complicate matters the EMF value is very small and thence easily affected. However even though this is a very probable reason but pipe pressure helps determine the possibility of air bubbles. The pipeline under consideration was pressurized at 8 bar and thence the possibility was very low [4]. Furthermore the flow sensor was immersed 5 inches into the pipeline.

Fig. 8 Mounting position of sensor

However on examining the water sample it was found that along with the water, solid particles and sometimes even plastic wrappers flowed through the pipe line. This helped identify the problem, instead of air bubbles it were solid particles flowing through the water that when flowed in front of the pipeline changed the liquids magnetic inductance. This phenomenon is not observed in normal magnetic meter which have electrodes at each diametric end of the pipeline and

magnetic coils wrap the entire flow tube section. Thus the passing of these solid particles resulted in change in the inductance of our fluid and caused our very small EMF signal to be affected. Two solutions were proposed for this problem:

- 1) The installation of a filter to clean the fluid however the filter would require cleaning and could get clogged. Such high maintenance was not possible at a cooling water pipeline and thus the proposition was dismissed.
- 2) The installation of another sensor and both acting in 2 out of 2 logic was considered. Steps were also taken on this proposition and as Fig. 7 depicts arrangements for the installation of the sensor are already available. This proposition is being acted upon
