Study of the Behavior of an Organic Coating Applied on Algerian Oil Tanker in Seawater

Abstract—Paints are the most widely used methods of protection against atmospheric corrosion of metals. The aim of this work was to determine the protective performance of epoxy coating against sea water before and after damage.

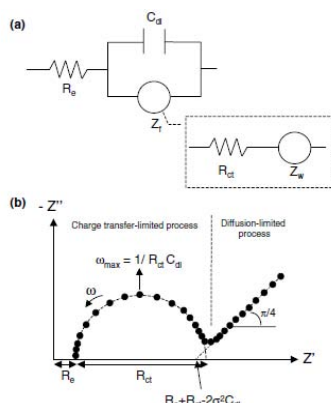
Fig. 1 (a) Randles equivalent circuit and (b) Nyquist Plot that describe impedance behavior of a simple electrochemical cell involving a single Faraday process

The Randles circuit is the simplest equivalent circuit that describes an electrochemical cell where a single-step Faradaic process in the presence of diffusion may occur (Fig. 1 (a)). It combines three components, namely the electrolyte resistance between working and reference electrodes (R_e), the double-layer capacitance (C_{dl}) and the Faradaic impedance due to the

charge-transfer process (Z_f) at the working electrode-electrolyte interface. Z_f is normally subdivided into a charge-transfer resistance (R_{ct}) and the so-called Warburg Impedance (Z_w), which reflects the influence of the mass transport of the electroactive species on the total impedance of the electrochemical cell. Thus, for those diffusion-limited processes, Z_w becomes dominant, whereas for those charge-transfer-controlled processes, Z_f is just R_{ct} . All these components can be identified by studying the variation in impedance of σ electrochemical cell over a wide frequency range (normally 100 kHz–0.1 Hz). A common way of showing the resulting data is the complex plane or Nyquist Plot (Fig. 1 (b)), in which the real (Z') versus the imaginary (Z'') components of the impedance are plotted. In this plot, two separate processes are very well differentiated, that is, a semicircle relating to a charge-transfer-controlled process, the intercept of which with the X axis gives R_e and R_{ct} values, and a straight line with a slope of 1 due to Z_w , whose extrapolation to the X axis allows calculation of the Warburg coefficient (σ), from which the diffusion coefficients of the electroactive species can be estimated. From the frequency at the top of the semicircle, where Z'' is maximum, the time-relaxation constant (τ) for the Faradaic process can also be calculated.

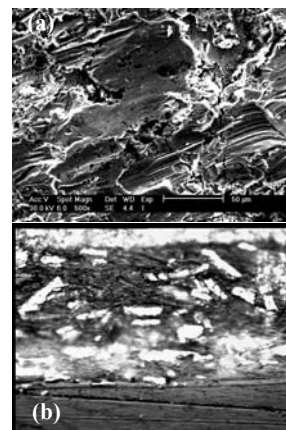
Fig. 2 (a) Cross section SEM micrograph on sandblasted Carbon steel (Sa 2.5) (b) Cross-section of the studied epoxy paint

The metallic substrate was X52 carbon steel (according to NF10027 standard) in conformity with the norm API (American Petroleum Industry), used in the tanker, the chemical composition of the tested carbon steel is given in Table I. Before coating application, the metallic substrate was sandblasted to Sa 2.5 (Swedish Standard SIS 05 59 00/67) (roughness Ra 6.2 μ m) or polished with emery paper up to G 400. Commercial epoxy was immediately applied onto steel panels using a brush or a roller (Fig. 2). Once cured, the samples were stocked in a desiccator until the moment of testing. The coating thickness was measured using an Elcometer gauge and was found around 80 μ m for all panels, the composition of the coating is proprietary information.

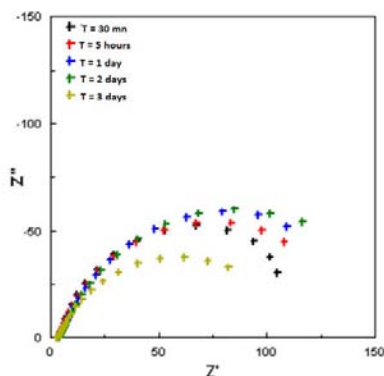
Fig. 3 Evolution of Nyquist diagrams as a function of immersion time in sea water for the sandblasted carbon steel

The Electrochemical Impedance Spectroscopy (EIS) measurement is carried out in sea water during 3 days, using sandblasted carbon steel panels (X52). The electrochemical impedance diagrams determined at different immersion times in sea water are shown in Fig. 3. The values of various parameters are summarized in Table II.

They are characterized by a single capacitive loop. As arcs are not centered on the real axis Z' for the calculation of R_p was extrapolated "low frequency" at zero frequency portions.

Analysis of the various electrochemical parameters shown in Table II, we note a significant increase in the polarization resistance R_{ct} between the first hours of immersion and the second day, beyond this time it drops to a value of 1.69 K Ω .cm². The gradual growth of R_{ct} for the first days of immersion (1.815 < t < 2.595), translated the film formation of corrosion products that grows with the immersion time [6] as rust layers consist mainly of hydroxides such as Fe(OH)₃ or an iron oxide Fe₂O₃.

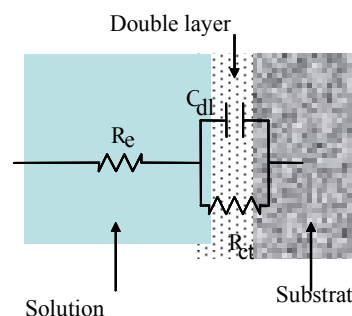
Fig. 4 Electrical circuits used to simulate the EIS results

The interfacial impedance is modeled in terms of equivalent circuit [7]. The electrical circuits that are used to simulate the EIS results are shown in Fig. 4.

The control of the electrochemical kinetics is under charge control, the contribution of the resistance of the electrolyte is simulated by R_e , the charge transfer resistance R_{ct} and the double - layer capacitance C_{dl} respectively. They are characteristic of the substrate.

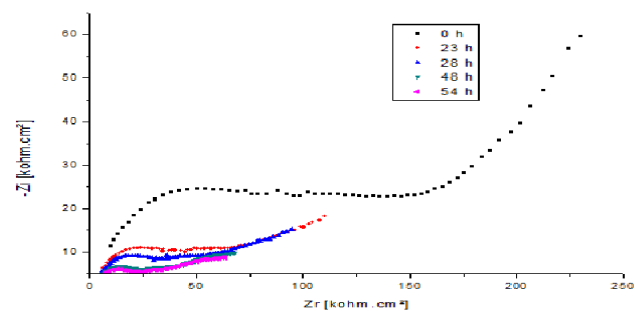
Fig. 5 Evolution of Nyquist diagrams as a function of immersion time in sea water for coated steel. (Z' , Z'' Ω .cm²)

The Nyquist impedance diagrams determined at different immersion times in sea water are shown in Fig. 5. The values of various parameters are summarized in Table III.

We note an evolution of the electrochemical parameters such as: the resistance of the electrolyte in the pores R_p , the transfer resistance of none covered metal R_{ct} , the capacity of the paint film C_f , and the resistance of diffusion σ .

The evolution of the electrochemical behavior of the covered material by epoxy paint in sea water, permits to conclude the existence of two capacitive loop (two constant of time) followed by a linear straight line inclined to 45°, This is a characteristic of the process of diffusion (WARBURG diffusion).

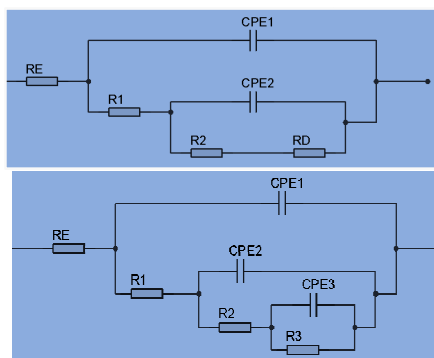
Fig. 6 Electrical circuits used to simulate the EIS results

The existence of a diffusionnel control is an indicator of the defective coating; this is confirmed by the decrease in the values of the diffusion resistance (R_d): 0.471 kΩ.cm²; 0.177 kΩ.cm² and 0.154 kΩ.cm². Fig. 6 shows the various electrical circuits related to the metal / paint interface immersed in sea water.

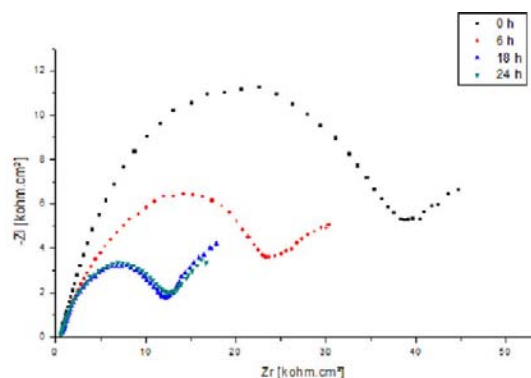
Fig. 7 Evolution of Nyquist diagrams as a function of immersion time in sea water for damaged (in-situ) paint

Damage is found by the formation on the paint layer of red rust due to the presence of oxide iron. The values of the parameters obtained through the EIS measurements on our damaged paint immersed in seawater are summarized in Table IV; Fig. 7 shows the evolution of the impedance spectra.

The impedance spectra represented in the Nyquist plane permits to conclude the existence of two capacitive loops followed by a linear straight line. According to the Nyquist

diagrams, several authors assign the loop at high frequencies to the intact part of the paint. Under the low frequencies, the processes become more and more slow. Thus, in some cases, the transfer resistance can be determined [9], [10]. At the limit of the low frequencies, a straight line is attributed to Warburg, interpreting this way the electrolyte diffusion phenomenon through the paint layer.

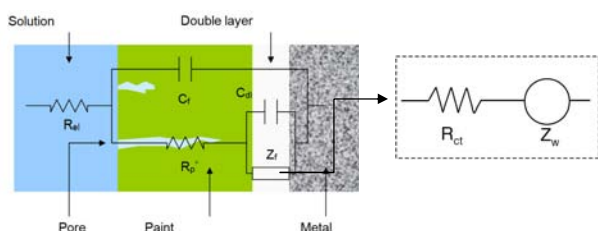
Fig. 8 Equivalent electrical circuit for a defective organic coating

As the diagrams of Nyquist, make to appear, the importance of the parameters R_p° , and C_f characterizing the performance of the coating for steel paints (Fig. 8), the impedance response of the coated electrode can be modeled by an equivalent electrical circuit simulating the interface coated metal/ electrolyte, corresponding.

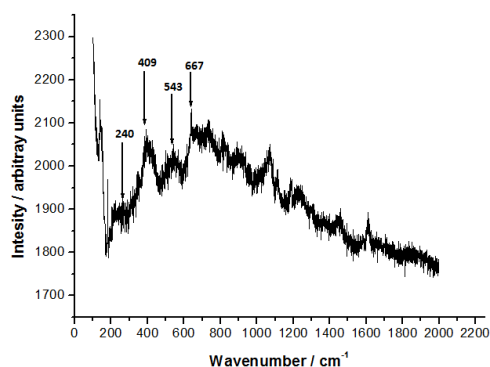
Fig. 9 Raman spectrum of the damaged paint at the interface film/electrolyte after immersion in seawater

In order to understand the behavior of epoxy paint, complementary analyzes were carried out. Raman spectroscopy analyzes were performed after immersion of the epoxy paint in seawater. This technique allows identifying locally zinc corrosion products inside the coatings. Representative spectra obtained for our sample are shown in Fig. 9, a characteristic peak was observed at 543 cm^{-1} which was attributed to a non-stoichiometric oxide Zn_{1+x}O [14], which is detected on some particles of zinc to some micrometers of the electrolyte/ coating interface whereas only the metallic zinc is detected on the other particles. This shape of the non-stoichiometric zinc oxide Zn_{1+x}O , where zinc ion is in interstitial position had been observed by [15]. Other corrosion products were detected inside the coatings and their characteristic wavenumbers. We detected additional peaks at 240.5 and 409.7 cm^{-1} attributed to simonkolleite [$4\text{Zn}(\text{OH})_2 \cdot \text{ZnCl}_2 \cdot \text{H}_2\text{O}$] The band around 667 cm^{-1} is related to the Magnetite (Fe_3O_4) [16].

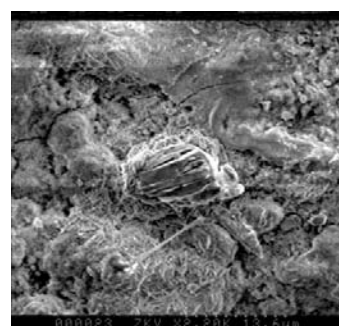
Fig. 10 SEM picture of the damaged epoxy paint in seawater

Cross section S.E.M. micrograph of damaged epoxy paint is shown in Fig. 10. It was clearly observed that the coating presented zones which did not contain zinc particles. Moreover, it can be seen that the zinc particle shape varied significantly from spherical to elongated forms. Most of the zinc particles were not in direct contact with the substrate. The oxidation of zinc in the coating creates the so-called “white corrosion”; the shapes of damage were under Cracks and scaling damage. White insoluble corrosion products are visible on the surface, the sample also presents a blister. The scheme outlines the possible reactions at the appearance of oxidation zinc products; these products are of alkaline nature and can manifest themselves in the neutralization protection mechanism [17].
