# A Review on Concrete Structures in Fire

S. Iffat, B. Bose

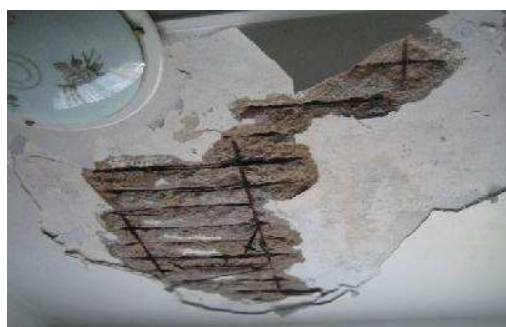
Fig. 3 Spalling of concrete

Spalling may significantly reduce or even eliminate the layer of concrete cover on the reinforcement bars, thereby exposing the reinforcement to high temperatures, leading to a reduction in the strength of the steel and hence a deterioration of the mechanical properties of the structure as a whole.

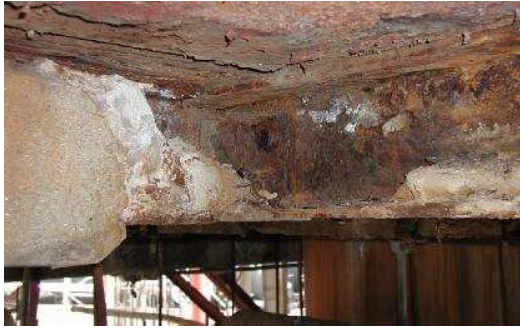
Fig. 4 Crack development in concrete structure due to fire

Geogali & Tsakiridis [31] made a case study of cracking in a concrete building subjected to fire, with particular emphasis on the depths to which cracking penetrates the concrete. It was found that the penetration depth is related to the temperature of the fire, and that generally the cracks extended quite deep into the concrete member. Major damage was confined to the surface in close proximity to the fire origin, but the nature of cracking and discolouration of the concrete pointed to the concrete around the reinforcement reaching 700°C. Cracks which extended more than 30 mm into the depth of the structure were attributed to a short heating/cooling cycle due to the fire being extinguished.

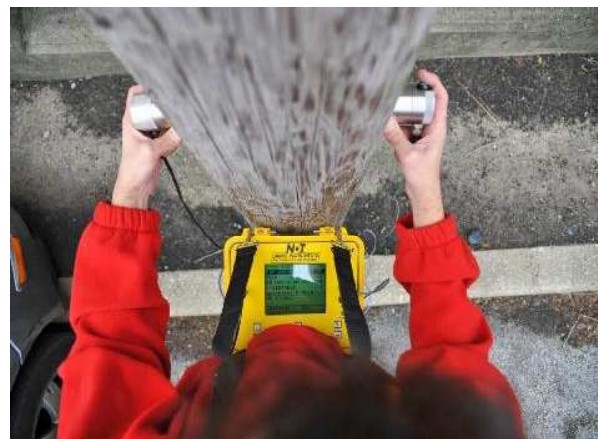
Fig. 6 UPV testing of concrete member

The UPV (Ultrasonic Pulse Velocity) measurement (Fig. 6) is one of the various non-destructive test methods used to evaluate concrete integrity and – more generally – the level of damage in the material. In particular, the velocity of sound in concrete is a high-quality thermal-damage indicator, due to its sensitivity to any change of the Young's modulus. When concrete is exposed to fire, the increase of temperature in the deeper layers of the material is rather slow and progressive. Because of this (due to the rather low thermal diffusivity of concrete), this process produces significant temperature gradients between the outer and inner layers of any given concrete structure (i.e. between the surface and the core). UPV technique may also be applied to determine the reduced quality of concrete by means of indirect or direct techniques on cores [36], [37].

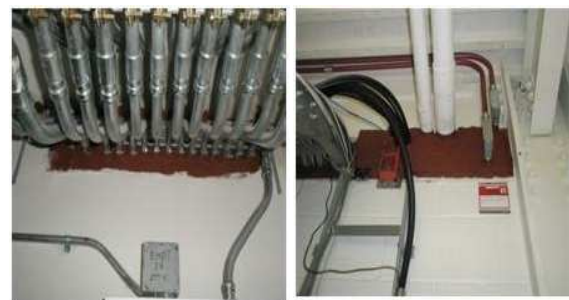
Fig. 9 Fire penetration protection system

Penetrating items are steel, ferrous or copper pipes, tubes or conduits. Annular space between the item and the fire-resistance-rated wall must be filled to maintain the fire-resistance rating with filling material - concrete, grout, or mortar (Fig. 9). Separation in buildings by structural elements prevent horizontal and vertical spread of fire [39]
