# Identifying Karst Pattern to Prevent Bell Spring from Being Submerged in Daryan Dam Reservoir

**Abstract**—The large karstic Bell spring with a discharge ranging between 250 and 5300 lit/ sec is one of the most important springs of Kermanshah Province. This spring supplies drinking water of Nodsheh City and its surrounding villages. The spring is located in the reservoir of Daryan Dam and its mouth would be submerged after impounding under a water column of about 110 m height. This paper has aimed to render an account of the karstification pattern around the spring under consideration with the intention of preventing Bell Spring from being submerged in Daryan Dam Reservoir. The studies comprise engineering geology and hydrogeology investigations. Some geotechnical activities included in these studies include geophysical studies, drilling, excavation of exploratory gallery and shaft and diving. The results depict that Bell is a single-conduit siphon spring with 4 m diameter and 85 m height that 32 m of the conduit is located below the spring outlet. To survive the spring, it was decided to plug the outlet and convey the water to upper elevations under the natural pressure of the

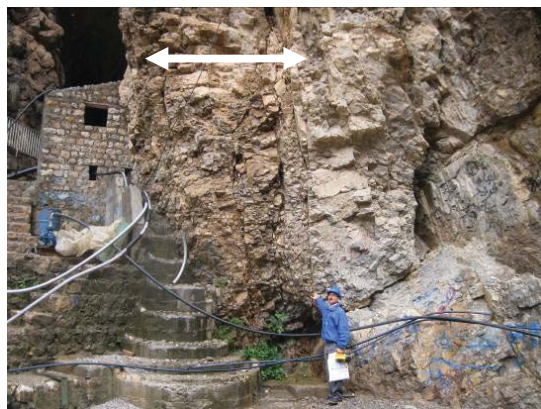
Fig. 5 Fractured zone of CBF

The spring outlet has been formed along this strike-slip fault. The fault dip is between 75 to 80 degrees and its dip direction is NE Fig. 4 (a). The fracture zone width of CBF around the spring is about 7 m (Fig. 5).

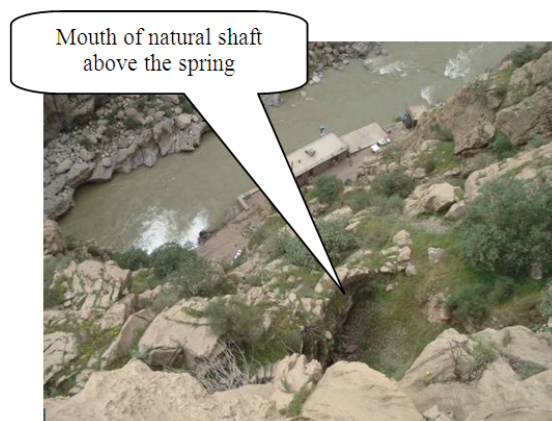
Fig. 6 Mouth of natural shaft before removing the infilling materials

An about 4 m diameter shaft with the height of about 52 m is another karstic feature around Bell Spring. The shaft was filled by angular materials (Fig. 6). After removing the materials, it was realized that the shaft is actually the remains of the old siphon conduit of the spring which has dried as a results of the formation of new outlets at lower levels (Fig. 7). The shaft is located in the intersection of CBF and F7. The shaft outlet is located at el. 770 masl.

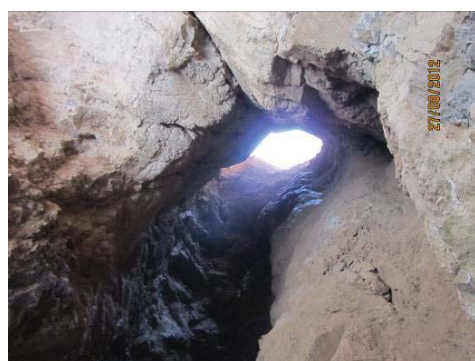
Fig. 7 Natural shaft after removing the infilling materials

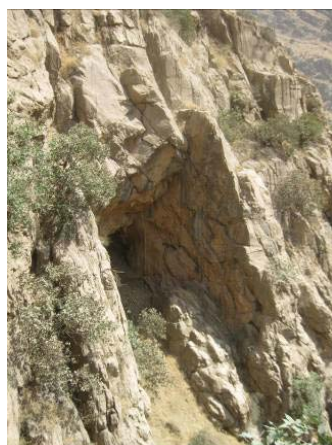
Fig. 8 Old spring conduit

The old outlet of the spring is located in about 28.5 m above the bottom of the present spring outlet at el. 746 masl (Fig. 8). After removing the materials via excavating G3 Gallery (Fig. 9), it was realized that the old conduit is a branch of the natural and vertical conduit of the spring or the natural shaft.

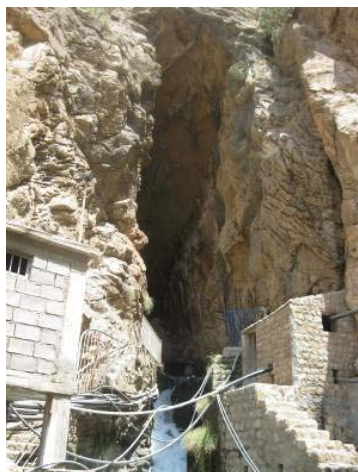
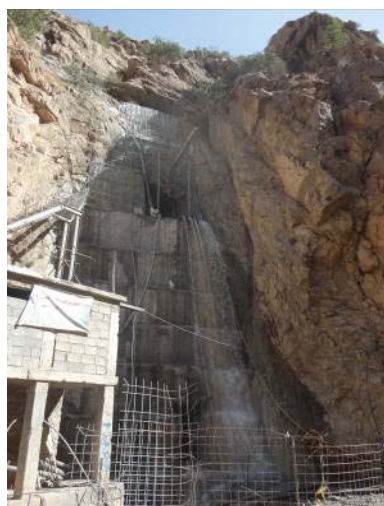
(a) Before plugging

(b) After plugging

Fig. 11 Natural outlet and plugging of the spring

The surface and sub-surface investigations depicted that Bell is a single-conduit siphonal spring (at least for 150 m distance to the spring outlet). Hence, it was decided to study on the alternative of water abstraction from karstic conduits in a distance not so far away from the spring outlet. This is one of the methods approved as for abstracting water from the karstic springs all around the world. The low permeable surrounding rocks of the conduit gave rise to the study on plugging the spring and conveying water to the upper levels under the pressure of the aquifer. In this plan, the siphon was plugged just from the shaft constructed at BH-24 location toward the spring outlet (Figs. 9 (b) or 11 (b)).
