Experimental and Finite Element Study of Bending Fatigue Failure: A Case Study on Main Shaft of a Gyrator Crusher

Rahim Sotoudeh Bahreini, Alireza Foroughi Nematollahi, Akbar Jafari

Keywords—Fatigue failure, finite element method, gyratory crusher, condition monitoring.

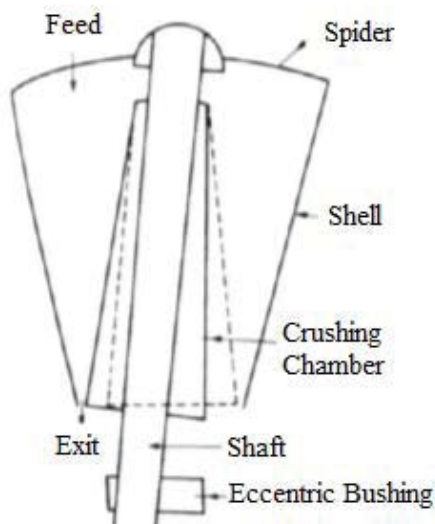
Fig. 1 A general view of Gyratory crusher [2]

crushers are more common in mineral processing lines. The Jaw crusher, as its name demonstrates, acts as mouth of some animals; it crushes the ore such like it chews it. This type of crusher is used in low to medium feed rate of material. For higher feed rate, Gyratory crushers are chosen [2]. Fig. 1 shows schematic of Gyratory crusher, and a more complete view is shown in Fig. 2. It can be seen that the central main shaft which is covered with abrasion resistant liner is rotating pendulum-like at the center of conical shell. This reciprocating movement causes changes in size of the exit area of crusher; therefore, ore crushing process is done by this mechanism. In fact, this type of crusher can be assumed as infinite number of very small jaw crushers located on the circumference of a circle. Regarding this description, it can be concluded that the efficiency of Gyratory crusher is much higher than jaw crusher. Although there is no exact equation for calculating the capacity of the crushers, it can be empirically said that, in the same condition of output size, capacity of Gyratory type is about three times of the Jaw crusher. Also, Gyratory type is recommended when the capacity of production line is more than 900 t/h. In addition, in a similar capacity due to the circular shape, the required space for Gyratory type is less than jaw crusher. Moreover, due to severe fluctuation of stress during the operation, a stronger foundation and supports are needed for Jaw crusher [2]. According to the special technology of crusher, very small numbers of manufacturers are able to manufacture and maintain the equipment. Also, providing spare parts leads to high costs of repair and maintenance. Thus, it is necessary and inevitable to study design optimization, improvement of equipment, and how to operate it better. Literature review indicates that focuses of research works are based on empirical analysis, particularly dealing with internal friction and abrasion of components of this type of equipment [4]-[6]. Accordingly, a good profile of the central shaft has been proposed for better crushing [7]. Furthermore, because of high energy consumption of this equipment, the optimal choice of that has been investigated [8].
