Protection of Floating Roof Petroleum Storage Tanks against Lightning Strokes

F. M. Mohamed, A. Y. Abdelaziz

III. PROBLEM DESCRIPTION

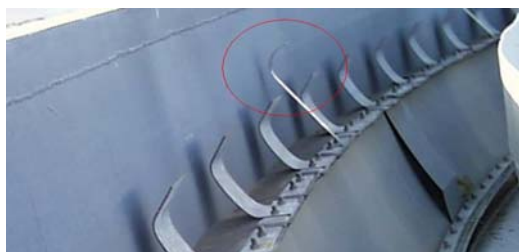
- 1) Dissipation array system (DAS) located above the telecom tower.
- 2) Spline pole system (SPS) located above lighting tower.
- 3) The shell is bonded to the tank through (shunt straps), and there was damage in some of these shunt straps; consequently, it is not connected to the tank shell as per Fig. 2.
- 4) The existing shunts are not electrically connected to the tank shell because of the heavy crude oil components, such as wax, tar, and paraffin, etc., that cover the inner wall of the tank, and thus breaking the electrical connection between the tank shell and shunts.

Fig. 2 Shunt not making contact with Out-of-Round Tank Shell [1]

- 1) The existing lightning protection system around the tank failed to absorb the lightning strokes and failed to provide a protection of the tanks against lightning strokes.
- 2) There is damage in the existing shunt strap system, and also, the tank inside wall is coated with heavy crude oil which leads to the discontinuity between the tank shell and the shunts which lead to the firing of the tank rim seal.
- 3) The company should review all the existing shunt straps, and replace the damaged shunt straps with new ones, change the tank rim seal, make necessary maintenance

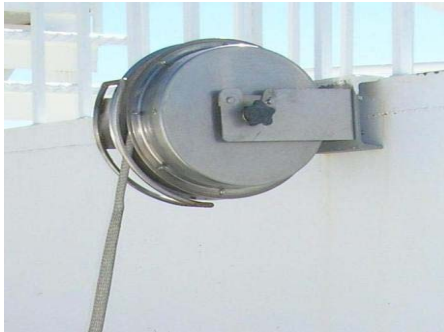
Fig. 3 LEC Retractable Grounding Assembly (RGA) on Floating Roof Tank [1]

- 3) It is also common practice to install bypass conductors between the roof and the tank spaced at intervals no more than 30 m around the circumference of the floating roof. For the new floating roof tank that shall be under our case study, it has a length of at least 49 m because the dimension of the tank (90 m diameter and 18 m in height). The installation of the bypass conductors is easy, inexpensive, and can be installed on both new and existing tanks. The bypass conductors shall have an impedance that is less than that of presented by shunts, so it shall attract the intermediate and long-duration component of the lightning-stroke current to pass through it rather than the shunts. However, the bypass conductor end-to-end voltage may be so high as to cause a dielectric breakdown of the insulating surrounding air. This lead the tank owners to use a retractable conductor wound on a spring-tensioned reel (RGA), instead of the standard conductor. Lightning Eliminators & Consultants (LEC) [1], has developed a roof-shell bonding mechanism (RGA) which is better than the conventional type of bypass conductor. RGA is complete with a spring to retract the conductors on the wheel. The length of the bypass conductor is always keeping the minimum length regarding the location of the floating roof at the top or the bottom of the tank. Also, a typical retractable grounding assembly (RGA) of floating roof tank is shown in Fig. 3. Due to the large diameter of the floating roof tanks (FRT's), and order to increase the electrical connection between the roof and the shell of the FRT, it is recommended to install multiple RGA's on the floating roof tank. The RGA should be installed at intervals no more than 30 m around the circumference of the floating roof [1]: so, in our case, the recommended number of RGA's shall be not less than 10 m, as the tank diameter is 90 m, and the circumference is about 285 m. Although RGA is better than conventional cables, it provides optimal solution for the tank protection against lightning

- 4) Installation of the retractable bypass conductor (RGA's), in addition to the existing shunt straps system, can be installed to existing and new tanks in the future.
- 5) Checking that all the tanks in the zone of the tank fire are connected to the earthing network, as per the applicable code.
- 6) Installation of an Early Streamer Emission (ESE) air terminal system on the tank shell according to the tank diameter.
- 7) Performing lightning risk assessment analysis for the new floating roof tanks that shall be installed in areas subjected to frequent lightning activity.
