Structural Engineering Forensic Evaluation of Misdiagnosed Concrete Masonry Wall Cracking

Abstract—Given that concrete masonry walls are expected to experience shrinkage combined with thermal expansion and contraction, and in some cases even carbonation, throughout their service life, cracking is to be expected. However, after concrete masonry walls have been placed into service, originally anticipated and accounted for cracking is often misdiagnosed as a structural defect. Such misdiagnoses often result in or are used to support litigation. This paper begins by discussing the causes and types of anticipated cracking within concrete masonry walls followed by a discussion on the processes and analyses that exists for properly evaluating them and their significance. From here, the paper then presents a case of misdiagnosed concrete masonry cracking and the flawed logic employed to support litigation.

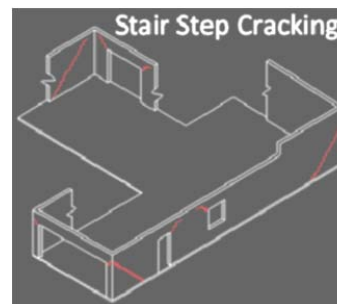
Fig. 1 Stair Step Crack Mapping

As previously discussed, the most common types of cracking manifest consist of stair step mortar joint cracking, horizontal joint cracking and vertical cracking. For purposes of analysis it is often helpful to map the locations and configurations of the cracking observed. This mapping serves to record the configuration, orientation and extent of propagation of the cracks manifest. See Figs. 1 and 2 for examples of crack mapping showing the types and common locations of cracking.

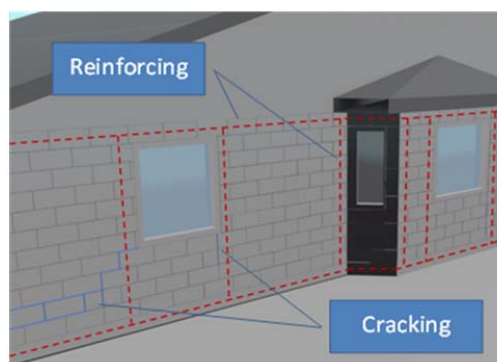
Fig. 3 As-observed by engineer #2

The [structure] exhibited signs of widespread negligible (hairline) to very slight (~ 1/32") masonry cracking. The majority of this cracking is the result of differential settlement of the foundation [shown in Fig. 3].

The location of vertically-orientated rebar/concrete filled masonry block cells were identified and found to be on either side of every opening and at a maximum spacing of 8 feet within the field of the walls [shown in Fig. 3].

Clearly, based on the fact pattern as presented, Engineer #2 has failed to consider the impact of anticipated cracking as the cause of the negligible, non-structural “hairline” to “very slight” ($< 1/32$ " or 0.8 mm) masonry cracking observed. In addition, Engineer #2 neglected to consider the full impact of the reinforcing within the wall.

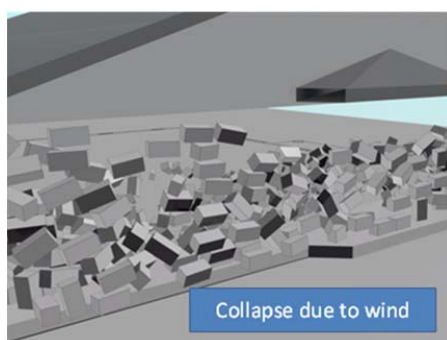
Fig. 4 Failure as theorized by Engineer #2

- 2) During the wind load case, considering that both uplift axial and out-of-plane bending forces must be transferred and resisted by the masonry structural components (masonry, mortar and the bond between the two) at the same time, the uplift counteracts the gravity loads limiting the flexural capacity gained by self-weight and dead load. Therefore, a wall segment that has been weakened by consecutive settlement related cracks may not adequately resist the building code mandated out-of-plane loads resulting in the failure shown in Fig. 4.

- 3) When the wind blows it will generate sufficient uplift to “lift the roof” off its supporting walls and relieve all axial loads,
- 4) Because the wall has cracks, it is incapable of resisting out-of-plane bending,
- 5) With no axial load to resist bending, the cracking will allow the wind to blow the wall down, and
- 6) If the wall cannot resist wind loads, it is structurally compromised.

This failure to consider causes other than differential settlement, combined with a failure to consider the impact of the reinforcing, combined with a failure to perform any computational analysis in support of the opinion, resulted in a catastrophically flawed analysis which was used to promote and prolong litigation. Furthermore, continued failure to consider anticipated causes of cracking within concrete masonry walls combined with a failure to perform a proper analysis, will only continue to result in or be used to support litigation.
