Assessment of Rehabilitation Possibilities in Case of Budapest Jewish Quarter Building Stock

Viktória Sugár, Attila Talamon, András Horkai, Michihiro Kita

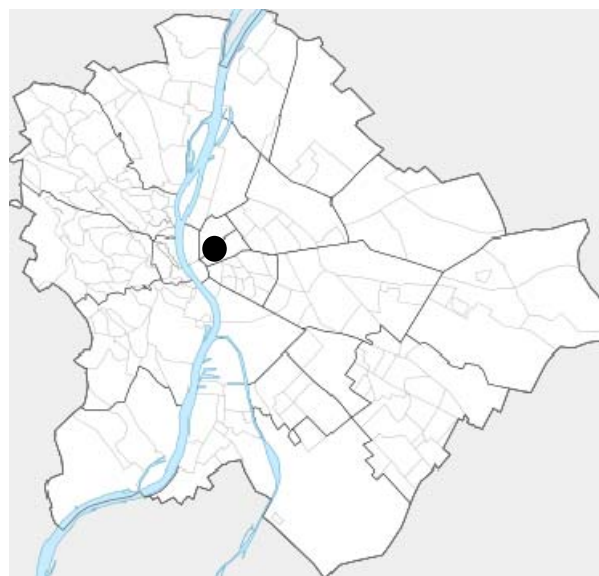
Fig. 1 The Old Jewish Quarter of Pest, in today's District 7 of Budapest [3]

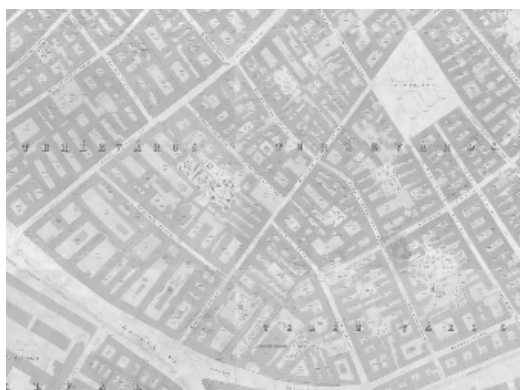
Fig. 2 Characteristic urban fabric of the turn of the 19th and 20th century in the district [4]

Until Joseph II, Emperor and King of Austro-Hungarian Empire, legislated the Patent of Toleration in 1783, Jews were prohibited to enter the walled Pest, and were also not allowed to settle until 1786. A law of 1840 at last permitted them to own real estate, until then, their praying rooms and apartments were also in rented houses. Naturally, the establishment started around the Jewish Market outside the city wall, alongside the main street of the area: Király Street (King Street, King of England Street at the time, Fig. 2) [2].

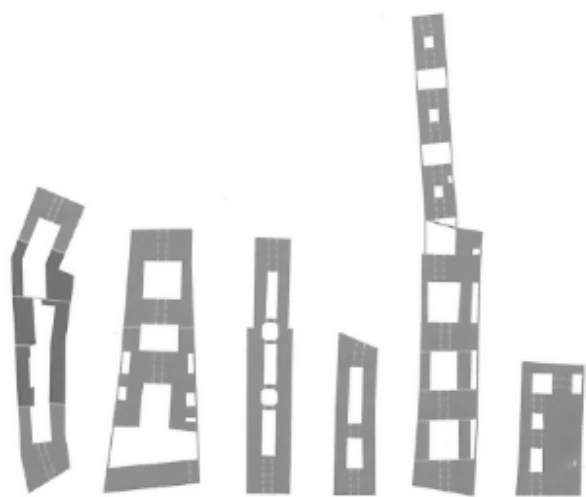
Fig. 3 Passage houses- chain layout connecting the streets and opening up the deep block for commercial life [2]

At the same time, the first passage houses (Fig. 3) and pedestrian crossings have developed through the deep blocks, later grown into a full system. The passage houses and crossings expanded the commercial life, at the same time

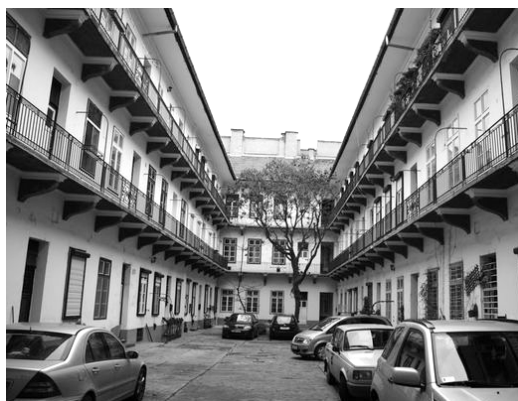
Fig. 7 Larger inner courtyard in the Jewish Quarter of Pest (Photo is courtesy of Kővári Csenge, Mészáros Mónika and Hegedüs Marcell – Ybl Miklós Faculty of Architecture)

In case of every architectural era, the enclosed geometry of the tenement houses with inner courtyard can be marked as characteristic. However, due to the higher ratio of early buildings, more L, U, or enclosed structure remained with spacious courtyard (Figs. 6, 7) – which is unique compared to the adjacent districts.

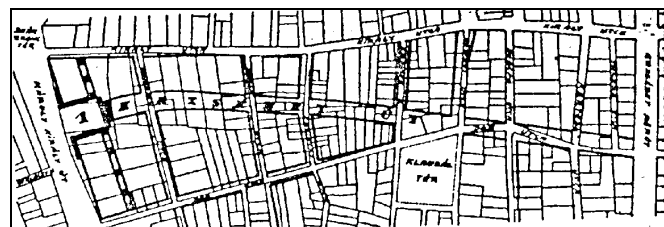
Fig. 9 Plan of Madách Boulevard – only the opening on the left part was finished [7]

The project of Madách Sugárút (Madách Boulevard) has been the most grandiose intervention in the mainly organic structure. The idea of the first so called Erzsébet (referring to Queen Elisabeth again) then later Madách Boulevard was first introduced in the beginning of the 20th century. The concept was to open a main road to rival the nearby Andrassy Boulevard, which is ever since its opening has been the most important avenue of the area. Several plans were created, from which in 1930's, the complex of 11 interlocking buildings were built with a great gate motif to open up the densely built in inner parts. The plan however halted here, and only the beginning of the boulevard was built (Figs. 8, 9) [8].

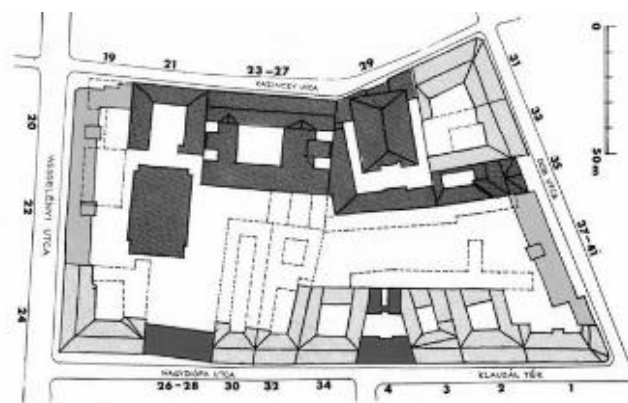
Fig. 11 Sample Block Nr. 15 after rehabilitation. The demolished wings are marked with dashed line [13]

The Erzsébetváros rehabilitation was started with the Sample Block Nr. 15 (Fig. 11).

The Sample Block Nr 15. contained a synagogue and other ecclesiastic buildings. Out of the existing 303 flats, 150 were

demolished, to build 170 in entirely new buildings. The average 49 m² floor space of the existing flats were enlarged averagely to 65 m². The inside of the blocks were rebuilt as parks and playgrounds. Between 1982 and 1985, the construction was finished. Above residential development, the public buildings (a university, a museum and offices) were renovated or given new buildings. Majority of the new residents were the same as before, or moved here from the adjacent blocks [11].

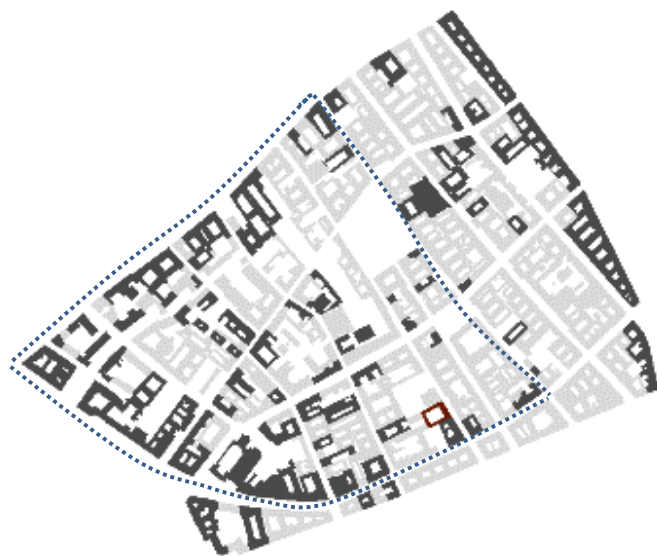
Fig. 12 Buildings under individual protection is shown with darker shade, the UNESCO buffer one area is marked by dotted line. It is also a conservation area. Based on [7]

As acknowledgement of its significance, it became part of the UNESCO World Heritage Area, which consist of the Buda Castle Hill, the Danube banks, the Andrásy Avenue (Fig. 12).
