# Assessment of the Number of Damaged Buildings from a Flood Event Using Remote Sensing Technique

**Keywords**—Flooding extent, Sentinel-1A data, JOSM desktop, damaged buildings.

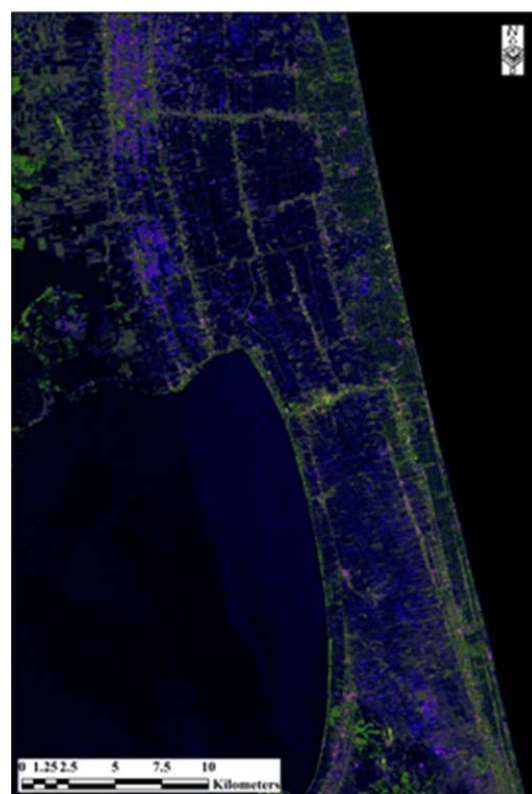
Fig. 3 (a) pre-flood is no flooded situation, and (b) during flood event is occurring

(a) Pre-flooding

(b) during flood event

The SAR-C data were classified by spectral values based on histogram thresholding. The results showed that the 1<sup>st</sup> image (28<sup>th</sup> December 2016) had 0-0.065 (water area) and 0.066 - 21.78 (land area), and 2<sup>nd</sup> image (9<sup>th</sup> January 2017) had 0-

0.0762 (water area) and 0.0762 -10.5 (land area). The thematic maps were compared using Sentinel-1A data as shown in Fig. 2 and these classification maps are used to identify flooding extent (Fig 4).

Firstly, the pre-processing stage included calibration, speckle filtering, and geometric correction. These methods were conducted on the Application Platform (SNAP) version 4.0 software, and it is free software to process Sentinel data as well. The antenna pattern of the data was corrected to create new products with calibrated values of the backscatter of coefficient. Then, the improvements of new products were performed by Lee filter with widow 7x7 based on speckle filtering. The geometric correction was used to re-project coordinated system (Geography projection), and the image data were re-sampled to 8 m x 8 m (Fig. 3) [7], [5].
