Energy Saving, Heritage Conserving Renovation Methods in Case of Historical Building Stock

Viktória Sugár, Zoltán Laczó, András Horkai, Gyula Kiss, Attila Talamon

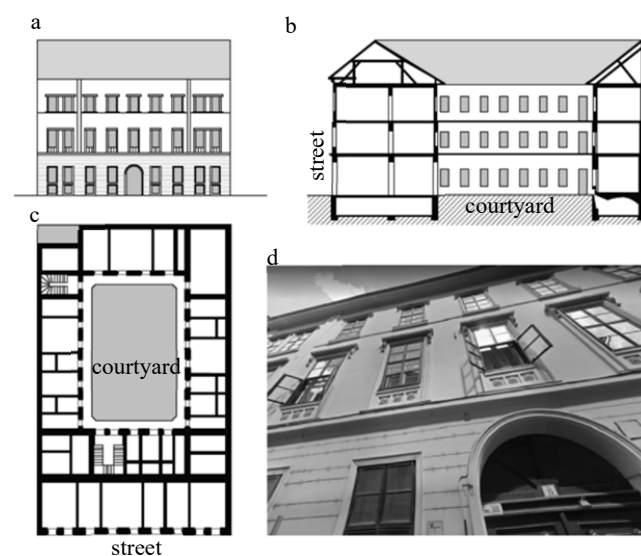
Fig. 1 Characteristic multi-apartment residential building in Budapest. (a) Street front façade. (b) Cross section, (c) First floor plan, (d) Façade detail with historical style elements

Fig. 1 shows an example of the aforementioned type. Usually, this type has been functioning as condominium with different size and variously equipped flats. The building is built around a courtyard. The street front wing is – as usual in this type – more decorated, containing larger flats. Traditionally, the owner or a rich renter occupied these. The courtyard wings contain simpler flats, often only with a kitchen and a room. Older examples of the type have common lavatories at the end of the corridors, as a conventional solution of hygiene in the 19th century.

The courtyard can be accessed by using the gate on the street front. Near the gate is the main staircase. The flats on the upper stories can be entered from the hanging corridors running parallel the walls. This type is mostly built in an unbroken row along the narrow streets of the 19th century Pest, connecting to each other with firewalls on three sides.

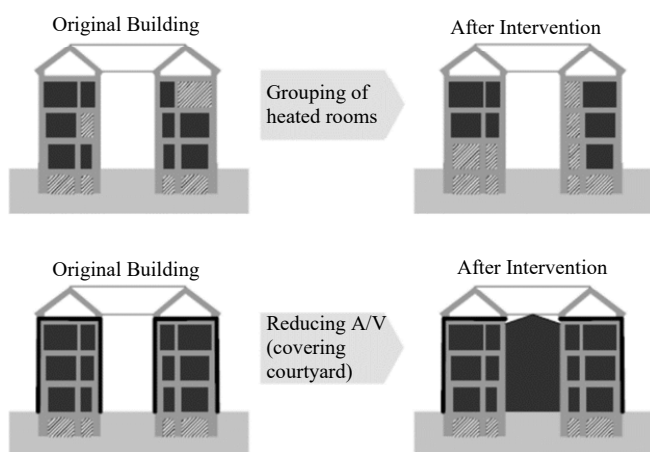
Fig. 2 Architectural intervention examples in case of historical buildings of Budapest (black color represents the heated volume)

To reduce the energy demand, the following architectural interventions can be utilized (examples on Fig. 2):

- reducing the heated volume,
- reducing the enveloping surface area per heated volume (A/V) ratio (for example covering the inner courtyard),
- repositioning (grouping) of heated rooms,
- increasing solar gains by new openings.

As a modification of the above scenarios, we calculated the effect of covering the inner courtyard also (as shown on Fig. 2), thus decreasing the enveloping area but increasing the heated volume. Thus, the above scenarios have two versions: original geometry and modified geometry.

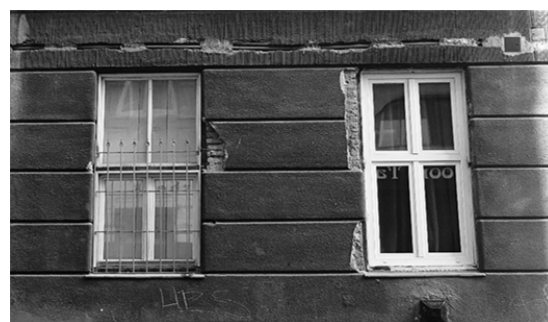
Fig. 3 Disagreeable modernization of a window by neglecting historical values (photo of Attila Zsoldos BSc Architect student)

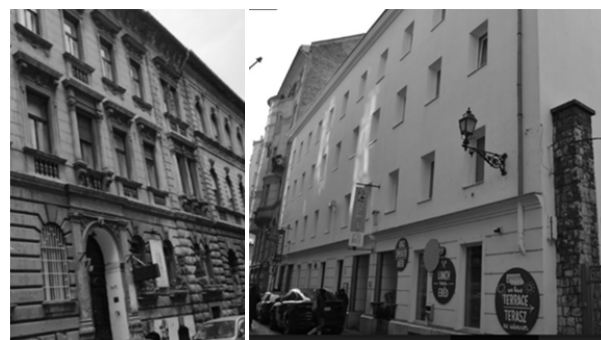
Fig. 4 Traditional building with original decoration, and a same age building with external insulation on a historical building,

Fig. 4 shows a once historical building after application of external insulation, and compared to it, a façade of a same age building: the standard insulation sheets clearly damaging the appearance of the building.

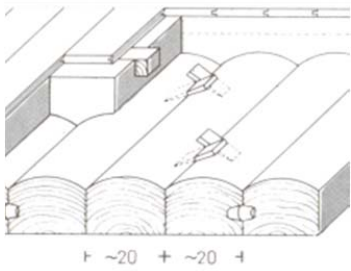
| Elements of the building envelope | | U (W/m ² K) |
|---|--|---|
| Attic slab | | |

| Elements of the building envelope | | U (W/m ² K) |
|---|--|---|
| | Existing state Wooden slab: clay (6cm); wooden beams (20cm); reed (1.5 cm); plaster (2cm) | 0.64 |
| | Standard refurbishment Additional 12 cm external insulation on top of existing structure | 0.23 |
| | Ambitious refurbishment Additional 28 cm external insulation on top of existing structure | 0.12 |

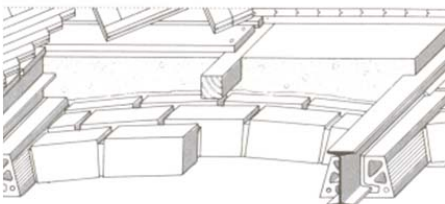
| Elements of the building envelope | | U (W/m ² K) |
|---|--|---|
| Cellar ceiling | | |

| Elements of the building envelope | | U (W/m ² K) |
|---|--|---|
| | Existing state Prussian vault: ceramic tiles (2 cm). concrete (5 cm). boiler slag infill (15 cm). brick vault between steel beams (12 cm) | 0.97 |
| | Standard refurbishment Additional 10 cm insulation on the underside | 0.35 |
| | Ambitious refurbishment Additional 20 cm insulation on the underside | 0.21 |

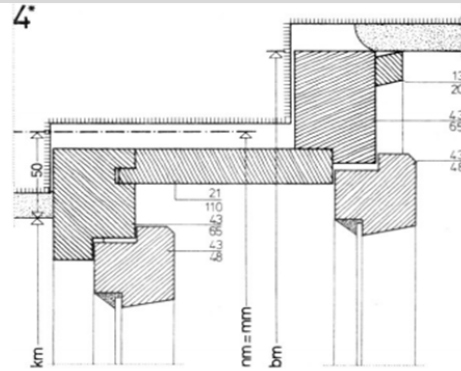
| Elements of the building envelope | | U (W/m ² K) |
|---|--|---|
| Window | | |

| Elements of the building envelope | | U (W/m ² K) |
|---|--|---|
| | Existing state Box-type wooden window with single glazing | 3 |
| | Standard refurbishment Window with double-glazing, low-e coating and argon gas filling | 1.6 |
| | Ambitious refurbishment Window with triple-glazing, low-e coating and argon gas filling | 1 |

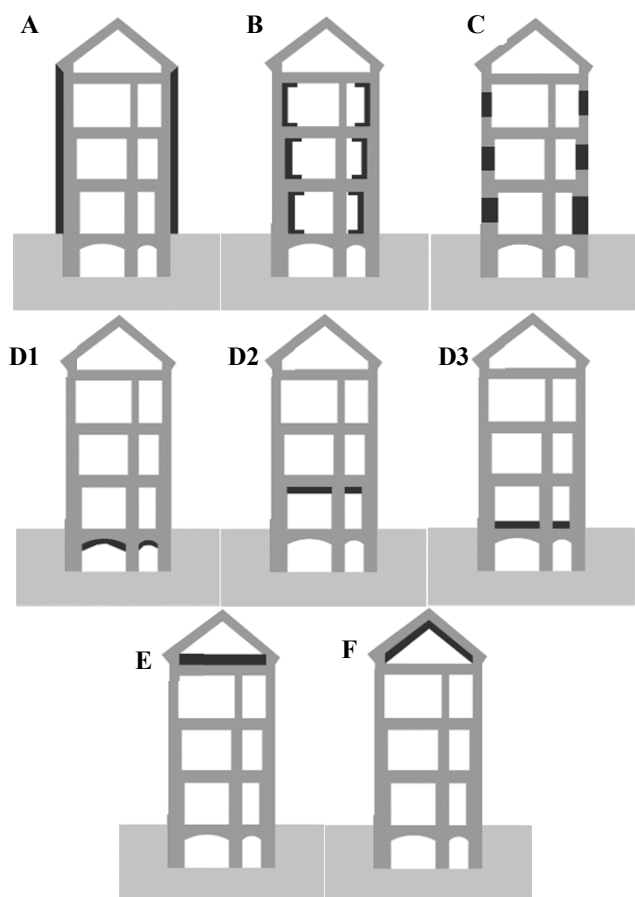
Fig. 5 Heat insulation possibilities on enveloping structures in case of heritage respecting modernization A: Outside insulation of the facade, B: Inside insulation of the facade, C: Window renovation, D: Bottom slab insulation; D1: Underside insulation of cellar vault, D2: Underside insulation in case of arcade, D3: Floor insulation, E: Closing slab insulation under pitched roof, F: Pitched roof insulation

Apart from the above, there are several options for enveloping surface insulation. Fig. 5 shows the possible insulated surfaces of the given type in case of heritage

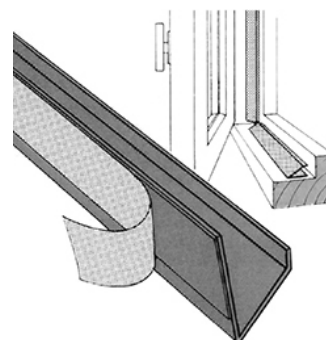
Fig. 10 Plastic filling for U value decrease [16]

First and foremost, as these wooden-glass structures are average 120-year-old windows, their connection points are mostly displaced, the wings are warped. By correcting the warping and using for example plastic strips (Fig. 10) to level out the uneven surfaces, the thermal transmittance value (U , W/m^2K) can already be decreased from $2.23 W/m^2K$ to $2.12 W/m^2K$ [7].

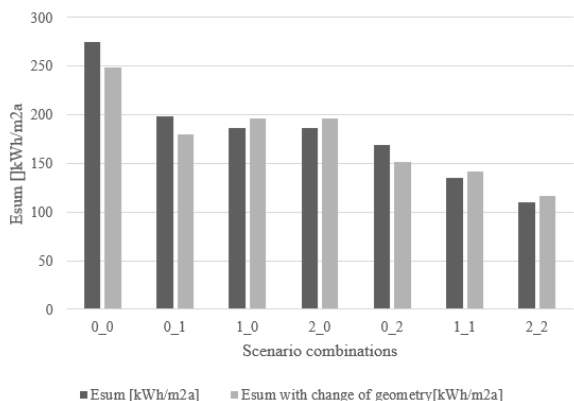
Fig. 11 shows the results of Table IV on diagram which includes the total energy usage of the building in case of the above variations, either in case of original (darker shade) and changed geometry (lighter shade).

The original state (0_0) of the building with either geometry variation uses the largest quantity of energy. In this case, the covered courtyard as a modification decreases the energy usage in response to the change of A/V ratio. Variation 2_2 is the most energy saving solution, offering 60.1% saving of energy in case of original structure and 53.3% in case of covered courtyard. Also, the CO₂ emission of the building decreases by 60t/year in with these scenarios.

In case of combination 1_0 and 2_0 the enveloping structures had been upgraded, which is resulting a significant

decrease of energy intake; however, in these cases the geometry modification increases the energy intake. The explanation of this is the following: the heated volume is increased slightly, but these two scenarios are not containing the engineering modernization, the engineering is the original, not effective convector heating, which increases the energy usage compared to the non-changed geometry. Also, in case of 1_1 and 2_2, the covered courtyard does not decrease the energy intake, the increased heated volume has more effect on energy intake than the decreased enveloping surface ratio.
