Restoring, Revitalizing and Recovering Brazilian Rivers: Application of the Concept to Small Basins in the City of São Paulo, Brazil

Juliana C. Alencar, Monica Ferreira do Amaral Porto

Keywords—Sustainable drainage, river restoration, river revitalization, river recovery.

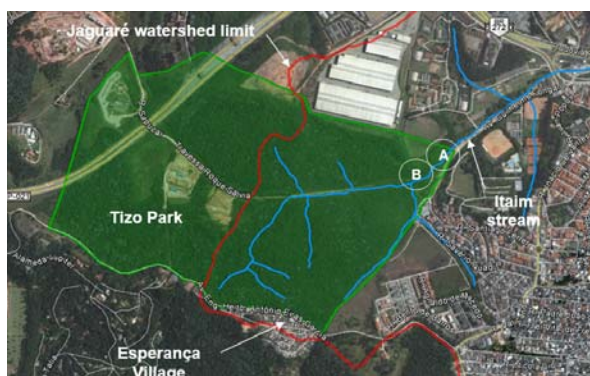
Fig. 2 Location of the Itaim stream in Tizo Park. Source: Prepared by the author from Google Earth Pro

For the application of these steps and elaboration of a restoration proposal, the area of Itaim stream was chosen, a greater tributary of the Jaguaré stream that is inside Tizo Park. Although the springs have been protected since the creation of the park, they are influenced by the pollutant loads coming from the external areas and diffuse loads coming from Esperança Village, which borders the park. Fig. 2 shows the location of the Tizo park area in green and the Itaim stream within the park.

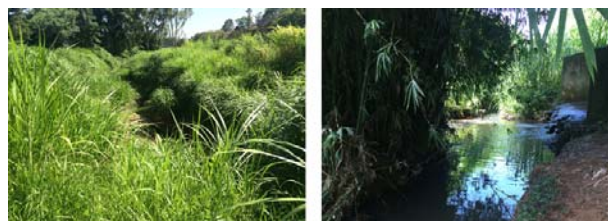
Fig. 3 Itaim stream in Tizo Park. Source: Photos of the author

In addition to the threats due to the release of pollutant loads, the channels within the park are not in totally natural conditions, and not integrated with the park goers. The section near the entrance to the park has its banks taken by tall exotic vegetation, which prevents access and even the view of the channel, as shown in Photo A of Fig. 3. Photo B of the same figure shows a second stretch of the canal where access is possible, but that presents the banks that are eroded and

without vegetation.

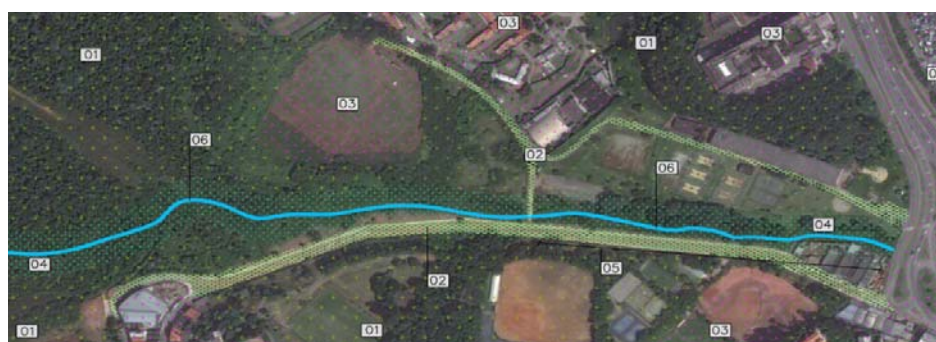
Fig. 5 Proposal for restoration of Itaim stream in Tizo Park. Source: Prepared by the author

Legend: (01) Area that demands environmental enrichment; (02) Road that requires green infrastructure; (03) Buildings and facilities; (04) Requalification of the floodplain area; (05) Zone next to the visitation area: demands water observation equipment; (06) Requalification of the channel.

Itaim stream has enormous potential for restoration since it is inserted in a context of vegetal remnant under protection; in this way, a series of measures were proposed for restoration, in order to attend the set of detailed techniques, as presented in the section of Figs. 4 and 5.

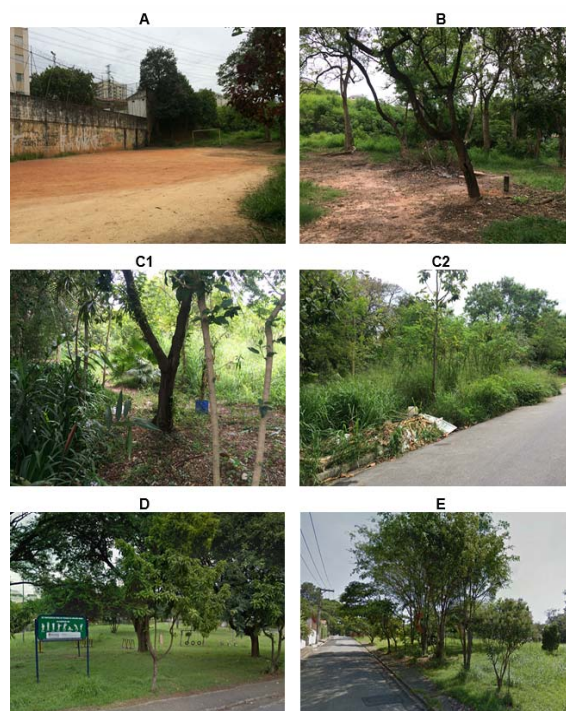
Fig. 7 Evandro Valério Square in the Jaguaré watershed. Source: Photos of the author

Fig. 7 shows emblematic points of the squares. Point A shows a football field installed by the population; photo B, photo C1 and photo E illustrate the density of vegetation at different points; photo C2 shows the lack of maintenance in one of the stretches, where vegetation invades the sidewalk, which ends up encouraging the inadequate deposit of waste by the population; and photo D shows an excerpt that has public equipment for sports practices.

The square also houses a spring that has a contribution from the underground aquifer, since it remains in the landscape with significant flow even in the dry season (Volumetric flow on 08/10/2015 = 0.33L/s), which is used intensively by the population for water abstraction for non-potable uses. In a 30-minute observation period from the source on a Saturday,

eight users were registered visiting the source for water collection (gallons) and car wash. The spring (photo G) was treated by the municipality service through the construction of a gravel trench, according to a resident, who directed the water to a catchment point where the population captures the waters (photo H2).

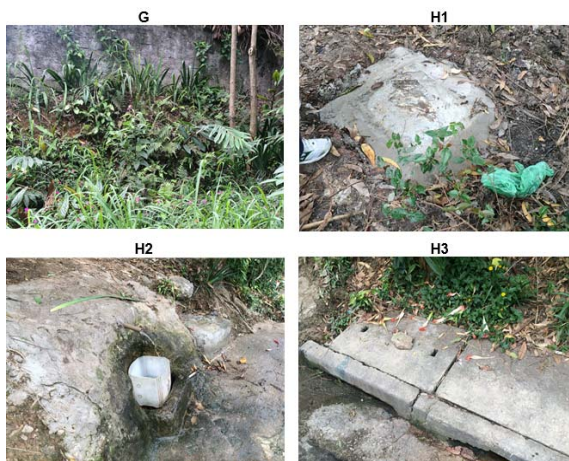
Fig. 8 Spring in Evandro Valério Square in the Jaguaré watershed.
Source: Photos of the author

The square receives the sewage of some houses, which is collected by a concrete box built by the local population (photo H1), it unduly directs the collected sewage to a drainage gallery near the spring. A sewage network exists a few meters from this box, and therefore it would be necessary to promote the correct connection, to eliminate this pollution source (photo H3). The site demands interventions to consolidate the sewage system in order to guarantee the preservation of the spring waters, since the demand for its waters by the population is high and the lack of proper management can pose a serious health risk. Fig. 8 below shows the area situation.

In spite of the presence of vegetation in the squares, there are stretches that require management, so the proposal includes the recomposition of vegetation in certain stretches (represented in Fig. 8 by the lighter green vegetation). For this, suitable species should be selected, such as those that promote erosion control and preserve water quality. The SVMA urban

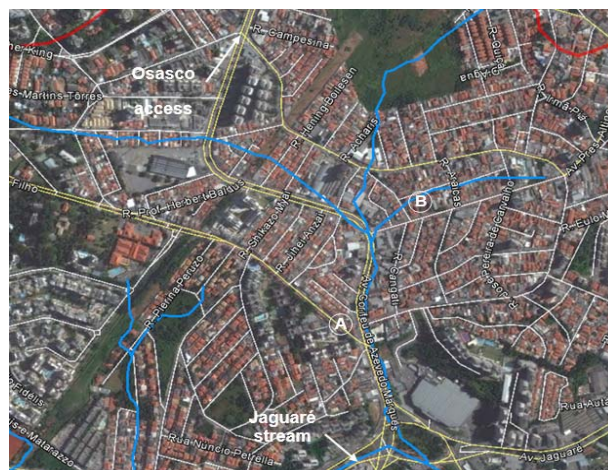
Fig. 10 Location of the canalized stream under Corifeu de Azevedo Marques Av. Source: Prepared by the author from Google Earth Pro

The stream under Av. Corifeu de Azevedo Marques is tributary of the Jaguaré stream, also runs under this avenue and surrounding streets; therefore, it has low potential for revitalization that would include the opening of the underground galleries since the avenue has heavy traffic. The channel opening in Corifeu de Azevedo Marques Avenue would require the complete deconstruction of the avenue, which is an important axis of circulation that connects Butantan village, Osasco city and Mario Covas highway. Today, the avenue has two lanes of road, one lane of buses and a track for cycling in each of the directions. In addition, the tributaries of the watercourse are under the narrow streets, so its opening would make it impossible for vehicles and traffic to travel these routes. The location of the watercourses and the situation of the roads are shown in Fig. 10 and Fig. 11, respectively.
