# Investigating the Effectiveness of a 3D Printed Composite Mold

**Abstract**—In composite manufacturing, the fabrication of tooling and tooling maintenance contributes to a large portion of the total cost. However, as the applications of composite materials continue to increase, there is also a growing demand for more tooling. The demand for more tooling places heavy emphasis on the industry's ability to fabricate high quality tools while maintaining the tool's cost effectiveness. One of the popular techniques of tool fabrication currently being developed utilizes additive manufacturing technology known as 3D printing. The popularity of 3D printing is due to 3D printing's ability to maintain low material waste, low cost, and quick fabrication time. In this study, a team of Purdue University School of Aviation and Transportation Technology (SATT) faculty and students investigated the effectiveness of a 3D printed composite mold. A steel valve cover from an aircraft reciprocating engine was modeled utilizing 3D scanning and computer-aided design (CAD) to create a 3D printed composite mold. The mold was used to fabricate carbon fiber versions of the aircraft reciprocating engine val

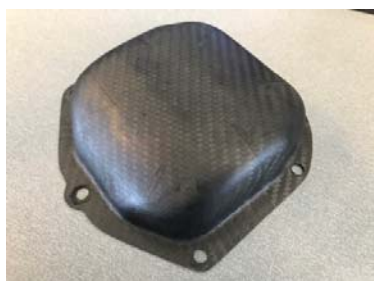
After curing in the autoclave, the carbon fiber valve covers were post processed. Each carbon fiber valve cover was sanded and finished to the dimensions of the original steel valve cover and the mounting holes of the valve covers were also drilled to match the original steel valve cover. Fig. 7 shows a completed carbon fiber valve cover after post processing.

Fig. 7 Completed carbon fiber valve cover

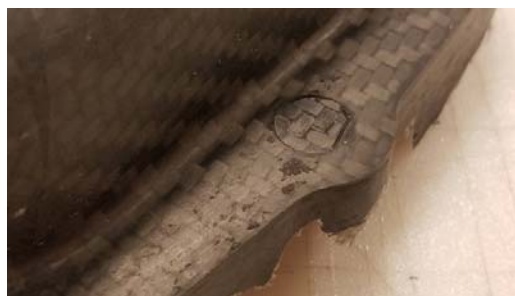
Fig. 8 Surface defects caused by mold surface chipping

A total of six carbon fiber valve covers were fabricated using the 3D printed composite mold. Dimensionally, the six carbon fiber valve covers were very consistent and all the carbon fiber valve covers mounted onto the aircraft reciprocating engine with no issues. The inconsistencies on the carbon fiber valve covers were mainly defects caused by the damages the 3D printed composite mold sustained after every part demolding process; although most of the defects on the carbon fiber valve covers as shown in Figs. 8 and 9 were cosmetic defects that can be easily remedied with some light post processing such as sanding and applying layers of clear coat. The condition of the 3D printed composite mold will continue to deteriorate as the fabricated part count increases. As a result of the deteriorating 3D printed composite mold, the quality of the carbon fiber valve covers will also continue to worsen.

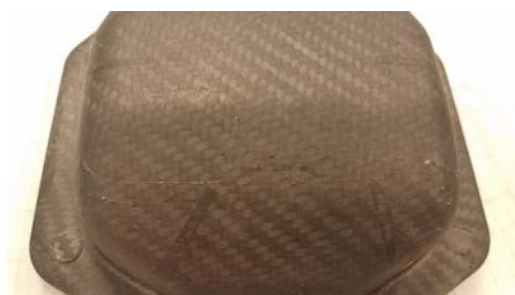
Fig. 9 Surface defects caused by mold surface cracking

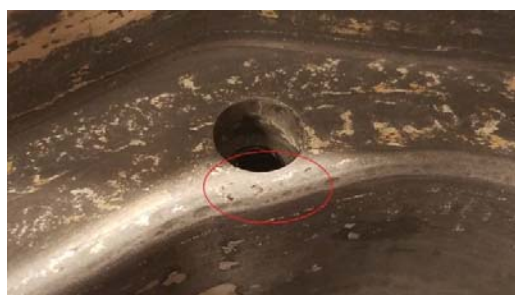
main defects the 3D printed composite mold had were chipping of the mold surface and some cracking on the mold surface between the bead interfaces as shown in Figs. 10 and 11 respectively.

Fig. 10 Mold surface chipping

In terms of the mold's performance, the 3D printed composite mold performed as expected and was used to successfully fabricate all six of the carbon fiber valve covers. All carbon fiber valve covers were cured and demolded from the 3D printed composite mold with no issues. However, durability wise, the 3D printed composite mold sustained increasing amounts of defect after every part demolding. The

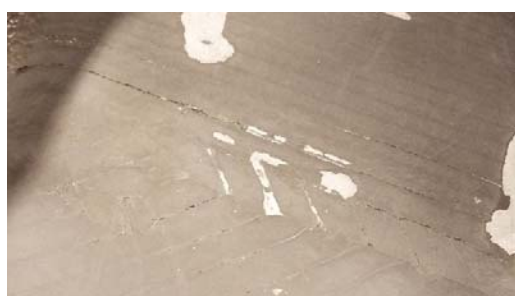
Fig. 11 Mold surface cracking between beads

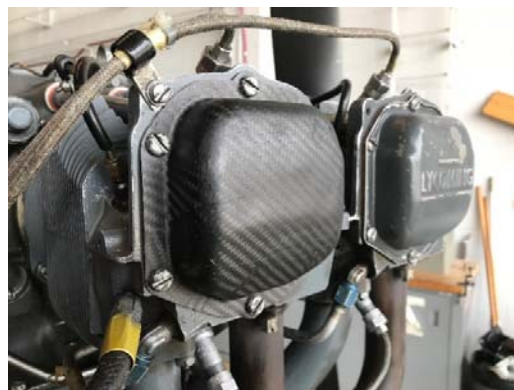
Fig. 14 Test fitting of carbon fiber valve cover

Based on the results from this study, the team was able to investigate the effectiveness of a 3D printed composite mold by producing six identical carbon fiber valve covers from a single 3D printed composite mold. The six carbon fiber valve covers were all test fitted onto the original aircraft reciprocating engine and all six carbon fiber valve covers fitted perfectly with no issues as shown in Fig. 14. The six carbon fiber valve covers however did have various surface defects that were caused by the mold surface gradually deteriorating from each part production, raising durability concerns for the 3D printed composite mold. There can be an abundance of factors that may have caused the deterioration of the mold surface. Some examples of these factors include porosity within the 3D printed composite mold, the 3D printing tool path of the 3D printed composite mold, and weak interfaces between printed beads of the 3D printed composite mold [1]. Many of these factors can essentially be removed by changes to the design and fabrication technique of the 3D printed composite mold. For example, the issue of porosity within the 3D printed composite mold can be rectified by heat treatments to the mold or by the application of surface coatings. Advance approaches forming molds with varying material composition also known as gradient materials may also be a suitable solution [6]. Other factors such as the printing tool path and weak interfaces between the printed beads may be solved by performing further tool-path optimization for the printing process of the 3D printed composite mold [7].
