Advanced Compound Coating for Delaying Corrosion of Fast-Dissolving Alloy in High Temperature and Corrosive Environment

Abstract—Fast dissolving magnesium (DM) alloy technology has contributed significantly to the “Shale Revolution” in oil and gas industry. This application requires DM downhole tools dissolving initially at a slow rate, rapidly accelerating to a high rate after certain period of operation time (typically 8 h to 2 days), a contradicting requirement that can hardly be addressed by traditional Mg alloying or processing itself. Premature disintegration has been broadly reported in downhole DM tool from field trials. To address this issue, “temporary” thin polymers of various formulations are currently coated onto DM surface to delay its initial dissolving. Due to conveying parts, harsh downhole condition, and high dissolving rate of the base material, the current delay coatings relying on pure polymers are found to perform well only at low temperature (typical < 100 °C) and parts without sharp edges or corners, as severe geometries prevent high quality thin film coatings from forming effectively. In this study, a coating technology combining Plasma Electrolytic Oxide

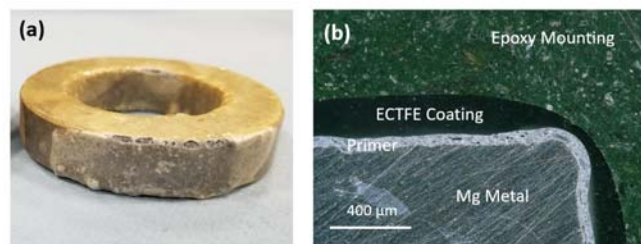
Fig. 1 Photo of failed polymer coating after aging (a) and OM image of ECTFE coating at sample edge area (b)

chemically inert in working environment (3% KCl solution and 150 °C) for days without any degradation. However, when coated on to DM parts, these polymer coating prepared by standard industrial spray coating technology all failed to protect/delay DM parts from dissolving even at low temperature (< 100 °C). We found that all these polymers have similar failure mode. Taking ECTFE coating as example (Fig. 1 (a)), the coating typical breaks at edges or corners, allowing corrosive fluid infiltrating into polymer/metal interface, and then got detached from metal base quickly with assistance of hydrogen gas pressure generated during DM dissolving process (i.e., reaction of Mg with water [9]). To improve bonding between coating and metal base, different primers have also been tried, however, they made little difference in final performance. OM characterization shows that polymer spray coating is typical thin at part edge (Fig. 1 (b)) and is also full of pin holes and other defects. Due to large difference in thermal expansion coefficient between Mg base ($2.7 \times 10^{-6} \text{ }^\circ\text{C}^{-1}$) and ECTFE coating ($5.6 \times 10^{-6} \text{ }^\circ\text{C}^{-1}$), we believe thermal stress generated during HT aging process could easily crack inferior thin coating at edge/corner area and caused such failure. To improve coating thickness at corner area, overall coating thickness has been gradually increased up to 500 μm (the limit above which DM parts cannot assembled), and the aging tests showed same detachment failure mode. Improving coating thickness does not address this issue.

Chemically and thermally stable fluoropolymer plus PEO coating has been reported to be successful in protecting flat DM surface in oil and gas [17], and effectiveness of this technology is also tested in this study on complex DM parts with edge/corners. After 150 °C 2 days aging, a fluoropolymer sealer material itself is found stable, however, the whole coating was detached from PEO base (Fig. 4 (a)). OM analysis shows that PEO coating is intact after seal spray coating, and the fluoropolymer sealer layer is effective into blocking porous PEO layer as green epoxy mounting material cannot infiltrate into PEO porous during sample preparation (Fig. 4 (b)). Sealer coating is uniform among flat area with thickness between 20-50 μm, but very thin at the edge/corner area. High resolution OM image at sealer/PEO interface area shows that the fluoropolymer does not infiltrate into PEO porous layer very deep, and voids between sealer and PEO coatings are broadly observed (Fig. 4 (c)). Since the chemical inert fluoropolymer has little affinity with PEO coating (thus low contact angle) and also high viscosity when melted during spray coating process, sealer material does not have enough driving force to deeply infiltrate into PEO pores, just forming a weakly bonded layer on its top. Therefore, it could be easily detached from PEO surface during thermal cycle as result of thermal stress from edge/corner area where polymer coating quality is poor, a failure mechanism broadly observed on polymer spray coating is discussed in Section A (Fig. 1).

same. It indicates that modifying sealer thickness does not improve protection if the bonding between sealer and PEO base is weak. Thermal stress, caused by thermal expansion mismatch between seal ($5.6 \times 10^{-6} \text{ }^\circ\text{C}^{-1}$) and PEO coating ($1.1 \times 10^{-5} \text{ }^\circ\text{C}^{-1}$) during HT aging process, could easily break the weak edge area regardless of its thickness ($< 500 \text{ } \mu\text{m}$ in concerned range), a phenomenon also observed in thin polymer spray coating without PEO under layer (Fig. 1).

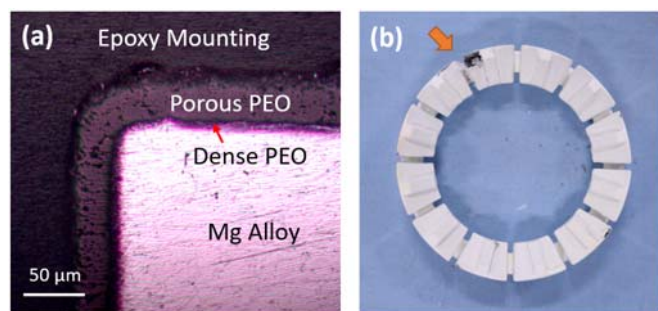
Fig. 2 OM image of PEO coating at sample edge area (a) and PEO-coated DM part after aging (b)

Besides polymer coatings, various popular inorganic coatings [13], including plating, chemical conversion & PEO, have also been tested at elevated temperature in hydraulic condition, which also failed at elevated temperature (not shown). Even though corrosion is most severe around edging area, coating detachment does not occur, which shows that inorganic coating bonds well onto base. However, these inorganic coatings are not “dense” enough to isolate Mg base from aggressive fluids, thus degrades more “uniformly” compared with polymer coating [14]. Among them, PEO coating shows the longest delaying time before failure, even moderate improvement over polymer coating, Microstructure analysis shows that PEO coating has more cracks and other defects at edge area (Fig. 2 (b)) and thus always fails first at edge area (Fig. 2 (b)). Most PEO coatings, especially in the outer region, are also porous (Fig. 2 (b)), which is consistent with reports that PEO typical has three layers: porous outer layer, intermediate dense layer, and thin inner dense layer,

respectively [15]. The latter two layers are most responsible for corrosion resistance, but not thick enough to delay severe corrosion in downhole conditions. Any mechanical damage during operation (common in oilfield) could lead to coating failure. Therefore, an effective sealer needs to be applied to block porous layers, making full usage of these tough thick layers. Commercial sealer material based on epoxy was tested in HT hydraulic environment, and seal layer detached from PEO coat very quickly. As water diffusion rate within epoxy is high, especially in HTHP condition, corrosive fluid could penetrate the sealer layer and corrode the PEO/Mg base. Therefore, advanced seal material needs to be developed to block porous PEO layer effectively at HT (> 150 °C) and corrosive environment.

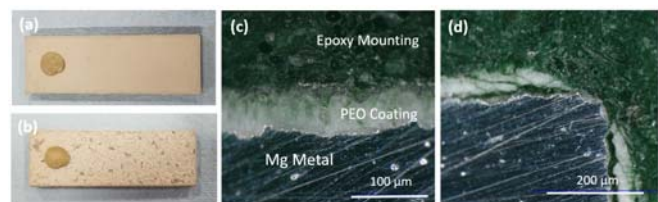
Fig. 3 Photo of CVD sealed PEO coating sample before (a) and after (b) 150°C aging test, OM image of such coating at flat (c) and edge area (d)

Since the material is deposited directly from gas state, Chemical Vapor Deposition (CVD) coating is supposed to be more effective to block open pores within porous PEO layers. In this study, SiO₂, thermal/chemical stable in working environment and compatible with PEO materials, is selected as sealer material, and directly deposited onto PEO-coated sample through industrial CVD coating process [16]. However, this sealer does not show obvious improvement. As shown in Fig. 3 (a) and (b), this coating breaks into pieces after 150 °C aging test. OM analysis shows that CVD coating is too thin to provide effective sealing (Fig. 3 (c)), as epoxy mount material (shown in green) easily infiltrates into porous PEO layer during hot molding process. In addition, the CVD coating process, typically high temperature > 400 °C, also causes thermal cracks and break PEO coating in the weak edge/corner area. As shown in Fig. 3 (d), PEO coating on edge is chipped away breaking surrounding coating into pieces, therefore allowing

green epoxy mount material to infiltrate between PEO/Mg base during sample preparation. Considering high cost and low effectiveness, CVD coating as sealer is proven to be not suitable for DM plug applications.

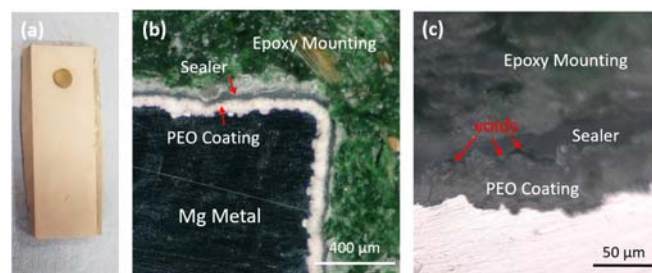
Fig. 4 Photo of a fluoropolymer sealed PEO coating sample after 150 °C aging test (a), OM image of this coating at edge area (b), high magnification OM image of coating microstructure (c)

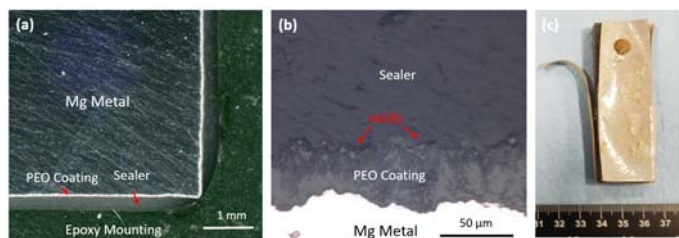
Fig. 5 OM image of thicker fluoropolymer sealed PEO coating near edge area (a), high magnification OM image of coating microstructure (b), and photo of coating sample after 150 °C aging test (c)

To increase the sealing effect, especially at edge/corner area, we increased the seal thickness from 20 μm to almost 400 μm, as shown Fig. 5. It is true that coating thickness at the edge is still much lower than that in flat area, however, it is still over 50 μm thick, and fully protects all the base material under edges. According to high magnification OM analysis (Fig. 5 (b)), interface between sealer and PEO is the same, i.e., full of voids. After aging at 150 °C for 2 days, the whole coating fails in the same way as thin coating, starting from edge and finally detached from PEO base. Besides, other thickness in between (i.e., 100 μm and 400 μm) were tested, and the results are the

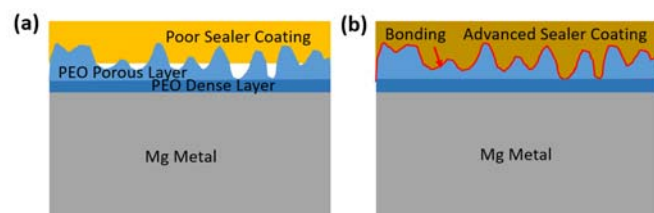
Fig. 6 Schematic illustration of poor seal (a) and high quality sealer (b) microstructure

Poor interface between PEO/fluoropolymer sealing layers is caused by low affinity of fluoropolymer to PEO layer, and its high viscosity in the molten state during coating process as result of its large molecular weight as thermoplastics, which both prevent fluoropolymer melt from infiltrating into porous PEO layers deeply (Fig. 6 (a)). To address this issue, sealer material, with both strong bonding to PEO and extremely low viscosity [18], needs to be developed to achieve a perfect design as illustrated in Fig. 6 (b). Therefore, a thermoset resin was finally selected with following properties: (1) dense and super hydrophobic to isolate fluid, (2) thermal/chemical stability in working condition, (3) higher affinity/bonding to PEO under-layer, and (4) most importantly reasonable elasticity or ductility to reduce thermal stress at edge during thermal cycling (Fig. 5). Besides, a volatile solvent is also added to such thermoset monomers to further reduce its viscosity, assisting infiltrating process during spray coating. A thin layer of such coating ($50 \text{ } \mu\text{m}$) was applied to PEO (Fig. 7 (a)) and OM analysis shows that these sealer materials penetrate deeply into porous PEO materials and no voids can be observed at sealer/PEO interface (Fig. 7 (b)), a structure similar to design illustrated in Fig. 6 (b). After aging at 150 °C for 2 days, no obvious change can be found for this coating. Of disclosed coating systems, it is the first thin coating in oil and gas industry that can delay DM complex parts (with sharp

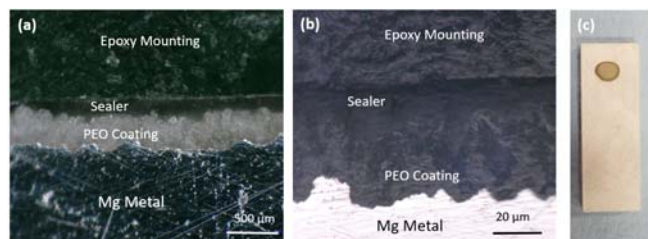
Fig. 7 OM image of thermoset sealed PEO coating (a), high magnification OM image of coating microstructure (b), and photo of coating sample after 150 °C aging test (c)

corners) in corrosive fluid at 150 °C for over 2 days. As reference, thin coatings of this sealer material without PEO under-layer, regardless its thickness, have also been tested, and DM samples fails very quickly even at low temperature ($< 100 \text{ }^\circ\text{C}$, not shown). Therefore, the significant improvement of this PEO/sealer system can be attributed to a synergistic effect between porous hard PEO coating and chemical inert elastic-polymer sealing. With this microstructure design, aggressive fluid has been efficiently isolated from reaching to PEO dense layer under thermal cycles; the diffusion to the Mg base was significantly reduced.
