Assessment of In-Situ Water Sensitive Urban Design Elements

Niranjali Jayasuriya and Majell Backhausen

Keywords—Bio-retention swales, Maintenance plan, Operational plan, Water Sensitive Urban Design, Water quality improvement.

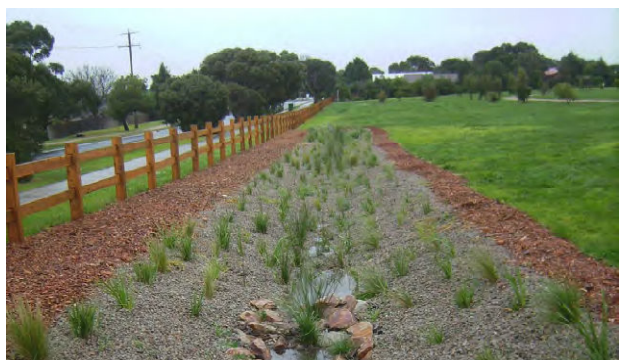
Bio-retention swales provide two main functions: stormwater treatment and the ability to convey stormwater safely (Figure 2). The swale component of the system uses vegetation and gravity to pre-treat the stormwater, removing coarse to medium sediments as well as litter and natural debris. After conveyance through the swale, the stormwater percolates through the prescribed filter media component of

the Bio-retention system located at the base of the swale removing finer particles, nutrients and contaminants. The filter media achieves this through fine filtration, extended detention treatment and some biological uptake. If designed and constructed properly a bio-retention swale system should also have the ability to retard some stormwater flow during large storm events and provide protection to natural receiving waterways from the high flow velocities associated with piped flows. In the occurrence of a large storm event, overflow pits are also incorporated in the design, directly conveying excess water into the stormwater pipe network.

Fig. 2 Bioretention swale Mornington Peninsula Shire Council, Victoria Australia

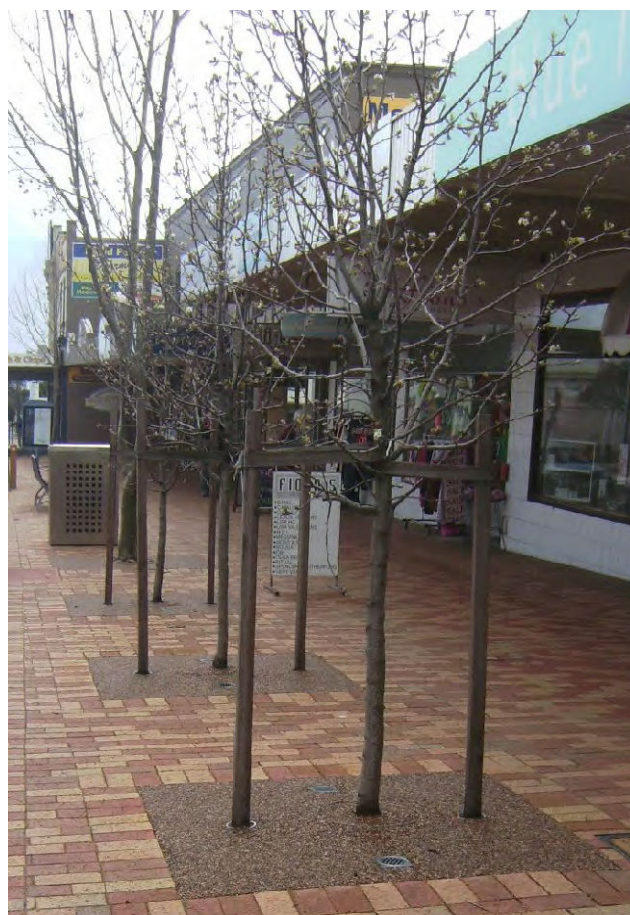
WSUD tree pits are a practical way of introducing WSUD into urban streetscapes where there is limited space to work with and impervious areas dominate the landscape (Figure 3). WSUD tree pits work as small scale bio-retention systems. The entire foot print of a standard tree pit is usually 6.25 square meters and only has to accommodate the health of one plant. This is another credit to its success as it provides treatment options in areas where vegetation is limited and linear swales or larger scale rain gardens simply cannot fit. WSUD tree pits have the ability to remove medium to fine sediment, nutrients, contaminants and litter. With very limited documentation found on the exact design, construction and maintenance of this feature it is assumed that the process of

Fig. 3 In-situ WSUD Street Tree Pit

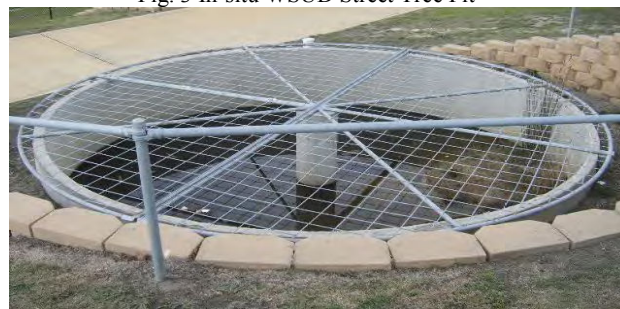
Sedimentation tank and Bio-retention tank systems have dual pollutant extraction ability. The sedimentation tank is the first course of treatment for harvested stormwater (Figure 4). Sedimentation removes gross pollutants, large and medium sized particles (sand, grit, rubbish). Bio-retention tanks will then receive the overflow pre-treated water and allow it to percolate through the filter media, removing finer particles, nutrients and contaminants (the same principles as the Bio-retention treatment in a swale). In the occurrence of a large storm event, allowances for water overflows are also incorporated in the design, directly conveying excess water into alternative pipe networks or creeks. With no documentation found on the exact design, construction and maintenance on this system, it is assumed that the process of implementation from the concept phase to operational phase follows the general guidelines of WSUD feature implementation.

Fig. 4 Hi-Capacity Sedimentation Tank

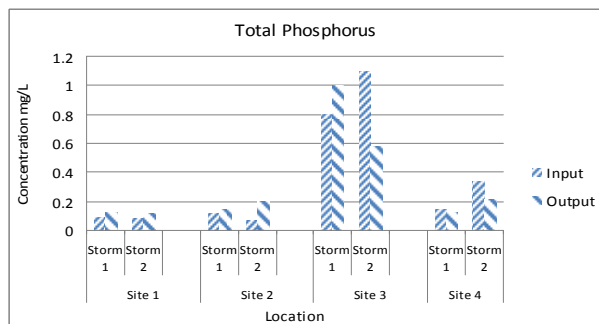
The concentration levels observed in each site are given in Figures 5 to 7. The pollutant concentrations identified were consistent with Event Mean Concentration (EMC) and Land Use relationship reported by [11]. According to above author, urbanized areas which consist of residential, commercial and industrial land had concentration levels ranging from:

A close examination of the pollutant concentration values given in Figures 6 to 8 show that the TSS values for all sites except Site 4 is in the lower range of the EMC values reported by [11]. Similarly the nutrient concentrations are also in the lower range, except in Site 3. The pollutant concentration levels depend on the surrounding land use pattern and as such, it is important to select the appropriate WSUD feature to improve the stormwater quality.

Fig. 7 Total Phosphorus concentrations at each site
