Survey on the Possibility of Post -Earthquake Quick Inspection of Damaged Building by Ordinary People using the European Macro-Seismic Scale 1998 (EMS-98)

Douangmala Kounsana, Toru Takahashi

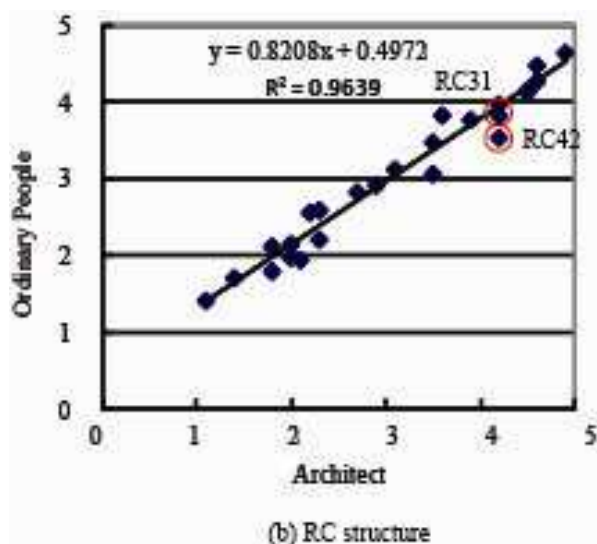
Fig. 4 Average of accuracy rate (a)-(b)

As for the average of masonry structure, the ordinary people group's result was slightly higher than the architect group and show opposite result for reinforced concrete structure. The masonry structure of the difference between 2 groups is a little higher than RC structure, but the difference was very small. On the other hand, the correlation coefficient of 2 groups shows a strong correlation.

As for the standard deviation, the value shows from 0.5 to 1, the variation of masonry structure is higher than RC structure and isn't much difference between 2 groups. Meanwhile, there is no correlation in their standard deviation between 2 groups. The change is also small and the reliability is obtained to the same degree. The Average and standard deviation of accuracy rate results are shows in Fig.4 (a) to (b) and Fig.5 (a) to (b) respectively.
