Damage of Tubular Equipment in Process Industry

Abstract—Tubular process equipment is often damaged in industrial processes. The damage occurs both on devices working at high temperatures and also on less exposed devices. In case of sudden damage of key equipment a shutdown of the whole production unit and resulting significant economic losses are imminent. This paper presents a solution of several types of tubular process equipment. The causes of damage and suggestions of correction actions are discussed in all cases. Very important part is the analysis of operational conditions, determination of unfavourable working states decreasing lifetime of devices and suggestions of correction actions. Lately very popular numerical methods are used for analysis of the equipment.

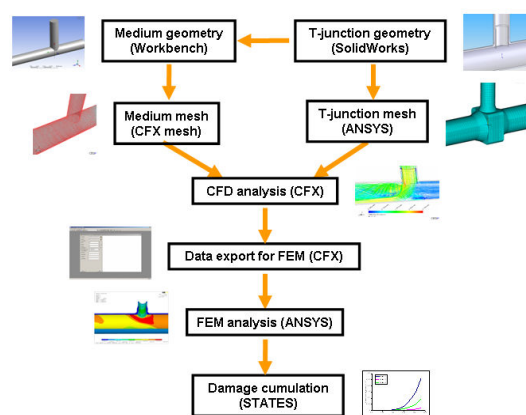
As it is not possible to assess equipment only from the operational temperature and pressure point of view, a very often used method for solving different kinds of tasks is the method of interactions of CFD and FEM analysis (FSI). These interactions of heat-hydraulic and tension analyses are called Fluid Structure Interaction (FSI). This method has been frequently used for solving different tasks in many industrial branches for several years [1], [2]. One of the possible procedures of solving tasks with the FSI method including assessment of fatigue is depicted in the Fig. 1 It is an analysis of a nozzle where flows of different temperatures and flow rates are being mixed.

Fig. 1 Diagram of design procedure of the FSI method including the assessment of fatigue

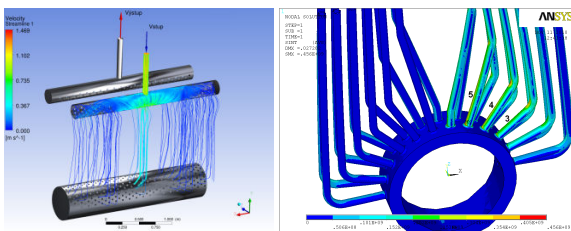
In this case it was an economizer of a waste-heat boiler, where after certain operation time spots where pipes connected to collectors were being damaged. It was not possible to determine the cause of the damage on the basis of operational conditions, because the stress in critical regions was negligible. Based on analytic heat-hydraulic calculations and CFD simulations the distribution of temperature fields was determined thus making this problem clear. The crucial problem was the low speed of water in the economizer and its imperfect distribution into other pipes. Because of that the speed in pipes under the distribution piping was high and in surrounding pipes it was significantly lower. In some of them the emerging negative pressure even caused flow in opposite direction (in the Fig. 2 on the left there are depicted the flowlines of medium in the correct direction, those not depicted flow in opposite direction).

Because of the uneven flow of medium the pipes were unevenly heated and those that were cooled better were gradually damaged. In the Fig 2 on the right one can see the stress distribution in critical areas near the connection of the pipes to the collector. Here there are apparent increased stress values in welded joints that were gained via stress analysis of temperature fields obtained from previous analyses and that confirm the cases of damaging in these areas.

Fig. 2 The results of CFD and FEM analysis of the economizer

The corrective action in this case would be to come with more appropriate structural design that would distribute the working medium better (the input and output piping must not be placed perpendicularly to the collectors but from the side) and that would be able to compensate the dilatations of the tube nests (avoid the connection of many pipes of small dimensions on firm piping of a large dimension). Thanks to these modifications it is possible to ensure a trouble-free operation of the boiler. Revision controls that must be planned and carried out should not be underestimated though.

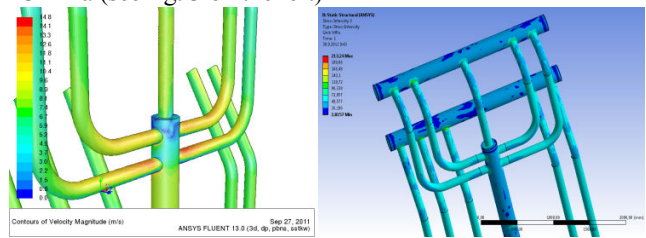
The second case solved in practice was a connecting piping of individual drafts of the evaporator of the fluidized bed boiler. It was a special construction that should have eliminated the dilatation of particular pipe manifold and distributed the working medium from one coil to another better (see Fig. 3). The working medium was saturated steam with the pressure of 3.3 MPa and working temperature about 290°C.

When carrying out the classical stress analysis using the FEM it was discovered that in the welded joint of the pipe and the main pipe the maximum tension was about 150 MPa. But this value was not significant considering the used material. That is why the examination of temperature fields was carried out, because water was distributed into the main vertical pipe through a little pipe coupling to regulate the temperature of the steam. In the Fig. 3 the flowlines are depicted, thanks to which it was found out that the flow rates of the working medium are not the same in all the pipes. Thanks to this analysis the distribution of the temperature fields that is crucial from the stress point of view was obtained.

The discovered distributions of temperature fields were the end conditions for the stress analysis of the transfer tubular construction. Because the temperature fields were specified, there occurred areas where the stress increased significantly to 213 MPa (see fig. 3 on the left)

Fig. 3 The results of CFD and FEM analyses of the transfer pipe of the boiler
