The Comprehensive Study Based on Ultrasonic and X-ray Visual Technology for GIS Equipment Detection

Abstract—For lack of the visualization of the ultrasonic detection method of partial discharge (PD), the ultrasonic detection technology combined with the X-ray visual detection method (UXV) is proposed. The method can conduct qualitative analysis accurately and conduct reliable positioning diagnosis to the internal insulation defects of GIS, and while it could make up the blindness of the X-ray visual detection method and improve the detection rate. In this paper, an experimental model of GIS is used as the trial platform, a variety of insulation defects are set inside the GIS cavity. With the proposed method, the ultrasonic method is used to conduct the preliminary detection, and then the X-ray visual detection is used to locate and diagnose precisely. Therefore, the proposed UXV technology is feasible and practical.

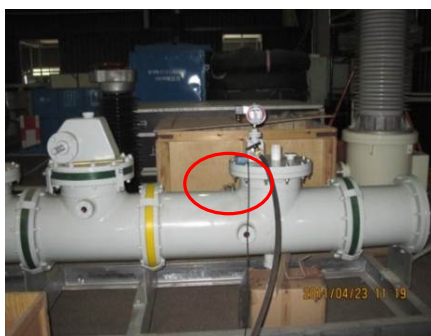
Fig. 5 The site layout photos of the detection equipment

machine, the imaging plate, the computer workstation and other components. During the detection process, the X-ray machine is placed at a certain distance in front of the GIS model, and the imaging plate is close to the GIS cavity and is behind it. The head of the X-ray machine is at the same horizontal line with the center of the imaging plate, and the imaging plate is connected to the computer workstation through the software to receive, display, store and process the data. The site layout photos of the X-ray machine and the imaging plate are shown in Fig. 5 (b).

(a) Site layout of the ultrasonic detection equipment

(b) Site layout of the X-ray detection equipment

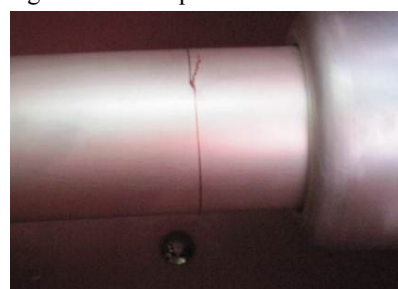
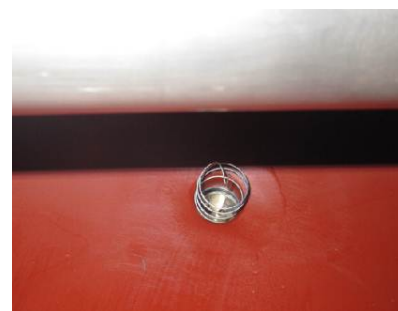
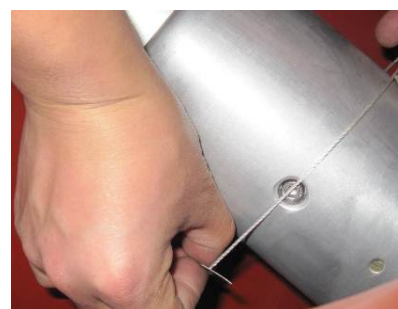
Fig. 6 The physical layout photos of teh simulated insulation defects

protrusion and the metal suspension as the insulation defect models which are usually caused by poor processing, mechanical damage or scratches when assembling. The high field strength area is created around the metal protrusion, and PD occurs consequently. During the experiment, a section of copper wire is wrapped around the high-voltage conductive pole in the bus segment chamber to simulate this defect type. It is shown in Fig. 6 (a). The length of the tip is 40 mm and the diameter is equivalent to 300 μ m. The second defect model is shown in Fig. 6 (b). A metal tip is set inside the GIS chamber wall. The material is iron wire whose equivalent diameter is 100 μ m and whose cutting-edge length is 30mm. The third model is shown in Fig. 6 (c). A piece of aluminum block is hung in the high-voltage conductive pole by the insulation rope. The distance is 20mm between the aluminum block and the high-voltage conductive pole.

(a) Tip on the high-voltage conductive pole

(b) Tip on the ground electrode

(c) Floating potential

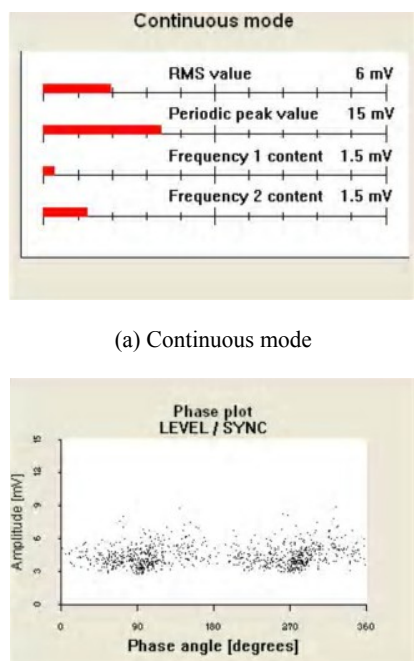
Fig. 7 AIA ultrasonic detection spectrums

Under the applied voltage amplitude of 101kV, the continuous mode and the phase pattern are shown in Fig. 7. The ultrasonic detection spectrums can be seen: (a) By the continuous mode, 100Hz correlation is greater than 50Hz

correlation; (b) From the phase mode, the discharge pulse focuses near the peak value of the voltage.

From the ultrasonic detection spectrums in Fig. 9 of view, 100Hz correlation is greater than 50Hz correlation. The size of the discharge amount and the distribution shape of the discharge are still similar to the spectrums in Fig. 7, and the phase has some drift with the change of the applied voltage value.

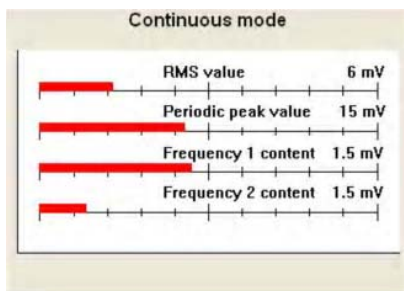
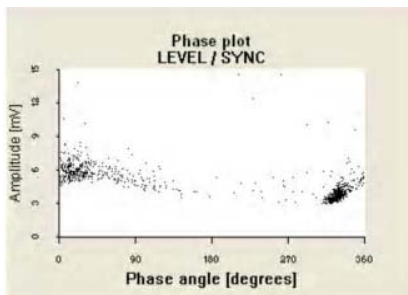
Fig. 11 AIA ultrasonic detection spectrums

(a) Continuous mode

(b) Phase mode

From the ultrasonic phase spectrums in Fig. 11(b), it can be clearly seen that the pulses mainly concentrate around $0^\circ \sim 45^\circ$ and $315^\circ \sim 360^\circ$. The continuous mode and the phase mode are shown in Fig. 11.

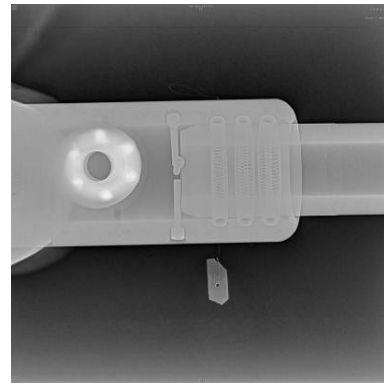
Fig. 12 The X-ray photo of a metal aluminum block on the high-voltage conductive pole inside the bus segment

Fig. 12 shows an aluminum block hung on the high-voltage conductive pole inside the bus segment. After the X-ray irradiation, the aluminum block can be clearly observed from the X-ray photo. Therefore, the X-ray visual detection technique is also effective to the insulation defect.
