Sustainable Development in Disaster Affected Rural Areas: The Case of Dinar Villages

Nese Dikmen

Keywords—Dinar, Post-disaster reconstruction, Sustainable development, Turkey.

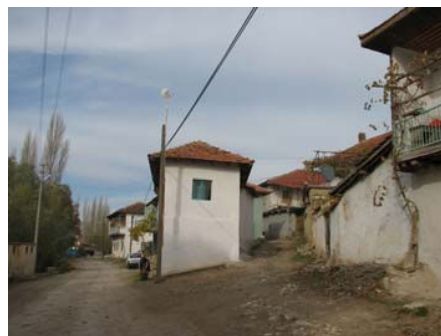
Fig. 1 View from an existing village (Dikici Village)

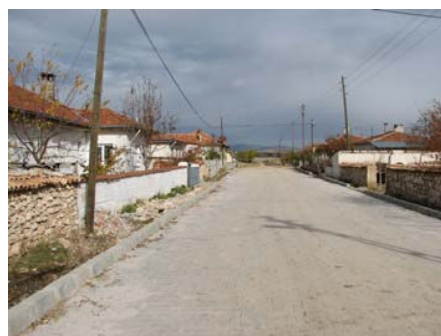
It was observed that the traditional settlements and the houses in the region show the characteristics of rural areas in Turkey. However, there are differences between the settlements erected after the disaster and traditional settlements. In spite of existing villages' organic form, new settlements were erected on a grid pattern. It is very difficult to distinguish the new settlements from each other, however the existing villages and the buildings in them have their own characteristics related to physical, socio-cultural and economical factors. Fig. 1 shows an existing village and Fig. 2 illustrates a new settlement.

Fig. 2 View from a new settlement (Gencali Village)

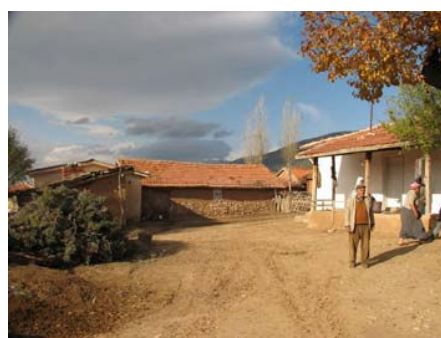
Research reveals that villagers modified the post-disaster houses and the cattle sheds. In addition, some of the beneficiaries constructed new buildings on their lots. Common additions are leans to roofs, storerooms and bread houses (space used for making bread) and most common new buildings are straw houses and cattle sheds (Fig. 3). Economy is dependent on agriculture and animal rearing in this region. Research in the region shows that some of the beneficiaries who rear animals did not get cattle shed, however some villagers who do not have animals got cattle shed during the provision period. Because of this, villagers who rear animals constructed cattle sheds and straw houses, beneficiaries who do not have animals changed the functions of cattle sheds.

Fig. 3 Addition to the post-disaster house and new buildings on the lot (Kızıllı Village)

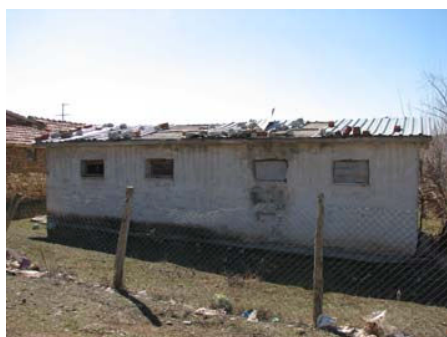
There are workmanship problems on some of the houses. Since metal claddings on the roofs of the cattle sheds were not fixed properly, the claddings have moved up in some of the villages (Fig. 4). Also, drain pipes of some houses and cattle sheds have fallen down. In addition, cracks were observed on the walls of a few houses. Some villagers, who could afford, repaired the buildings. One family left their post-disaster house, on which there are cracks. They said that they did not feel safe in the house.

Fig. 4 Cattle shed with its moved up roof cladding (Kızıllı Village)

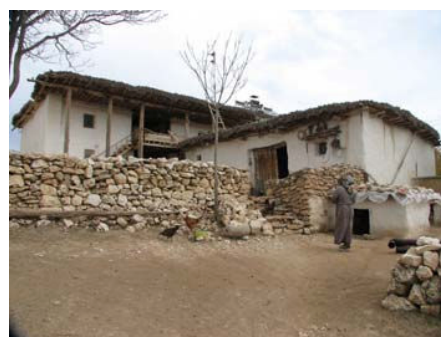
It was seen that the villages and the houses in them are the products of the socio-cultural factors in the study area. The houses in the villages have different characteristics depending on the life styles of the users (Fig. 5). However, the post-disaster houses, designed years ago for any region and any family, do not meet the needs of some of the families. The users had to make additions to the houses and construct new buildings on the lots.

Fig. 5 A traditional house (Karahacıllı Village)
