Hydrophobic Characteristics of EPDM Composite Insulators in Simulated Arid Desert Environment

Yasin Khan

Abstract—Overhead electrical insulators form an important link in an electric power system. Along with the traditional insulators (i.e. glass and porcelain, etc) presently the polymeric insulators are also used world widely. These polymeric insulators are very sensitive to various environmental parameters such temperature, environmental pollution, UV-radiations, etc. which seriously effect their electrical, chemical and hydrophobic properties. The UV radiation level in the central region of Saudi Arabia is high as compared to the IEC standard for the accelerated aging of the composite insulators. Commonly used suspension type of composite EPDM (Ethylene Propylene Diene Monomer) insulator was subjected to accelerated stress aging as per modified IEC standard simulating the inland arid desert's atmospheric condition and also as per IEC-61109 standard. The hydrophobic characteristics were studied by measuring the contact angle along the insulator surface before and after the accelerated aging of the samples. It was found that EPDM insulator loses its hydrophobic properties propor

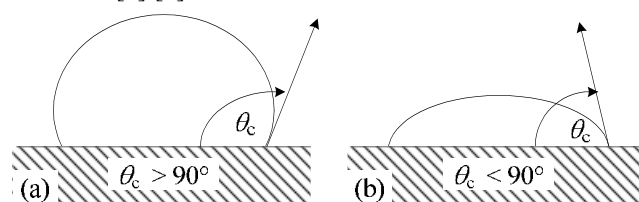
Fig. 1 Schematic diagram of water drop on:
(a) Hydrophobic surface (b) Hydrophilic surface

weathering and from dry band arcing, suffer from erosion and tracking which may lead ultimately to failure of the insulator, faulty insulators are difficult to detect and life expectancy is difficult to evaluate [1]. The property of high hydrophobicity of the composite insulators assures them better performance in contaminated environments. Hydrophobicity of a material is its resistance to flow of water on its surface or resistance to the formation of continuous film of water. It can be described using contact angle (θ_c) on the material surface that a liquid drop makes on the solid surface when it comes into contact with it. The hydrophobic materials allow less water surface contact and thus make $\theta_c > 90^\circ$ as shown in Fig. 1(a), whereas materials which are easily wettable allow water to touch a large surface area and hence make $\theta_c < 90^\circ$ as shown in Fig. 1(b) and is known as hydrophilic. Surface is said to be hydrophobic, when $\theta_c > 90^\circ$, hydrophilic when $\theta_c < 35^\circ$ and partially wettable when $35 < \theta_c < 90^\circ$ [2].

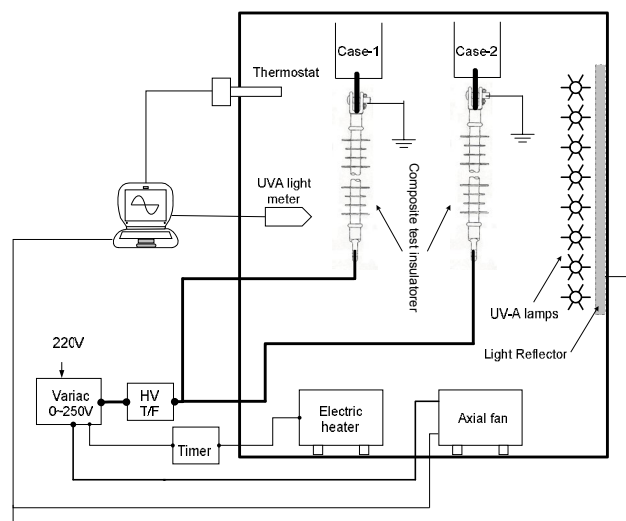
Fig. 2 Schematic diagram of accelerated aging cycle chamber

The actual UV-A radiations level and temperature variations in central region of Saudi Arabia is quite higher as compared to the values recommended in the IEC std. 61109 [9]-[10]. To simulate the ambient conditions of arid desert, a wooden chamber was fabricated for the accelerated aging process for the EPDM test composite insulators. Schematic diagram of the chamber with suspension insulators and other accessories in place is shown in Fig. 2. Based on the above discussion, two types of experimental conditions were created in the accelerated aging test chamber for the tested insulator by applying different stresses mentioned in Table 1, i.e.:

Case 2: Modified aging cycle based on the actual UV-A radiations level (40 W m^{-2}) as shown in Fig. 2.

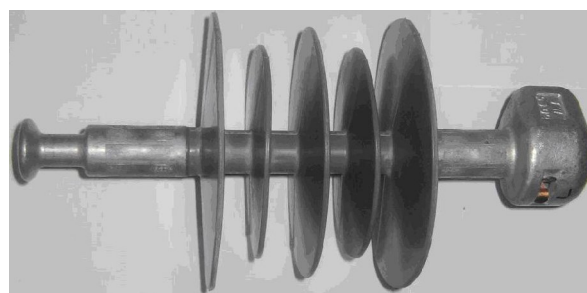
Fig. 3 Suspension EPDM insulator

Three samples of EPDM suspension insulators procured from WT-Henley (UK) were used for accelerated aging for each case-I and case-II. Fig. 3 shows the photograph of the tested insulator. The salient dimensions of the insulators are mentioned in Table 2.

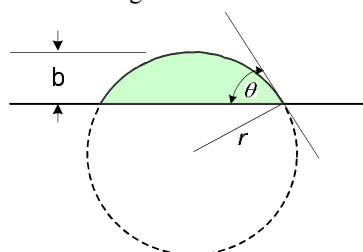
Fig. 4 Contact angle theoretical model.

The Contact angle analysis software "ImageJ" in general assume the drop is part of a sphere as shown in Fig. 4. However, due to gravitation and molecular dispersion, the shape of a drop is close but not exactly a part of a sphere. The hidden assumption is when the drop volume is small; the gravitational effect can be ignored.

$$\theta = 90 - \tan^{-1} \left[\frac{r - b}{\sqrt{2rb - b^2}} \right]$$

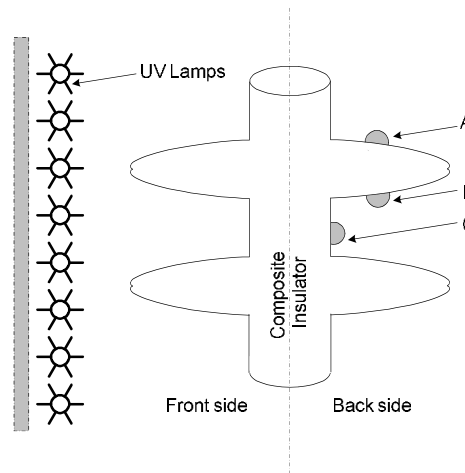
Fig. 5 Schematic diagram of composite insulator showing contact angle measurement positions

The schematic diagram of the composite insulator aged in the accelerated aging chamber (Fig. 2) is as shown in Fig. (5). One side of the insulator is always facing the UV lamps whereas, the other side is not. The contact angle for both sides i.e. front as well as back side of the insulator was recorded along the length of the insulator for the points A, B, and C (i.e. top, bottom and core), respectively as shown in Fig. 5. For measurements of the contact angle at desired positions (A, B or C), the insulator was oriented so the surface under consideration was approximately horizontal. The drop is carefully placed on the horizontal surface of the insulator with the help of a hypodermic syringe needle. The photographs of drops are taken quickly with the help of high resolution digital camera just after putting the drop of water on insulator and the data was analyzed by computer software "ImageJ". The drop volume was controlled in the range 10~25 μ L [12]. Deionized water of ~100 μ S conductivity was used. Methylene blue was added to change the color of the water to get more clear images.

The EPDM insulators were placed and aged in the aging chamber as per Case-I (UV-A:1mW/cm²) and Case-II (UV-A:4mW/cm²) mentioned in Table 1 above and the contact angles were measured by using "ImageJ" software for the New (virgin), Old aged and Newly aged insulators. The results are graphically shown in Figures(6)-(8), that compares the EPDM insulator's shed-wise contact angle characteristics for the positions A (Top), B (Bottom), C (Core) as shown in Fig. 5 above, for:

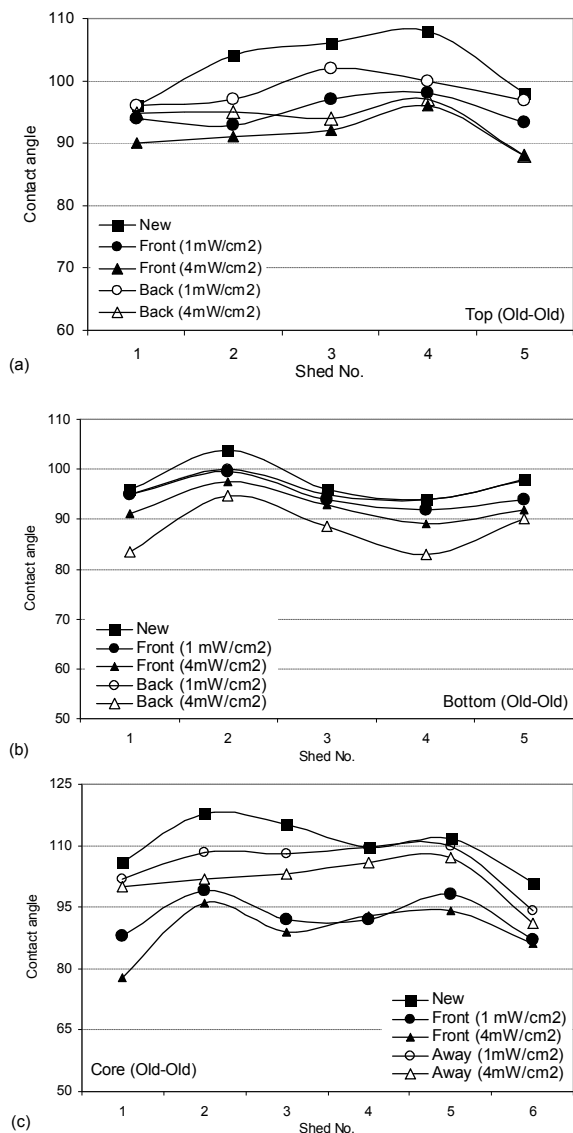
Fig. 6 Contact angle characteristics along the insulator sheds for old-old aged (a) Top (Position A, Fig. 5) (b) Bottom (Position B, Fig. 5) (c) Core (Position C, Fig. 5)

Fig. 6 compare the shed-wise top, bottom and core contact angle measurement results of front to back side for the old-old aged under UV radiations intensity of 1mW/cm² and 4mW/cm². Comparison of these figures clearly shows that contact angle for new (virgin) insulator is highest as compared to old aged insulators. Furthermore, it is also observed that the contact angle of aged insulator under UV radiation intensity of 1 mW/cm² is higher as compared to aged insulator under UV radiation intensity of 4mW/cm². It is also found that the part of the insulator facing the UV radiations have lower contact angle as compared to the back side of the tested insulator. Similarly, higher UV radiation intensity deteriorated the insulator surface more [9] and causes less contact angle as compared to lower UV radiation intensity thus the insulator shows a more hydrophilic behavior under higher UV radiation intensity.

The contact angle measured on both the front as well as back sides of the insulator were also measured and shown in Fig. (6) & (7). The contact angle measured was smaller on the front side as compared to the back side of the aged insulator. This shows that the front side of aged insulator was more hydrophilic as compared to the back side which suggests that natural environment plays an important role in the aging process. The variation in contact angle between the front and back face is several degrees. The greatest difference between the front and back is seen on the core in the center of the insulator length, may be due to enhanced electrical activity in this region.

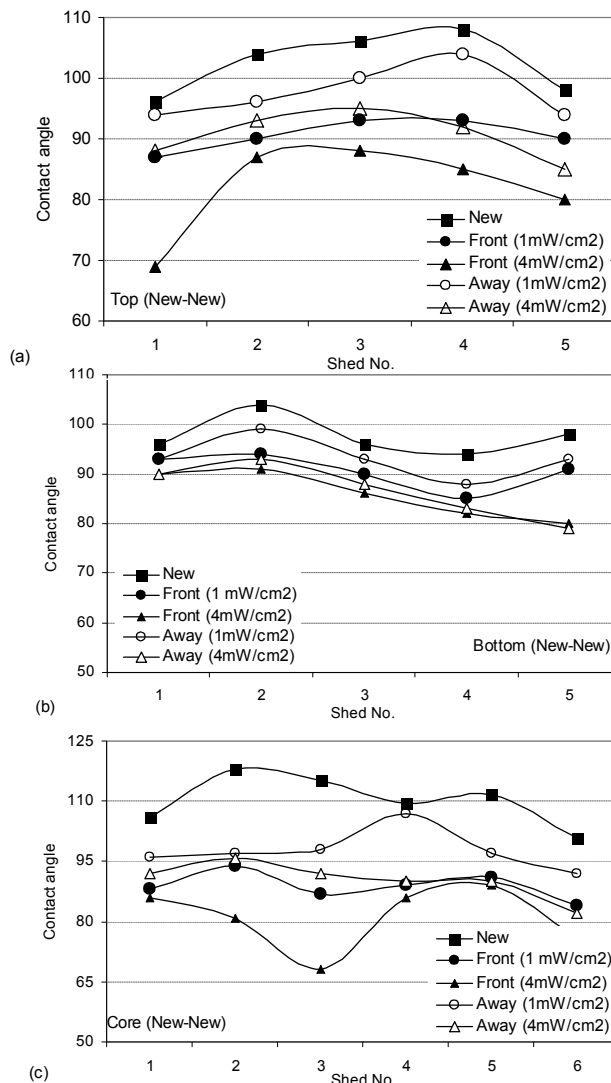
Fig. 7 Contact angle characteristics along the insulator sheds for New-New aged (a) Top (Position A, Fig. 5) (b) Bottom (Position B, Fig. 5) (c) Core (Position C, Fig. 5)

Fig. 7 compares the shedwise contact angle measurement results of front to back side for the new-new aged under UV radiations intensity of 1mW/cm² and 4 mW/cm². Comparison of these figures clearly shows that contact angle for new (virgin) insulator is highest as compared to newly aged insulators. Furthermore, it is also observed that the contact angle of aged insulator under UV radiation intensity of 1mW/cm² is higher as compared to aged insulator under UV radiation intensity of 4mW/cm². It is also found that the part of the insulator facing the UV radiations have lower contact angle as compared to the back. Similarly, higher UV radiation intensity that deteriorates the insulator surface has less contact angle as compared to lower UV radiation intensity thus the insulator shows a more hydrophilic behavior under higher radiation intensity. The variation in the contact angle for the

newly aged and virgin insulator is more as compared to the variations depicted in Fig. 6, before.

The contact angle variation between the top and bottom surfaces of the insulator was also marked. The average variation in the contact angles from HV to ground electrode for top (position A) as well bottom (position B) is more consistent, however, the wide variation in contact angle was observed especially under the newly aged insulators when the insulator was aged under high UV radiation intensity (i.e. $4\text{mW}/\text{cm}^2$) as shown in Fig. 7(a) & 8(a).

On the core the variation in contact angle is about 15° - 20° from HV to grounded electrode end. The lowest values were observed in the center as evident from Fig. 7(c) & 8(c). This shows that, this part of the core is more heavily damaged than the sheds. One explanation to this is that this part of the insulator presents a smaller cross-section to the leakage

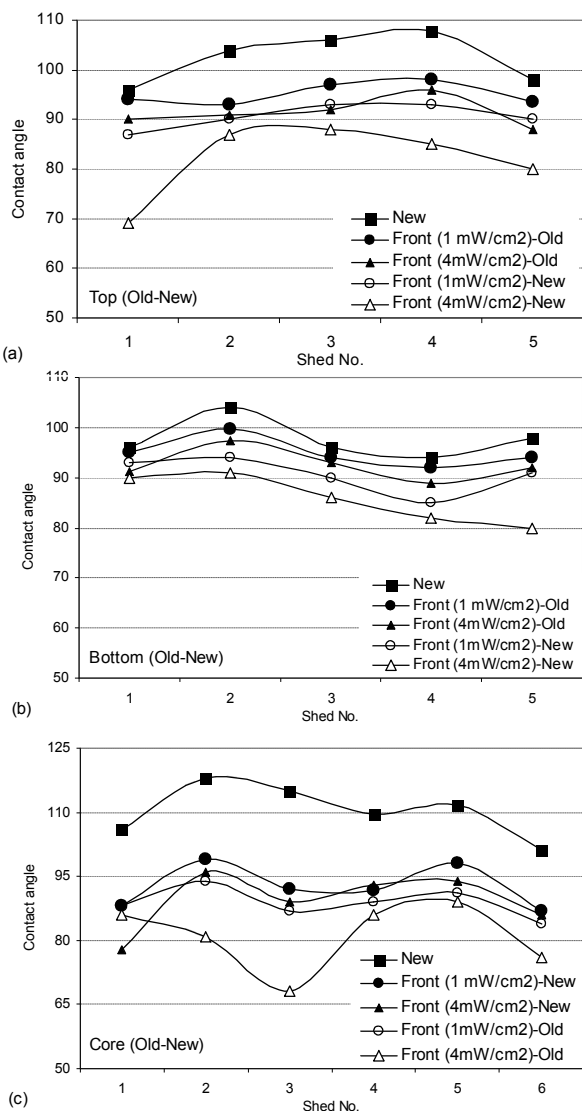
Fig. 8 Contact angle characteristics along the insulator sheds for Old-Newly aged (a) Top (Position A, Fig. 5) (b) Bottom (Position B, Fig. 5) (c) Core (Position C, Fig. 5)

The contact angles data for the old aged insulators was compared with the newly aged insulator, and the result is shown in Fig. 8. Comparison of these figures clearly shows that contact angle for newly aged insulator is lower as compared to old aged insulator under. This result shows that the EPDM insulator also recover some of its hydrophobic properties with the passage of time but this rate of recovery is very slow as compared to SiR which usually recovers very quickly [5], [13].

Scanning Electron Microscopic (SEM) photographs of the EPDM insulators surface were tried to obtain but due to static charges in the samples, the author was unable to get these images. Fig. 8, shows the hydrophobicity recovery of the tested insulators as the contact angle of the old aged insulator is more as compared to the newly aged insulator. It can also be seen that higher the UV-radiation intensity, the EPDM insulator shows more hydrophilic characteristics for the newly aged as well as old aged insulators. This property of EPDM material can be co-related with the static charge on the sample. Hydrophobicity recovery takes place after decaying these static surface charges. Therefore, charge accumulation on EPDM insulator should be considered in hydrophobicity recovery process.
