Improvement in Mechanical Behavior of Expulsion with Heat treated Thermite Welded Rail Steel

S.Rajanna, H.K.Shivanand, Akash Deep B.N

World Academy of Science, Engineering and Technology International Journal of Mechanical and Mechatronics Engineering Vol:3, No:12, 2009

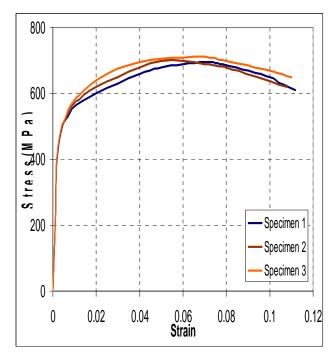
Fig. 2 Stress v/s Strain Curve of Heat treated Thermite welded rail

As mentioned above two techniques conditions tests were conducted at ambient temperature. The room temperature mechanical properties of yield strength, Ultimate tensile strength and ductility mentioned in Table 1 and 2 for above mentioned two different techniques condition of thermite welded rail. The stress is calculated based on the original cross sectional area before testing. The summary of these mechanical properties for two different techniques conditions of thermite welded rails are also given in Fig 2 to 3.. Expulsion and heat treated rail exhibits increase in ultimate tensile strength, yield strength and elongation as compared to heat treated thermite welded rail. The result of present work shows the significant improvement in mechanical properties. In heat treatment causes the replacement of very coarse ferritic-pearlitic structure[6] by much finer structure very thin cementite lamellae appears in the pearlite were as the fine ferrite network on the grain boundaries indicates the size of the prior austenite grains from which the fine ferritic pearlitic structure has evolved. And also changes from brittle to ductile nature.In expulsion process comprises the filler metal in weldment. Thermite welded rail was expelled from between the rail ends helps in fill the cavity formation during welding due to aluminium oxide in partially solid state. This expulsion would alter the solidification microstructure and decrease the number and size of the metallurgical discontinuity in the fusion zone by decreasing the volume of metal thus improving the mechanical properties.

TABLE .I
TENSILE TEST RESULTS OF HEAT TREATED THERMITE WELDED
RAIL STEEL

Young's	Yield		
	modulus	strength	UTS	Percentage of
S. No.	(GPa)	(MPa)	(MPa)	elongation
1	211.23	510	694	12
2	214.97	512	699	10.2
3	217.11	516	711	12.1
Average	214.44	512.67	701.33	11.43

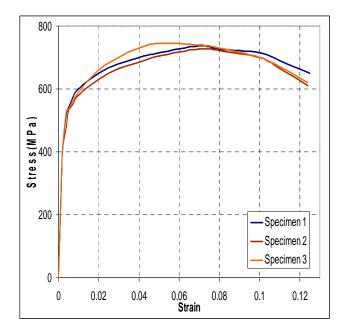
Fig. 3 Stress v/s Strain Curve of Expulsion with heat treated Thermite welded rail

TABLE II
TENSILE TEST RESULTS OF EXPULSION WITH HEAT TREATED
THERMITE WELDED RAIL

Young's	Yield		
	modulus	strength	UTS	Percentage of
S. No.	(GPa)	(MPa)	MPa)	elongation
1	214.54	535	738	12.6
2	213.42	528	728	12
3	214.01	534	745	12.9
Average	213.99	532.33	737	12.50

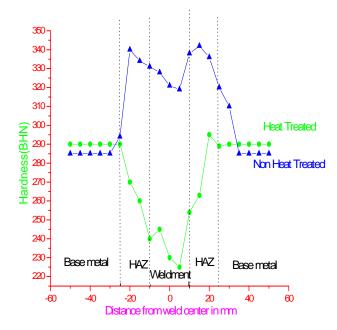
Fig. 4. Brineel Hardness number of thermite welded rail steel

Wear resistance is strongly dependent on the microstructure of metals. In case of rail steels, wear resistance is advanced through the pearlite microstructure. From the above hardness profile of the thermite welded rail steel after heat treatment shows that their significant difference in hardness of thermite welded rail steel and exhibits same hardness profile of Expulsion and heat treated thermite welded rail.. Nonsymmetrical hardness traversing along the longitudinal direction has been observed in this work as shown in the fig 4. After heat treatment, minimum hardness in the weld metal and on the boundary between the heat affected zone and the base metal was observed this could indicate that faster wear will occur on the weld metal softening of heat affected zones of welded rails may deteriorate their fatigue and wear behaviour. This can lead to depressions on the running surface of the rail, disturbing the train passenger comfort.. Minimum hardness existence at heat affected zone nearer to the base metal finer ferritic pearlitic structure existence in post weld treated thermite welded rail. In Expulsion with heat treated techniques normally comprises the filler metal of a full fusion thermite rail weld was expelled from between the rail ends while in a liquid or partially solidified state. This expulsion was caused by applying an axial force to the rails to move their ends together. It was believed that the expulsion would alter the solidification microstructure and decrease the number and size of metallurgical discontinuities in the fusion zone by decreasing the volume of filler metal, thus improving the joint's strength with out changing the hardness.

- Hardness profile of both expulsion with heat treated heat treated thermite welded rails exhibits almost same profile.
- Failure of thermite welded rail at weldment in both due to lower hardness at weldment after heat treatment expulsion with heat treated heat treated.
- Microstructures exhibits more porosity and inclusion in heat treated as compared to expulsion with heat treatment.
- Heat treatment changes the property of weldment from Brittle to ductile in both. Ie Changes in Microstructure from coarse grain to fine grain structure.manganese sulphide precipate on grain boundary of ferrite and cementite in heat treated thermite welded rail.
