# Diagnostics of Fatigue Damage of Gas Turbine Engine Blades by Acoustic Emission Method

**Abstract**—the work contains the results of complex investigation related to the evaluation of condition of working blades of gas turbine engines during fatigue tests by applying the acoustic emission method. It demonstrates the possibility of estimating the fatigue damage of blades in the process of factory tests. The acoustic emission criteria for detecting and testing the kinetics of fatigue crack distribution were detected. It also shows the high effectiveness of the method for non-destructive testing of condition of solid and cooled working blades for high-temperature gas turbine engines.

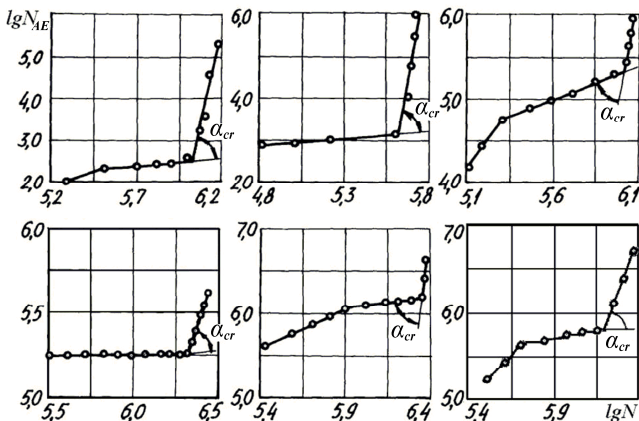
Fig. 1 presents the data characterizing dependencies  $lgN_{AE} = f(lgN)$  at the example of six tests of the first lot of solid working blades. It is obvious that all dependencies have qualitatively similar nature: areas of slow growth of total AE are followed by areas of its sharp increase.

Fig. 1 Change of total AE during cyclic loading of solid blades with the use of  $\alpha$ -criterion

Intersection of the specified areas form angles  $\alpha_{cr}$  ( $\alpha$ -criterion) [5, 6] that characterize the presence of inflection point in the graph. Tests of the first lot of blades were stopped at the point when  $\alpha_{cr}$  appeared. For the second lot, reaching maximum value  $E_{max}$  (energy criterion –  $E_{cr}$ ) by AE energy  $E$  was considered the criterion for stopping the tests.

In spite of different testing conditions from the point of view of stresses in the dangerous section of the body of the first and second lot of working blades, the behaviour of dependencies  $lgN_{AE} = f(lgN)$  with the use of both  $\alpha$ -criterion and E-criterion was identical (see Fig. 1, 3). The difference between graphs lies in the fact that testing of the first lot was stopped with the first appearance of  $\alpha_{cr}$  (see Fig. 1), while the use of  $E_{cr}$  for the cessation of tests is followed by the appearance of one or more  $\alpha_{cr}$  (see Fig. 3). Thus the graphs obtained for blades 2 and 3 have one  $\alpha_{cr}$ ; the ones obtained for blades 1 and 4 have two  $\alpha_{cr}$ ; the ones obtained for blade 5 have four  $\alpha_{cr}$ .

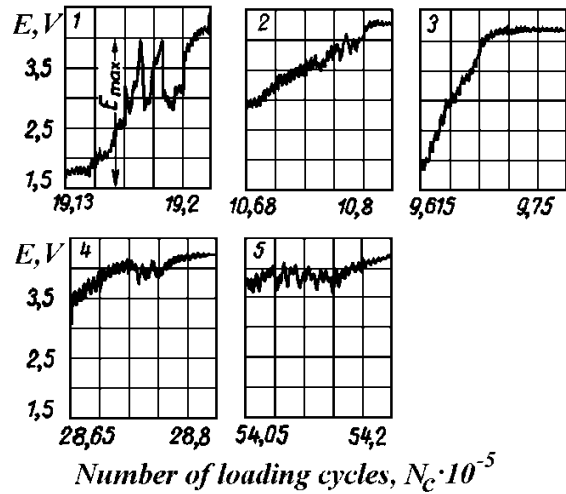
Acoustograms of energies and graphs of dependencies  $lgN_{AE} = f(lgN)$  for tests of five solid blades from the second lot are shown in Fig. 2 and 3.

Fig. 2 Acoustograms of AE energy change during cyclic loading of solid blades with the use of E-criterion

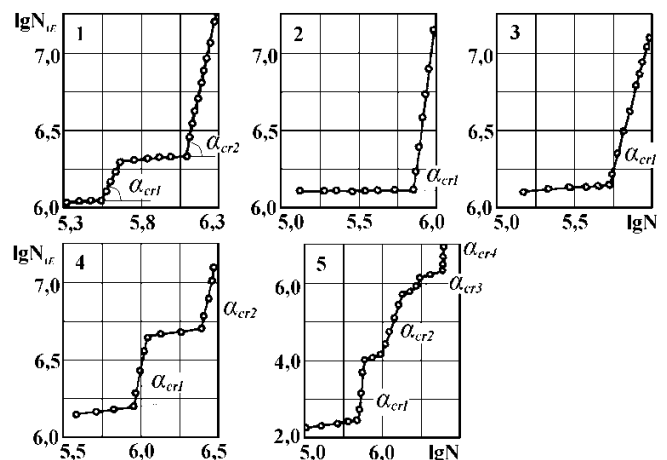
Fig. 3 Change of total AE during cycling loading of solid blades with the use of E-criterion

However, the results of subsequent luminescent control revealed the presence of fatigue cracks in each of the both tested lots of working blades. The number of  $\alpha_{cr}$  formed in the process of using E-criterion usually corresponds to the number of fatigue cracks that appeared during the tests.

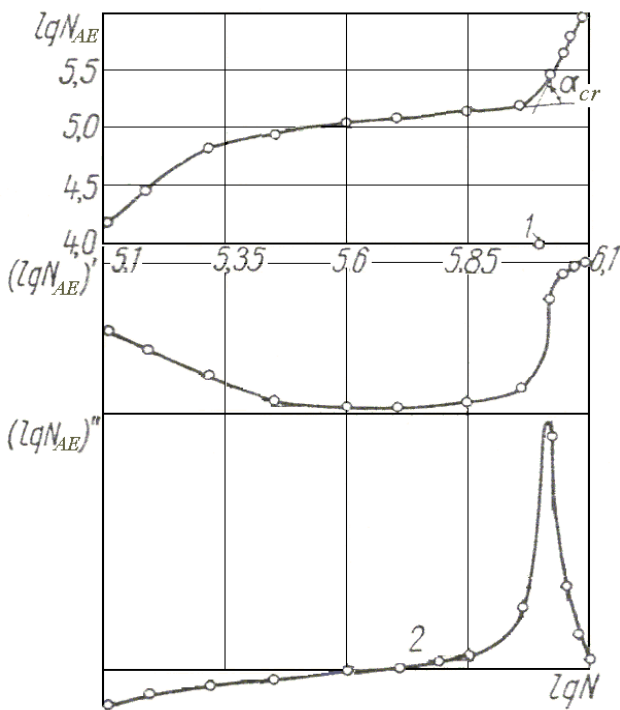
Using the above mentioned criteria, fatigue cracks were registered not only along the blade body but also in the root, i.e. in the place of nipping on the shake table. The comparative evaluation of blade fatigue cracks by length parameter, which was carried out with the help of luminescent control, showed that the length of cracks revealed on the basis of  $E_{cr}$  in all cases exceeded the size of cracks detected on the basis of  $\alpha_{cr}$ . Thus it can be presumed that the appearance of an initial crack in a working blade during testing occurs long before reaching the specified threshold  $E_{max}$  ( $E_{cr}$ ). Thus in Fig. 3, the first appearances of  $\alpha_{cr}$  characterize the formation of initial cracks. However, the blade still does not lose its rigidity properties (natural-vibration frequency of a blade body measured using manufacturing technology still does not decrease) right till the end of the test. Therefore, the criterion assesses the real operability (survivability) of those blades that already have initial cracks. The quantitative estimation of this value showed that blades with cracks detected in accordance with the first  $\alpha_{cr}$  do not lose their operability (by the criterion of natural-vibration frequency) in the range of 30 to 90% of the total loading time. One of the possible criteria for early detection of fatigue cracks in the process of fatigue loading is the second derivative  $(\lg N_{AE})''$  by time from function  $\lg N_{AE} = f(\lg N)$ . Fig. 4 presents an example of change of the first  $(\lg N_{AE})'$  and second  $(\lg N_{AE})''$  derivatives on the basis of results of testing the third blade from the first lot (see Fig. 1). The behaviour analysis of derivatives in the process of cyclic loading shows that the stage of loading at which the second derivative becomes positive (see Fig. 4 point 2) corresponds to the moment of fatigue crack initiation.

Fig. 4 The changes in time of the first and second derivatives of functions  $\lg N_{AE} = f(\lg N)$ : 1 — moment of crack detection by  $\alpha$ -criterion; 2 — moment of crack detection by  $(\lg N_{AE})'' > 0$

Thus, to detect the moment of fatigue crack initiation during a fatigue test, which separates the first stage of fatigue accumulation of damage from the second one,  $\alpha$ -criterion, E-criterion as well as the value of the second derivative when it takes on a positive value can be used. The latter criterion ensures earlier detection of a crack; then, from the point of view of accuracy, there follows  $\alpha$ -criterion; and E-criterion is the “roughest” criterion for detection of longer fatigue cracks.  $\alpha$ -criterion appeared to be the easiest-to-operate criterion for detection of the moment of fatigue crack initiation. The correctness of the given criterion choice as well as its reliability were checked on both solid working blades of other construction and cooled working blades of other construction.

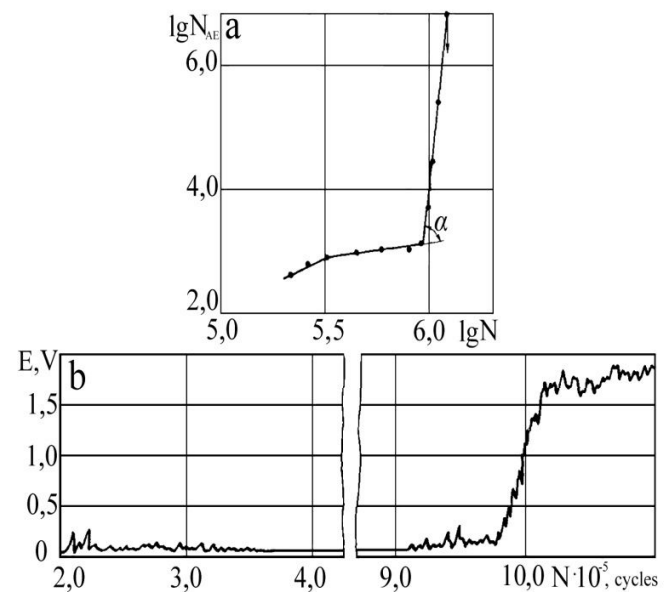
For cooled blades, investigation was carried out in three stages. At first, in the conditions of stationary cyclic loading with the stresses of  $\sigma = 220$  MPa, the tests were carried out until the operation of the “roughest” criterion  $E_{cr}$ . In this case, the nature of dependencies  $\lg N_{AE} = f(\lg N)$  is identical to the one that was obtained earlier for solid blades: areas of slow growth  $N_{AE}$  are followed by areas of sharp increase. Intersection of the specified areas form angles  $\alpha_{cr}$ , similarly to the case with solid blades. At the same time none of the tested blades lost its rigidity properties (natural-vibration frequency of blade body remained constant). Fig. 5 presents the results of specified dependencies change at the example of one of the tested blades.

Fig. 5 The change of total (a) and energy (b) of AE signals in the process of cyclic loading of a cooled working blade (the point at which the tests were stopped is shown with an arrow)

after its opening. It is seen that the fatigue crack in the blade, for which the dependency was obtained and which is presented in Fig. 5, appeared near the base of the cooling intensifier of a cylindrical shape (shown with an arrow). Fig. 6b presents a photo of fracture area along the crack. It is seen that the fatigue crack in this blade has developed to the depth, which is greater than half the thickness of the wall of blade body back, however it has not reached the outside surface yet. The metallographic analysis of other fractures along such cracks showed that they also had fatigue nature and were developing from the inner surface of hollow blades to their outside surface.

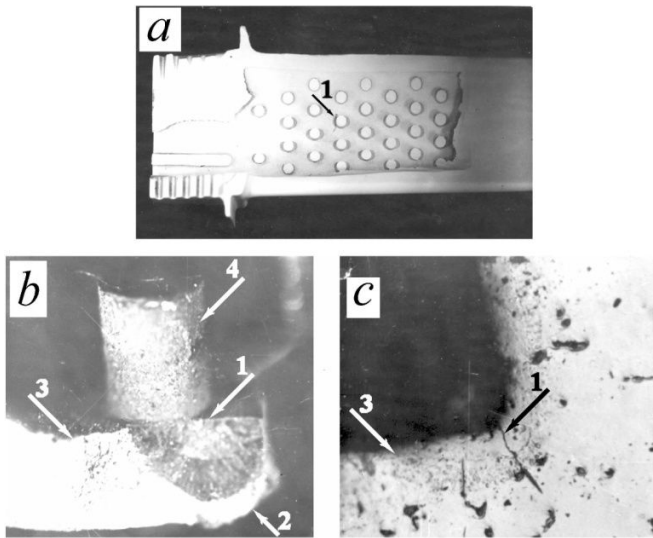
Subsequently all blades were subjected to tests to reveal the presence of cracks with the help of traditional methods. The carried out luminescent control did not show any defects on the outer surfaces of the blades. After opening, defects of crack type were detected in the blades. Fig. 6a presents an example of a photo of inner cavity of one of the cooled blades

Fig. 6 Photo of a blade with a crack: a) – general view of the internal cavity after opening, b) – area of fracture along the crack (x10), c) – metallographic section (X100): 1 - crack, 2 – outside surface of blade, 3 – inner surface of blade, 4 – cooling intensifier

Thus the high efficiency of  $\alpha_{cr}$  operation is demonstrated, while the use of  $E_{cr}$  in these tests gave the opportunity to reliably register the appearance of fatigue cracks by using traditional methods. Further metallographic investigation demonstrated that the earlier the tests were stopped after  $\alpha_{cr}$  registration the smaller was the crack. In cases when tests were stopped practically right after the registration of angle  $\alpha$ , cracks could be detected only after long-term exposure (more than three days) with the help of the luminescent method. Subsequent metallographic analysis of sections of these areas confirmed the presence of fatigue cracks (Fig. 6c).

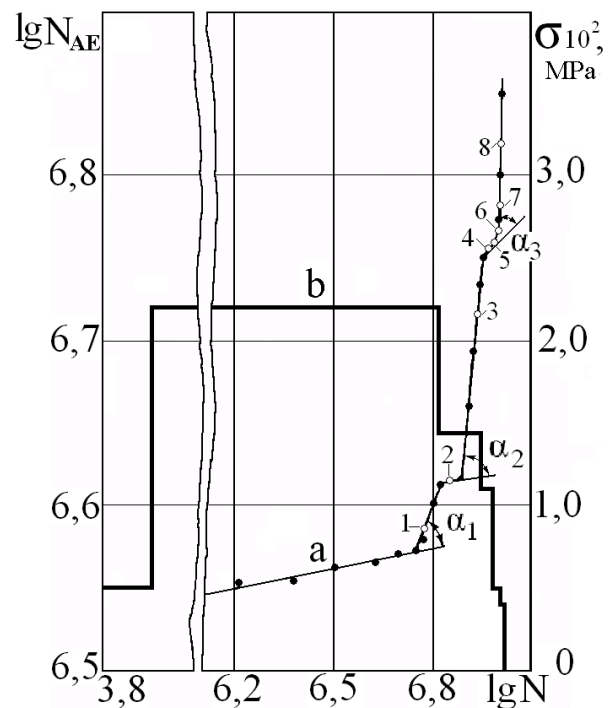
purpose arose. The process of “growing” in certain moments involved the repeated use of fatigue tests of  $\alpha_{cr}$  and  $E_{cr}$ , the essence of which lies in the following facts: The investigated blade was preliminarily subjected to cyclic loading that created the stress equal to 50 MPa. If AE was not recorded, the blade was considered defect-free. Then, in order to accelerate the experiment, the stress was increased up to 220 MPa with subsequent stepwise decrease at the moments of time corresponding to the initial appearance of a crack and then corresponding to its accelerated growth with new stress values. Graphical construction of dependency  $\lg N_{AE} = f(\lg N)$  was carried out right in the process of testing using the above described method. The load was reduced at the moments of time that corresponded to reaching AE signals energy value  $E_{cri}$  after the recording of angles  $\alpha_{cri}$  (Fig. 7) where  $i = 1, 2, 3 \dots$  is a number of stepwise reductions of load.

Fig. 7 The change of total AE (a) in case of staged step change of stress (b) in the process of cyclic loading:

- – experimental points; o – points corresponding to the record of acoustograms of AE signals energy change

Thus the first reduction was made after operating time  $lgN = 6.81$  (see Fig. 7b) after the formation of angle  $\alpha_{cr1}$  and subsequent operation of energy criterion  $E_{cr1}$ , which characterized the reliable appearance of fatigue crack. The change of AE signals energy in the area prior to the reduction of stress is presented in Fig. 8 (acoustogram area 1, obtained in point 1) with  $lgN = 6.78$  (see Fig. 7a). With a new stress value which is equal to 145 MPa (see Fig. 7b) the deceleration of the crack occurs, which is confirmed by the change of total AE (see Fig. 7a) and the reduction of energy level (see Fig. 8, acoustogram area 2) obtained in point 2 with  $lgN = 6.83$  (see Fig. 7a). In the process of subsequent cyclic loading, the growth of the crack accelerates (angle  $\alpha_{cr2}$  is formed). The level of energy increases again up to value  $E_{cr2}$ , which can be well seen in Fig. 8 (acoustogram area 3 obtained in point 3) with  $lgN = 6.94$  (see Fig. 7a). Then, with  $lgN = 6.95$ , the following reduction of stress up to 110 MPa was made (see Fig. 7b), which entailed the deceleration of the crack and, correspondingly, the reduction of values of AE parameters (see Fig. 8, acoustogram area 4). After the recording of angle  $\alpha_{cr3}$ , the level of energy increases up to value  $E_{cr3}$  (see Fig. 8, area of acoustogram obtained in point 5). At the moment corresponding to operating time  $lgN = 6.99$  the stress was reduced up to 50 MPa (see Fig. 7b). The growth of the crack decelerated for a short time, which is insufficiently reflected in Fig. 7a and well illustrated in Fig. 8 (area 6 of acoustogram obtained in point 6), with  $lgN = 6.99$  (see Fig. 7a). Then the growth of the crack accelerates again, which is confirmed by the increase of AE energy level up to another energy criterion  $E_{cr4}$  (see Fig. 8, acoustogram in point 7). The next reduction of stress up to 40 MPa practically does not exert any influence on the velocity of crack growth; energy criterion remained at the same level of  $E_{cr4}$  (see Fig. 8, acoustogram in point 8). When the stress was below 40 MPa, counting with the help of the frequency meter stopped. During the subsequent luminescent control of blades tested with the help of the above described programme no cracks were detected on the outer surface. However, after the opening of blades, both the luminescent control and the metallographic analysis confirmed the presence of cracks of fatigue nature on inner surfaces.

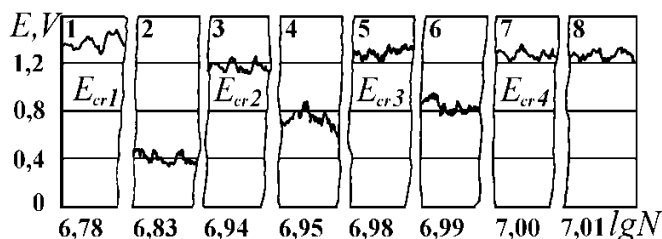
Fig. 8 Acoustograms of AE signals energy change at typical stages of loading of a cooled blade

Fig. 9 presents a photo and a diagram of blade fracture along the crack (shown with arrows), for which the dependencies presented in Fig. 7 and 8 were obtained. It is seen that the crack in this blade has reached approximately half the thickness of the wall and has not reached the outer surface.

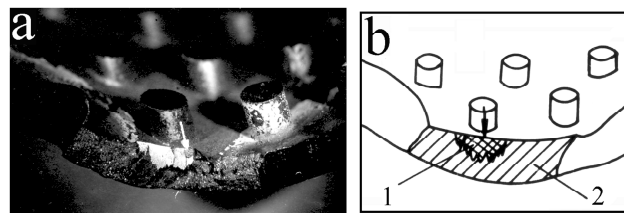
Fig. 9 Photo and diagram of blade fracture along the crack
