Degradation Propensity of Welded Mild Steel in Coastal Soil of University of Lagos

S. O. Adeosun, O. S. Sanni

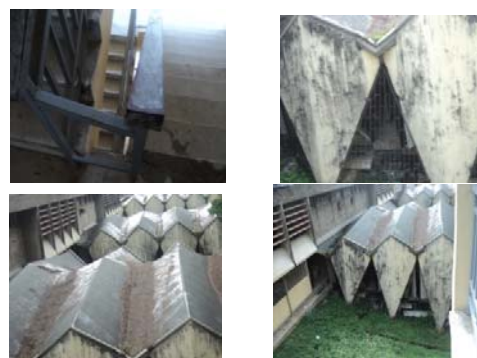
Fig. 1 Corrosion attacks of steel and concrete structures in the University of Lagos, Nigeria

Structures in the University of Lagos have also been found to suffer tremendous physical degradation of its steel and concrete members (see Fig. 1). Most alarming are the structures put up in the last ten years which are located close to the lagoon.
