Seismic Behaviour of Romanian Orthodox Churches, Modeling of Failure Modes by Rigid Blocks

Marius Mosoarca, Victor Gioncu, Ovidiu Cosma

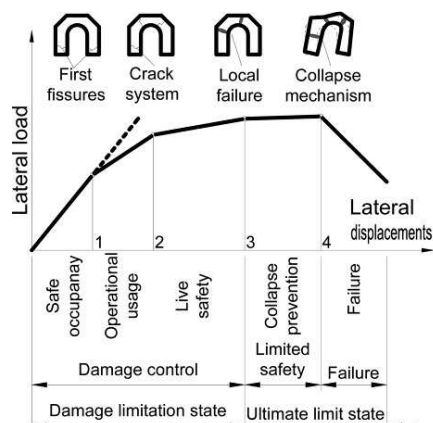
Fig. 1 Behaviour of a masonry triumphal arch

It is well known that masonry structure analysis requires nonlinear modeling accounting for the low tensile capacity and the consequent cracking phenomena. It is well known though that such models cannot be used in the case of very complex structural systems characterized by large number of degree of freedom. In the same time, it is very clearly that the methodologies required for the two limit states differ very much. While for damage limitation state one can use the elastic analysis (with or without considering some fissuration effects), for the ultimate limit state, the methodology must be very different. Therefore, analyzing the behavior of historical buildings, it is need to be adopted a two step procedure as shown in Fig. 1.

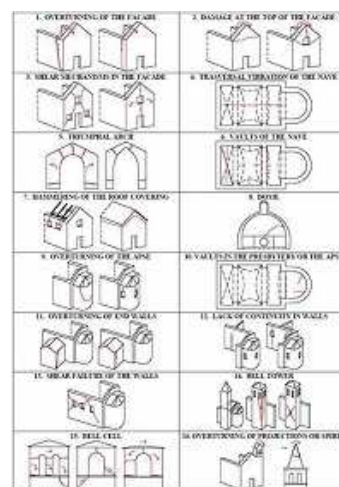
Fig. 2 Romanesque churches. Masonry rigid block [5]

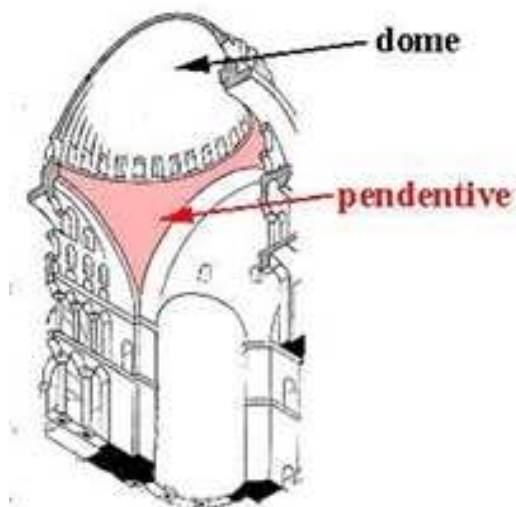
Fig. 3 Pendentive in Byzantine churches

The buildings of Romanian Orthodox churches are based on the Byzantine style, being characterized by the using pendentives and dome on pendentives as in Fig. 3. It must be pointed that the main structural characteristic of Byzantine architecture is the use of pendentive domes, dome on pendentives, and tower on pendentives. This is unique way of adjusting the circular form of a dome or tower to a square plan. The pendentive dome is derived by trimmer the sides of a circular dome over a square plan as in Fig. 4. The pendentives dome enables to transfer the total load of the roof to the four corners of the building.

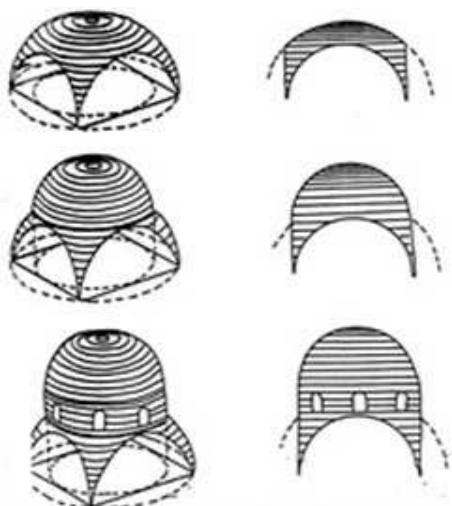
Fig. 4 Pendentives and dome and tower on pendentives

Additionally, the top dome enables to transfer the total load of the roof to the four corners of the building. The top of the pendentive can be trim to introduce another dome on top. The additional dome can further be raised to introduce a cylindrical tower between the pendentive dome and the additional dome.

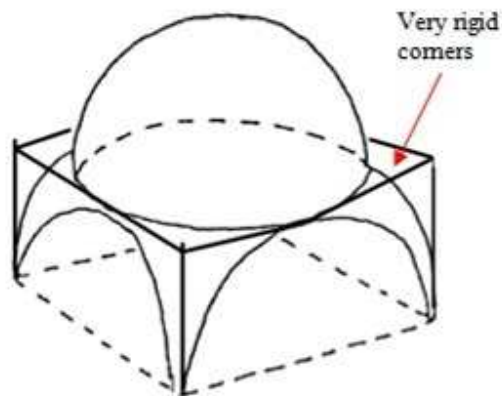
Fig. 5 Rigid corner pendentives, including the surrounding walls

Windows can then be introduced in the cylindrical tower enabling architects to create interior light effects. The surrounding infilled and exterior masonry walls also contribute to carry out the loads, forming very rigid corner pendentives as in Fig. 5.

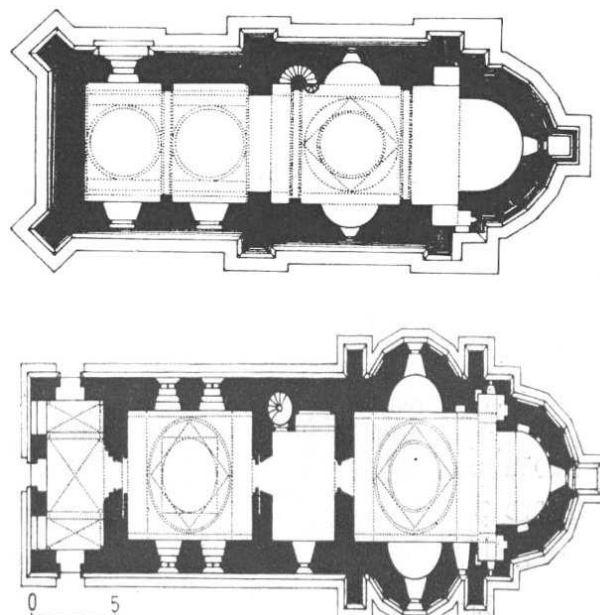
Fig. 6 Typical rectangular and tree-lobed plans [8]

The typical plans of Orthodox churches are presented in Fig. 6: rectangular nave with one lob and three-lobed nave. Unlike the Catholic churches, the Romanian Orthodox churches are relative small in size. The main typical Romanian orthodox churches are the three-lobed plan. This form plays a crucial role in the improving the church behaviour during the earthquakes, because it reduces the distance between stiffness centre and centre of gravity on the longitudinal axis of symmetry [8]. In some cases, some churches were provided with buttresses in order to reduce the distance between these two centers.

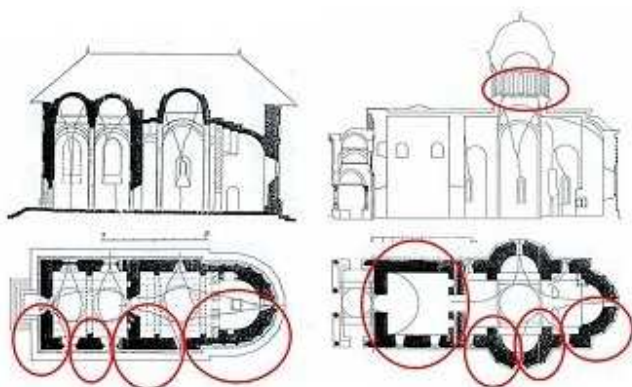
Fig. 7 Damage of Borzesti and Cozia churches due to 1977 Vrancea Earthquake [2]

earthquakes, Fig. 7 presents the Borzesti (rectangular plan) and Cozia (three-lobed plan) churches [2].

Analyzing the occurred system of fissures and cracks it is very clear that the spatial collapse mechanism is formed by a longitudinal fracture and multiple transversal fractures which round the pendentives, due to the great rigidity of these ones.

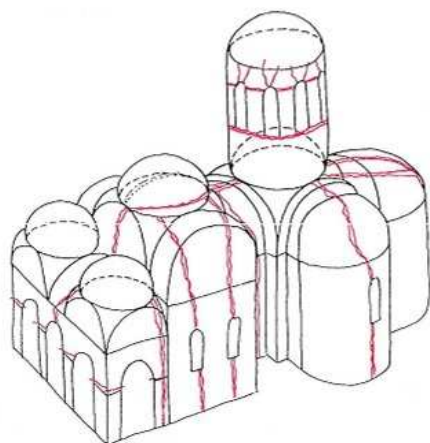
Fig. 8 Blocks system in ultimate limit state [2]

In addition, cracks occurred at the base of tower. The cracks start always from the windows, due to reduced rigidity in these zones. Considering the system of fractures, it is very clear that, in the ultimate limit state, the churches form a block system, working independently each other's as in Fig. 8.

The blocks are formed by the wall delimited by two indows and the corresponding corner pendentives. Due to the seismic actions, the blocks rotate around a basis axis. This rotation is equilibrated by the gravity loads, mainly due to the masonry weight.

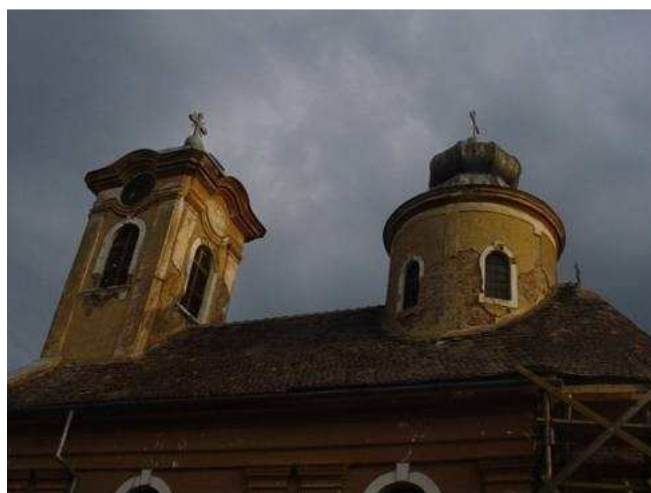
Fig. 9 The two towers of the church

Hall-type church building is covered with brick arches and wood framing. The church has two towers: the West Tower and East Tower in Fig. 9 and Fig. 10.

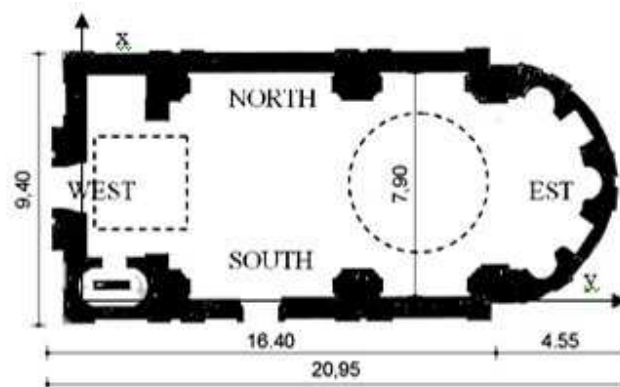
Fig. 10 Horizontal section

- i. The church was divided into rigid blocks based on observations recorded after earthquakes cracks in the Banat area since 1991. Transfer blocks are shown in Fig. 17, based on 3D drawing. Global system of axes is shown in Fig. 10.

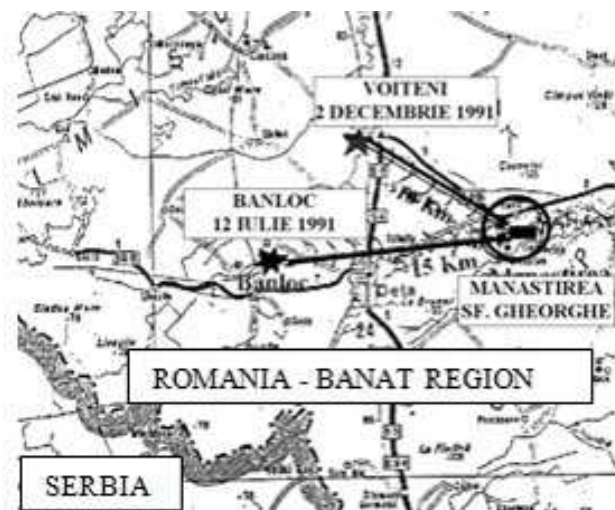
Fig. 11 The distances to the earthquake poles

Unveiling of foundations in the altar area and in North facade revealed that there are no cracks in the foundation. Because the distances to the two poles are 15 km and 10 km as in Fig.11, this earthquake fits the category of "epicentral earthquake" which is characterized by:

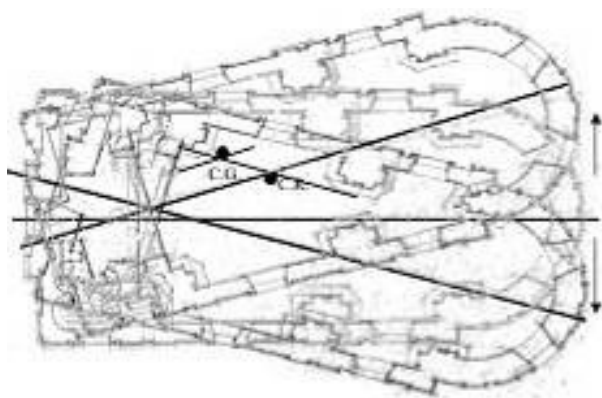
Fig. 12 Rotation of the church

In these circumstances, taking into account the position of the church to the two poles, the church's main action direction is longitudinal. Given the longitudinal asymmetry of the church, the west is much stiffer than the east. The center of rigidity of the structure is moved to the west. At the same time, taking into account the different stiffness of the stair area on the opposite side, the center of rigidity is moved in north. Rotation of the church from the center of rigidity is shown in Fig. 12. It can be noticed that the round wall next to altar is the most stressed, being the farthest from the center of rigidity.

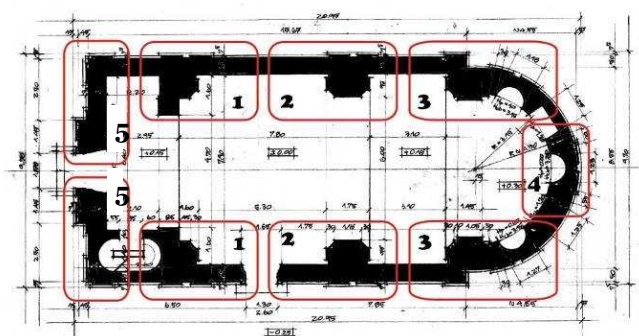
Fig. 13 Mechanism blocks

Under these conditions, considering the presence of openings, masonry has a tendency to separate into blocks by splitting of arches above the openings thus forming nine blocks. The most stressed is block 4 of the eastern wall where are the largest lateral deformations in Fig. 13.

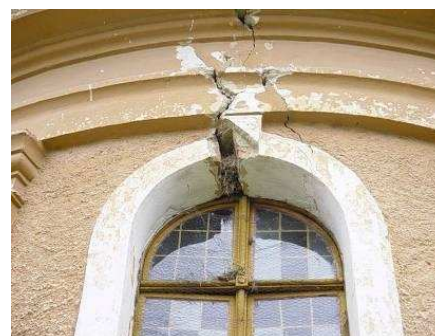
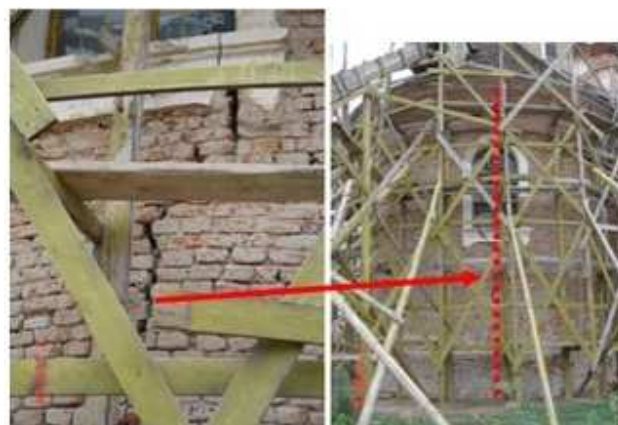
Fig. 14 Cracks at the eastern wall

Brick walls are 75 cm thick, reinforced with brick pillars in front of the roof arches. Masonry structure has a longitudinal symmetry, except the West side where the presence of the stair has introduced an asymmetry characterized by walls with a thickness of 40-45 cm. The window openings on the altar apse and reduced thickness of the wall under the windows have caused cracks in Fig. 14.

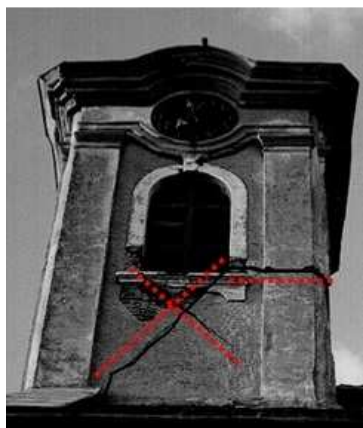
Fig. 15 Cracks at bell tower

The cover in the central area is made of two domes on brick pendants resting on arches. One of the vaults supports a tower with circular section. Rectangular bell tower section is being supported on one side of the church walls, and on the opposite side of a brick arch that has no tie to the beginning and shows cracks. Under the bell tower windows, X cracks were found on the South and North facades, damages characteristic of seismic actions in Fig. 15.

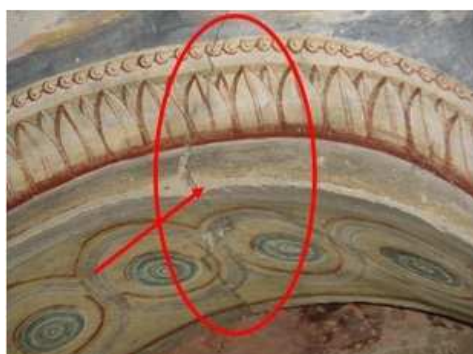
Fig. 16 Cracks at arches

Eastern Tower, not being bounded by land and moving freely with the dome, has minor cracks. Inside the church there are cracks at the top of the vaults because arches don't have ties for taking vertical loads in Fig. 15.

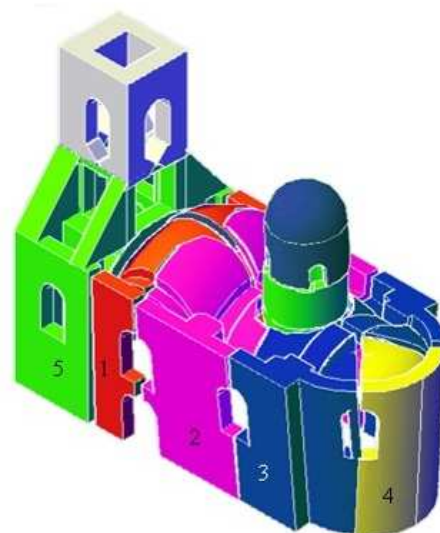
Fig. 17 St. George church, blocks system in ultimate limit state

- ii. Because the greatest damages were recorded in the nave and apse altar, a special attention was given to these areas. They were divided into blocks 1, 2, 3 and 4.

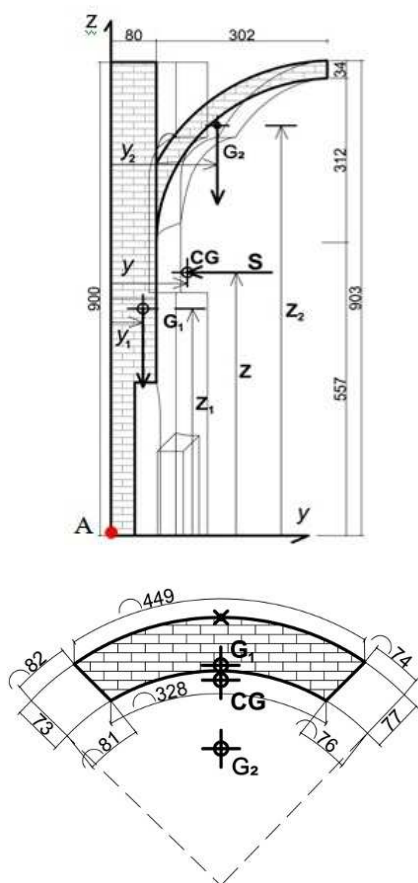
Fig. 18 Dimensions in plan and positions of centers of gravity for block 4

ix. The equilibrium relation between overturning moment and stabilisation moment was written for each failure block in relation to point A from the wall as shown in Fig. 18. It is located at the outer end wall. According to [6] the proportion ratio between the overturning moment and the stabilisation moment of the transfer block is called seismic coefficient and is noted by λ . It has subunit value and represents the maximum value of ground acceleration for which the building collapse that occurs outside of the plan of the failure block. Maximum seismic acceleration of ground in the Monastery of St. George is $0.16g$, so $\lambda_{\max \text{ field}} = 0.16g/g = 0.16$. λ values calculated by theoretical modeling for each failure block were compared with this value of $\lambda_{\max \text{ field}}$. Blocks with a value of λ

Because the most damaged transfer block after 1991 earthquakes is block 4, in Figure 18 are presented the dimensions and position of the center of gravity and the point of application of seismic force. There are only two centers of gravity for masonry and bolt and one for the entire block 2. The Name of symbols used in Figure 18 are shown in Table I.

For failure block 4, who was the most damaged after earthquake, λ is determined with (1) [9]. Calculations are presented in Table II. The value of λ is calculated in (2).

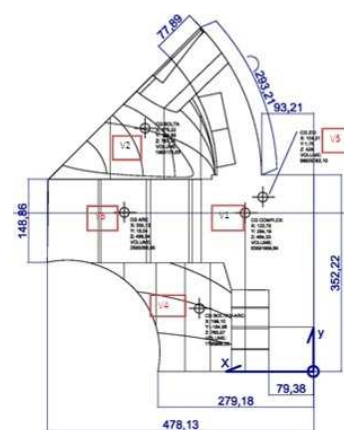
Fig. 19 Dimensions in plan and positions of centers of gravity for block 2

In Fig. 19 and Fig. 20 are shown the dimensions in plan, the positions of the center of gravity and the point of application of seismic force for failure blocks 2 and 3 in 3D coordinates. There are five centers of gravity for each failure block caused by wall, domes and arches. Values of stabilization and overturning moments are presented in Tables III and Table IV. The values are presented in (3) and (4).

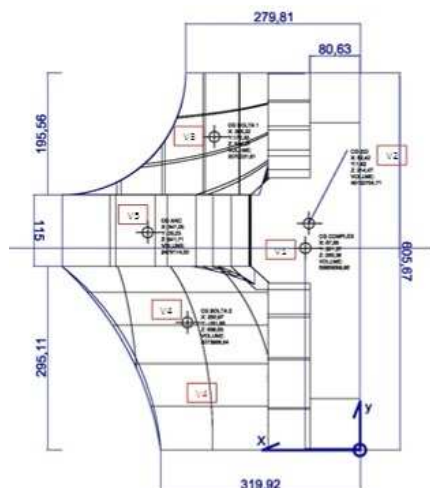
Fig. 20 Dimensions in plan and positions of centers of gravity for block 3
