Vibration and Operation Technical Consideration before Field Balance of Gas Turbine Utilities (In Iran Power Plants SIEMENS V94.2 Gas Turbines)

Abstract—One of the most challenging times in operation of big industrial plant or utilities is the time that alert lamp of Bentley Nevada connection in main board substation turn on and show the alert condition of machine. All of the maintenance groups usually make a lot of discussion with operation and together rather this alert signal is real or fake. This will be more challenging when condition monitoring vibration data shows $1X$ (X =current rotor frequency) in *fast Fourier transform* (FFT) and vibration phase trends show 90 degree shift between two non-contact probe directions with overall high radial amplitude amounts. In such situations, CM (condition monitoring) groups usually suspicious about unbalance in rotor. In this paper, four critical case histories related to SIEMENS V94.2 Gas Turbines in Iran power industry discussed in details. Furthermore, probe looseness and fake (unreal) trip in gas turbine power plants discussed. In addition, critical operation decision in alert condition in power plants discussed in details.

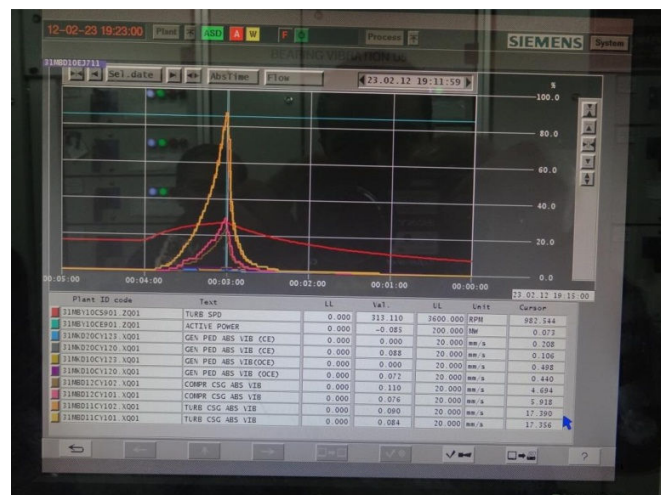
Fig. 1 Trip vibration condition

We analyzed the condition monitoring data in trip moment and realized that the main vibration peak was in 1X. Two direction amplitude overall both considerably high and the phase data shows 90 degree shift between two main direction in that moment. All those evidences led us to unbalance. We decided to operate balancing program in two steps because

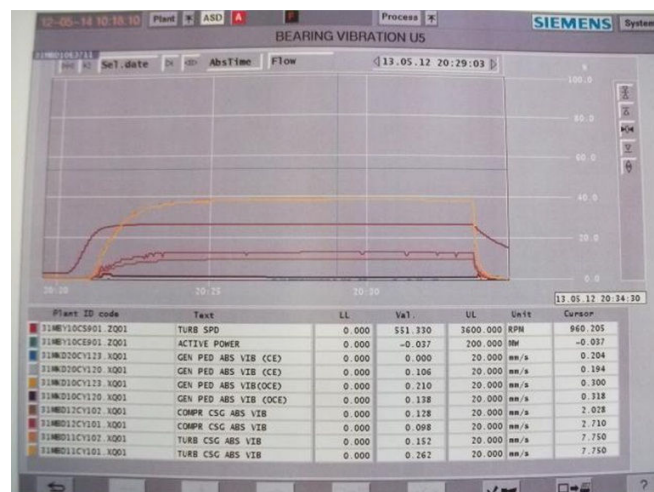
In first step, we were planning to operate the balancing process in 3000 RPM between the period of Saturday, May 12, 2012 and Tuesday, May 15, 2012. In this stage, we installed 19 balancing weights in Compressor Disk Stage ten 165° and 27 balancing weight in turbine Stage four 165°. However, unfortunately, process has some considerations and they could not run the gas turbine in the operation condition then we had to waiting for the suitable condition to operate the next stage of balancing program [13].

Fig. 2 Vibration condition in first balancing stage

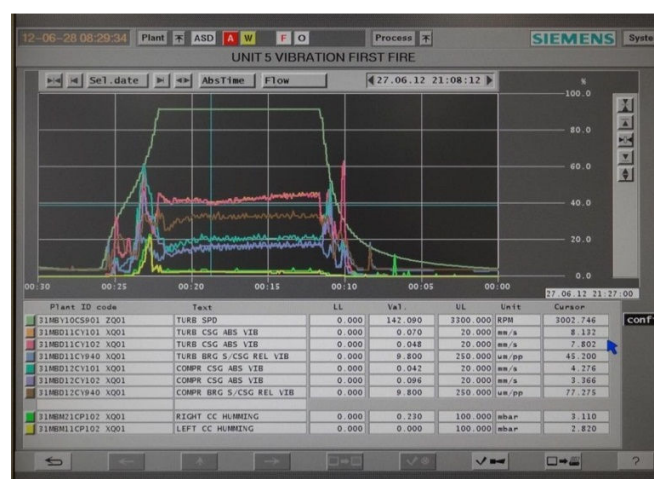
In the next stage process operated the gas turbine in 3000 RPM and balancing operation continue between the period of Tuesday, July 3, 2012 and Friday, July 6, 2012, finally we decided to install 15 balancing weight in Compressor Disk Stage ten 150° and 23 balancing weight in turbine stage four 155°.

Fig. 3 Vibration condition in 3000 RPM

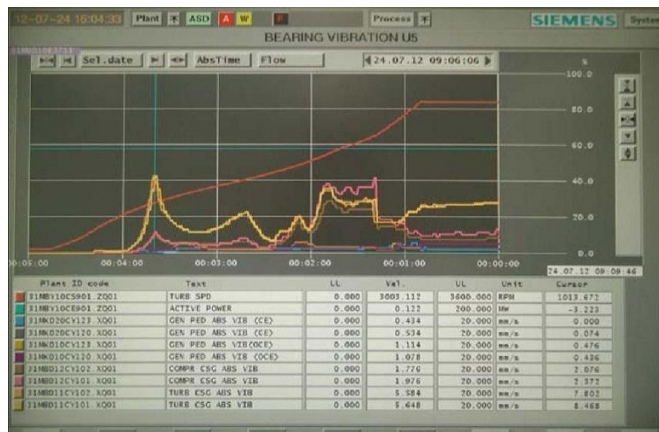
Fig. 4 Vibration condition in 3000 RPM after synchronize the unit by process

In conclusion after synchronizing the unit by process in Monday, July 23, 2012 and analysis the vibration trends in the base load we could operate the gas turbine in process condition with close monitoring [14].

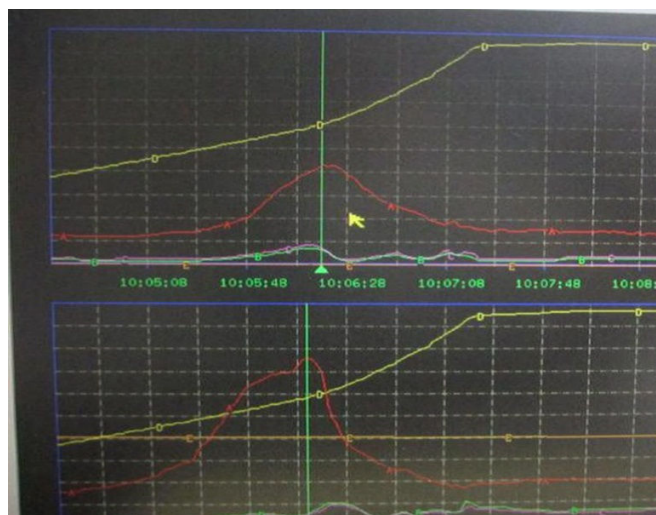
The process of Kerman utility unit 2 reported that the relative vibration of OCE journal pass over 159 micrometer peak to peak after the turbine passing 1800 RPM (first critical speed) in shut down process. After analyzing the vibration data, we decided to operate the single panel balancing process on middle shaft at Wednesday, October 24, 2012.

Fig. 5 Startup vibration of generator journal before balancing process

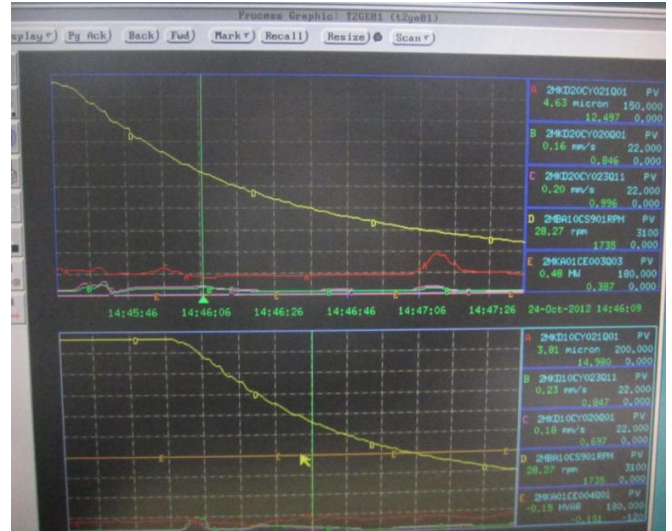
Fig. 10 Shutdown vibration of generator journal after balancing process

After adding trial weights finally we achieve to 19 balancing weight 40 grams 155° there relative vibration of OCE journal reduce too much when turbine passing 1800 RPM [15]

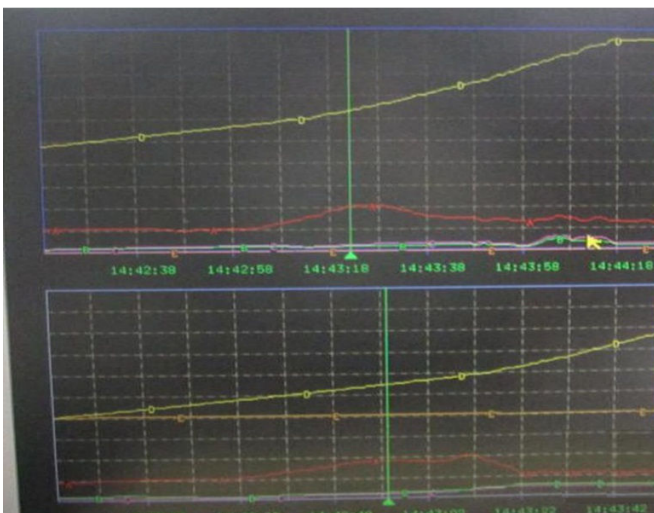
Fig. 9 Startup vibration of generator journal after balancing process

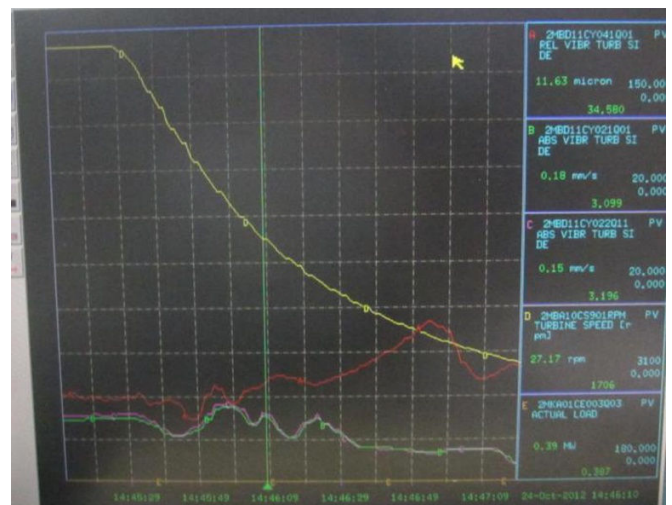
Fig. 12 Shut down vibration of turbine journal after balancing process

Due to the vibration, overall amount after balancing process and vibration limits in technical document of this gas turbine the vibration condition of this machine is in good condition therefore this unit can continue operation without any problem [16].

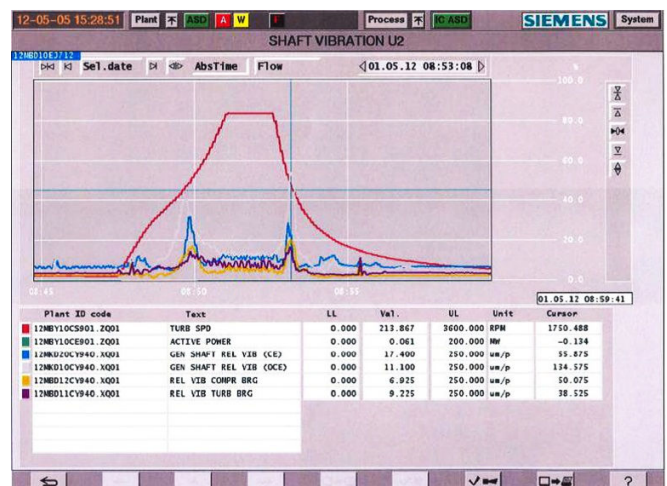
Fig. 14 Relative vibration trend shut down turbine side before change the cables

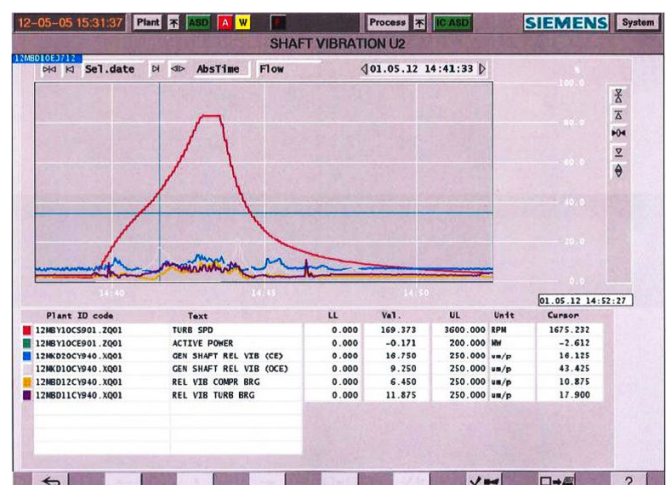
Fig. 15 Relative vibration trend startup turbine side after change the cables

The electrical special tools reinstalled the probes with new cables and the gas turbine restarted for operation. The vibration trends in startup and shut down before and after change the cables was as following.

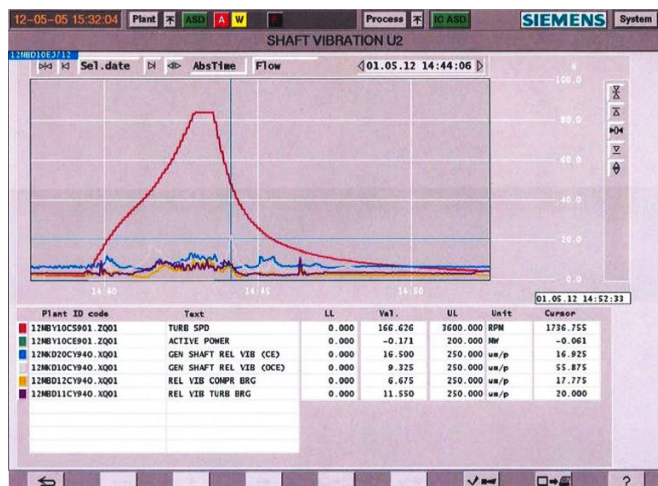
Fig. 16 Relative vibration trend shut down turbine side after change the cables

Due to the vibration overall amount after changing the cables the vibration of this gas turbine was in good condition after overhaul and this gas turbine could continue operation and the trip vibrations was unreal or fake[20].
