# Vibration and Operation Technical Consideration before Field Balance of Gas Turbine Utilities (In Iran Power Plants SIEMENS V94.2 Gas Turbines)

Omid A. Zargar

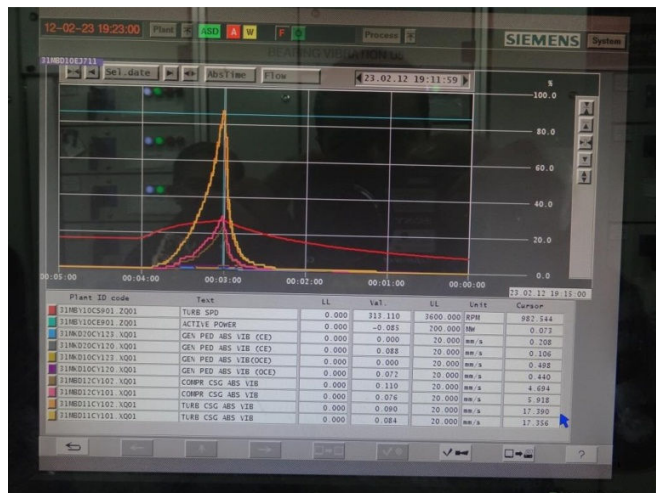
Fig. 1 Trip vibration condition

We analyzed the condition monitoring data in trip moment and realized that the main vibration peak was in 1X. Two direction amplitude overall both considerably high and the phase data shows 90 degree shift between two main direction in that moment. All those evidences lead us to unbalance. We decided to operate balancing program in two steps because

In first step, we were planning to operate the balancing process in 3000 RPM between the period of Saturday, May 12, 2012 and Tuesday, May 15, 2012. In this stage, we installed 19 balancing weights in Compressor Disk Stage ten 165° and 27 balancing weight in turbine Stage four 165°. However, unfortunately, process has some considerations and they could not run the gas turbine in the operation condition then we had to waiting for the suitable condition to operate the next stage of balancing program [13].

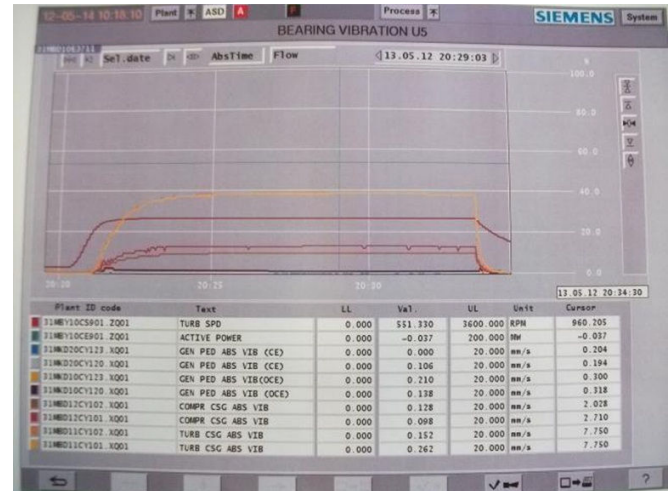
Fig. 2 Vibration condition in first balancing stage

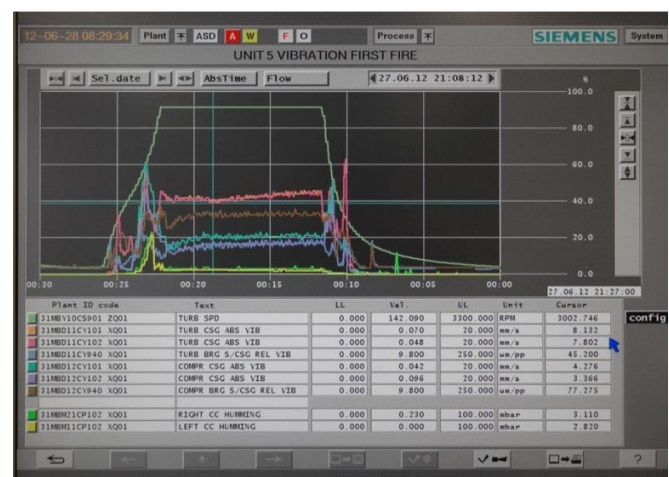
Fig. 3 Vibration condition in 3000 RPM

In the next stage process operated the gas turbine in 3000 RPM and balancing operation continue between the period of Tuesday, July 3, 2012 and Friday, July 6, 2012, finally we decided to install 15 balancing weight in Compressor Disk Stage ten 150° and 23 balancing weight in turbine stage four 155°.

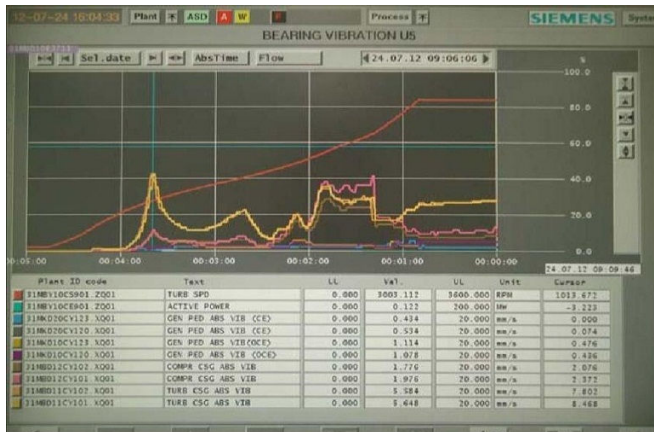
Fig. 4 Vibration condition in 3000 RPM after synchronize the unit by process

In conclusion after synchronizing the unit by process in Monday, July 23, 2012 and analysis the vibration trends in the base load we could operate the gas turbine in process condition with close monitoring [14].

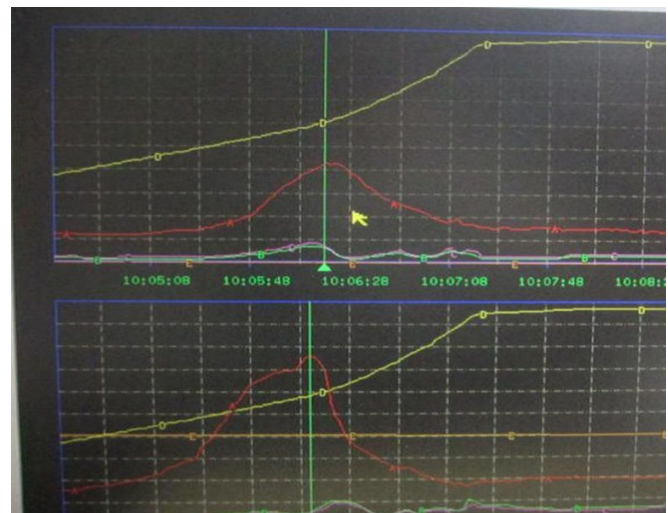
The process of Kerman utility unit 2 reported that the relative vibration of OCE journal pass over 159 micrometer peak to peak after the turbine passing 1800 RPM (first critical speed) in shut down process. After analyzing the vibration data, we decided to operate the single panel balancing process on middle shaft at Wednesday, October 24, 2012.

Fig. 5 Startup vibration of generator journal before balancing process

After adding trial weights finally we achieve to 19 balancing weight 40 grams 155° the relative vibration of OCE journal reduce too much when turbine passing 1800 RPM [15]

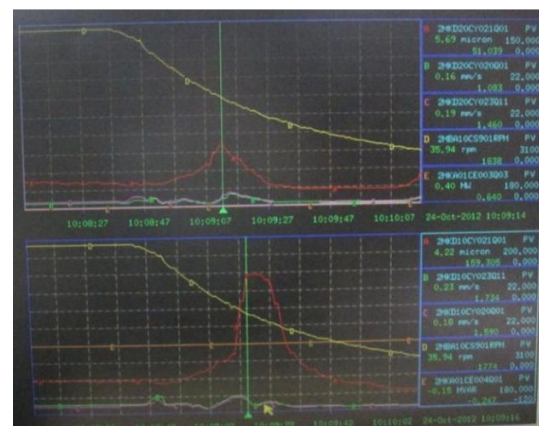
Fig. 6 Shutdown vibration of generator journal before balancing process

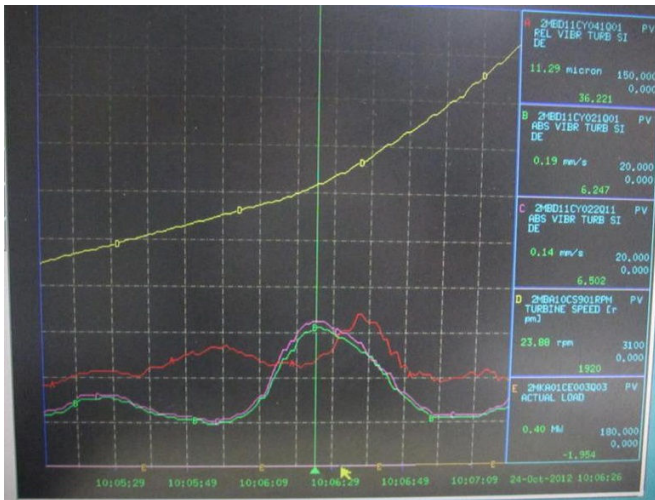
Fig. 7 Startup vibration of turbine journal before balancing process

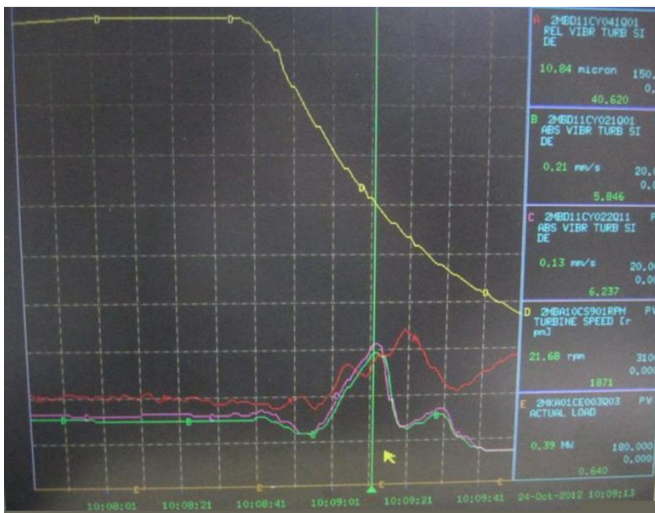
Fig. 8 Shut down vibration of turbine journal before balancing process

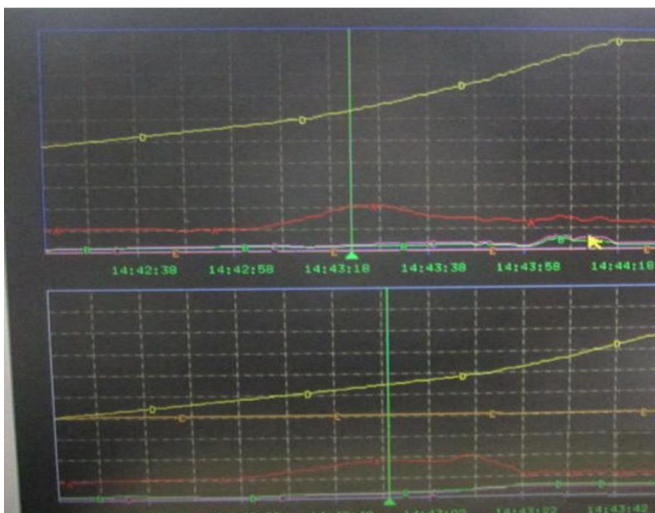
Fig. 9 Startup vibration of generator journal after balancing process

Due to the vibration, overall amount after balancing process and vibration limits in technical document of this gas turbine the vibration condition of this machine is in good condition therefore this unit can continue operation without any problem [16].

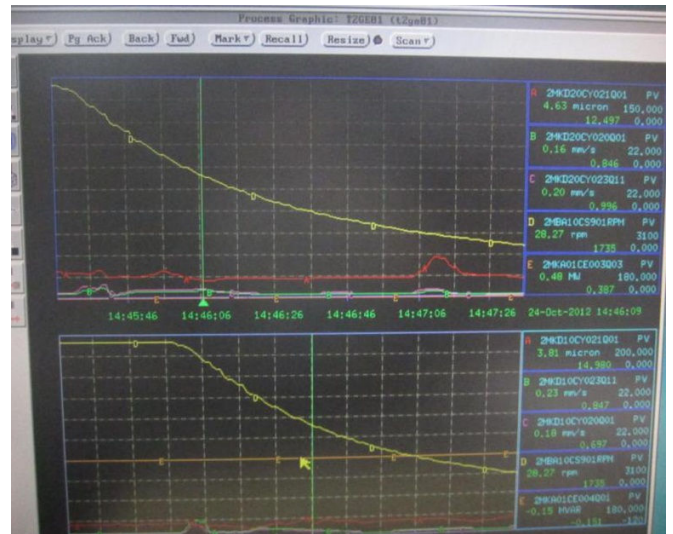
Fig. 10 Shutdown vibration of generator journal after balancing process

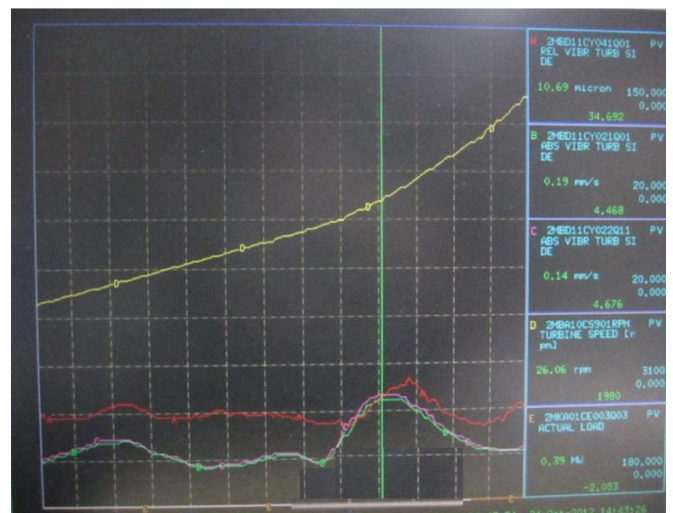
Fig. 11 Startup vibration of turbine journal after balancing process

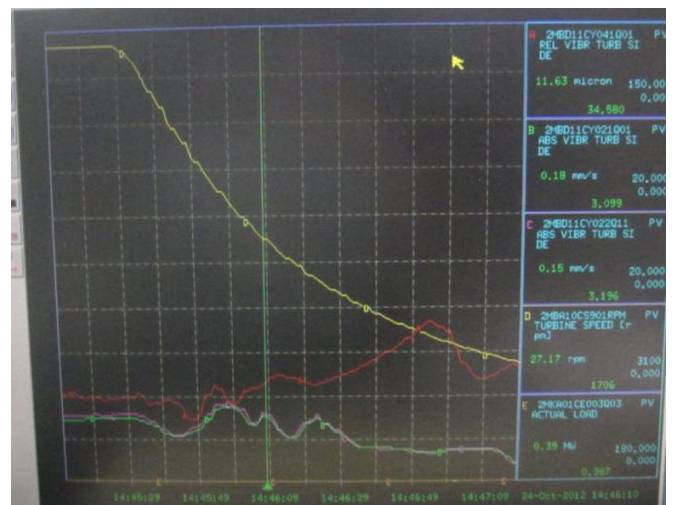
Fig. 12 Shut down vibration of turbine journal after balancing process

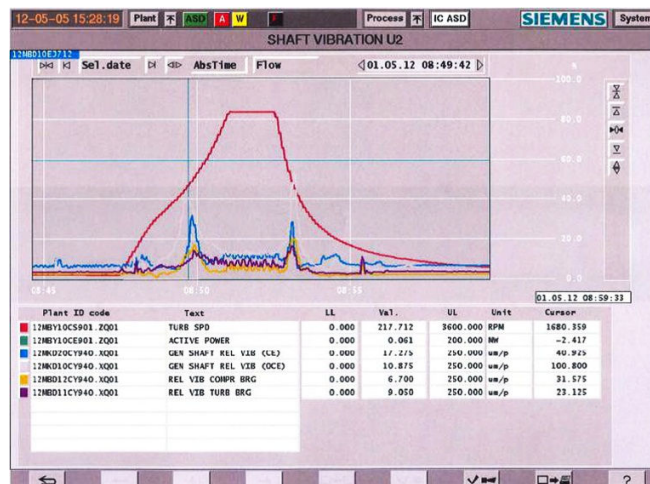
First of all CM records showed that the frequency shift randomly but the overall amplitude is relatively in same situation all over the startup and shut down process. This kind of behavior reject the hypothesis of probe looseness and also the 1X vibration was not always dominated in different RPM. Besides, the phase have not 90 degree shift between two main direction therefore the unbalance hypothesis also rejected therefore they may have some problem in adjusting probe installation or any related electrical or electronic considerations [18].

The electrical special tools group then planning the installation check in Wednesday, May 2, 2012 they first checked the distance between probes and the shaft by digital volt meter all the records was correct by 0.01 volt accuracy then they check the angle that was  $45^\circ$  by 0.1 accuracy all was acceptable and in the range of technical document of gas turbine but there was a ridiculous mistake that the transfer cable must be 1 meter but the installation guy install 1.5 meter cable that was the recommended cable of gas turbine unit 6 by mistake and the electrical resistance of these length of cable caused unreal signal and unreal signal cause unreal shut down or trip [19].

Fig. 13 Relative vibration trend startup turbine side before change the cables

The electrical special tools reinstalled the probes with new cables and the gas turbine restarted for operation. The vibration trends in startup and shut down before and after change the cables was as following.

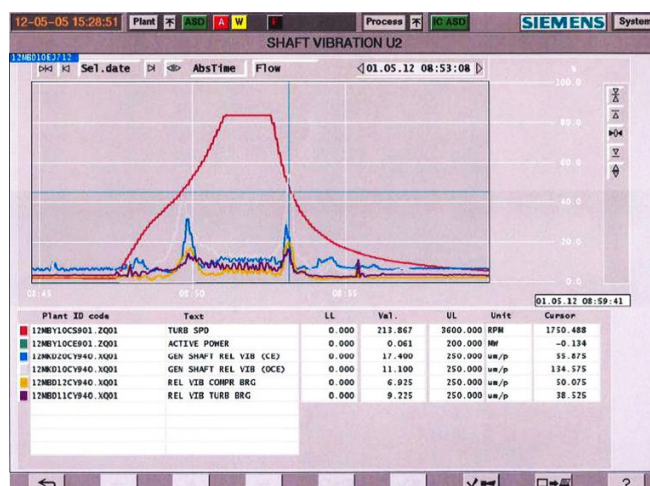
Fig. 14 Relative vibration trend shut down turbine side before change the cables

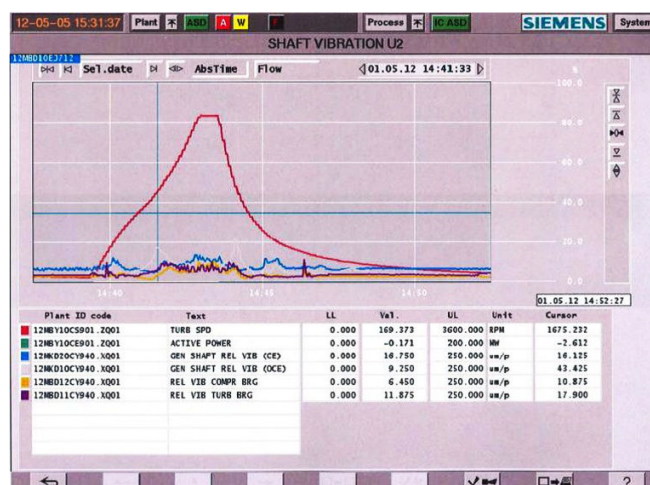
Fig. 15 Relative vibration trend startup turbine side after change the cables

Due to the vibration overall amount after changing the cables the vibration of this gas turbine was in good condition after overhaul and this gas turbine could continue operation and the trip vibrations was unreal or fake[20].

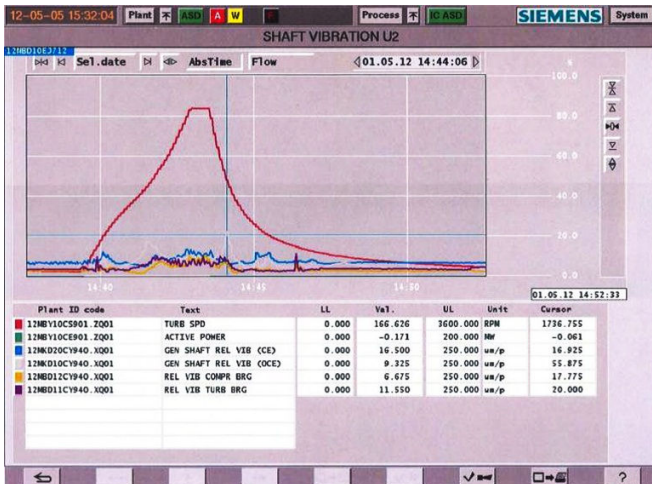
Fig. 16 Relative vibration trend shut down turbine side after change the cables

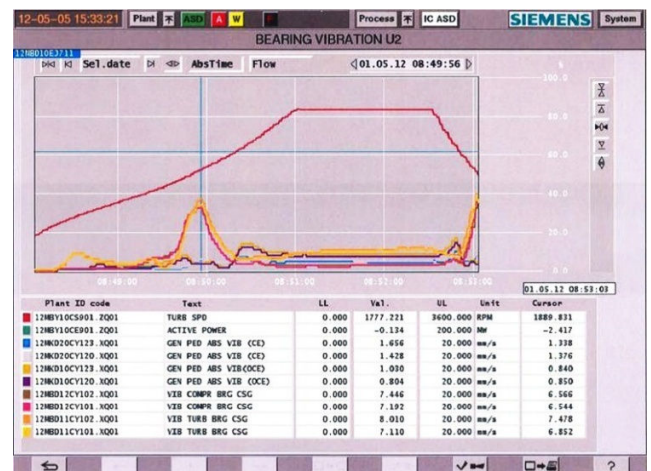
In these conditions, operation increased the load up to 40 MW and the overall vibration increased up to 1 mm/s.

Fig. 17 Vibration condition SIEMENS V94.2 Gas Turbine utility 3000 RPM without any load

The exhaust liner was engaged and the machinery maintenance actions take place in the next stage. The alignment check operated by machinery group between compressor and generator due to the condition monitoring vibration analysis. In addition, we decided to continue the balancing operation to reduce the amount of vibration on Thursday, April 18, 2013. The initial vibration amounts were as following:
