Performance of Bridge Girder with Perforations under Tsunami Wave Loading

Sadia Rahman, Shatirah Akib, M. T. R. Khan, R. Triatmadja

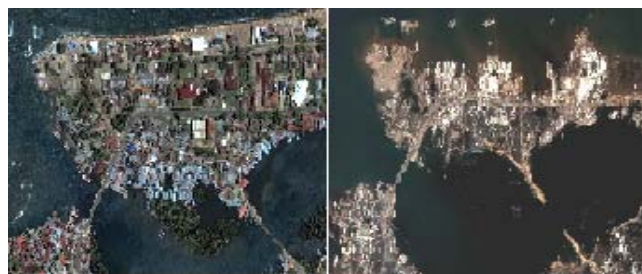
Fig. 1 Effects of tsunami 2004, along coastal line and bridge structures in Banda Aceh, Indonesia

destruction could be identified to be done by tsunami rather than earthquake. Tsunami has the power to destroy or collapse the infrastructures including bridges in its course. Fig. 1 showed the impact attributed by 2004 tsunami along coastal line in Indonesia. Several structural damages were featured by many researchers during 2004 tsunami [1]-[5]. Therefore, it is evident that the tsunami induced forces should be introduced in the design of coastal structures.

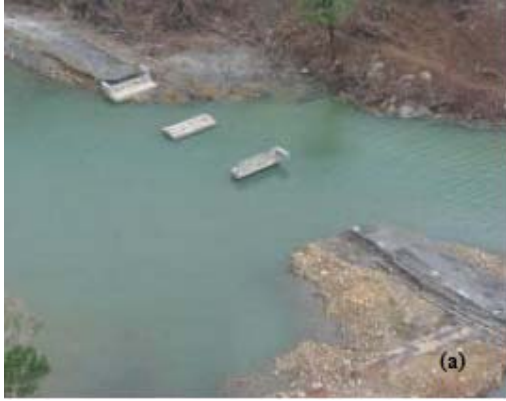
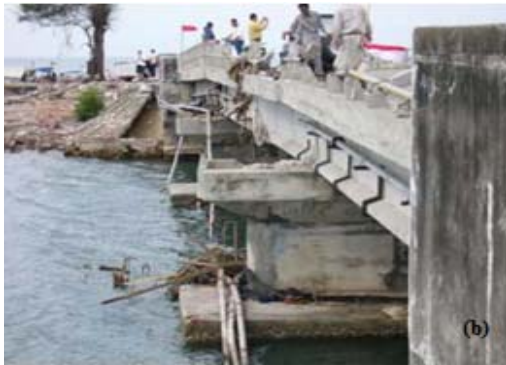
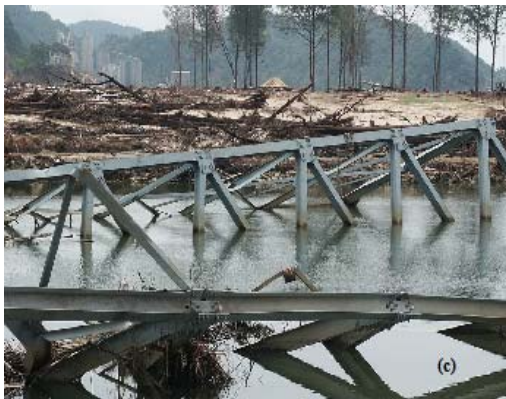
Fig. 2 Bridge damage due to tsunami attack in Banda Aceh (a) Total Wash-Away of Deck [7] (b) Excessive Deck Displacement [12] (c) Damaged steel truss bridge with damaged cement plant in the background in Lhok Nga, Banda Aceh

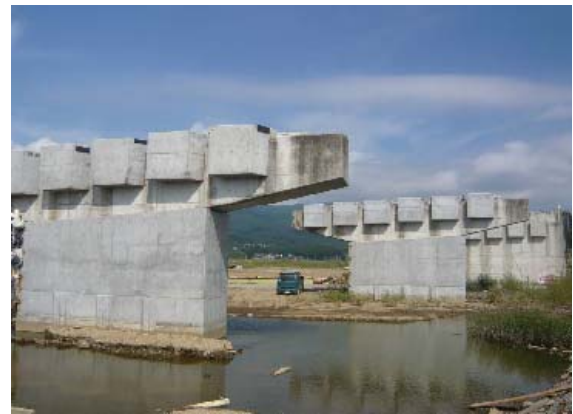
Fig. 5 Damaged Numata-Kosen bridge during Tohoku Tsunami

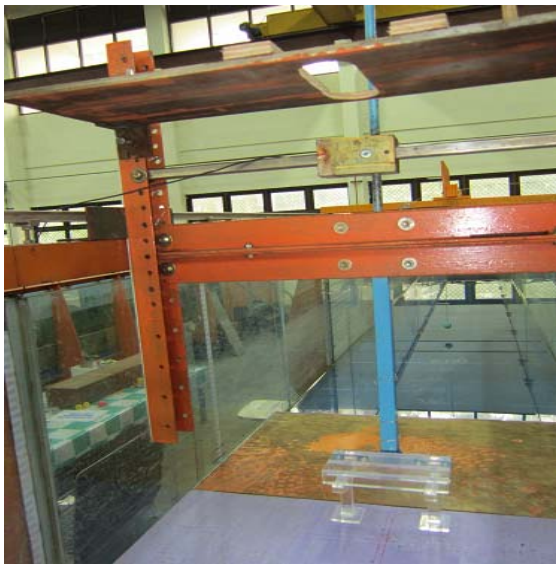
Fig. 9 Photo of the bridge model installed inside the flume

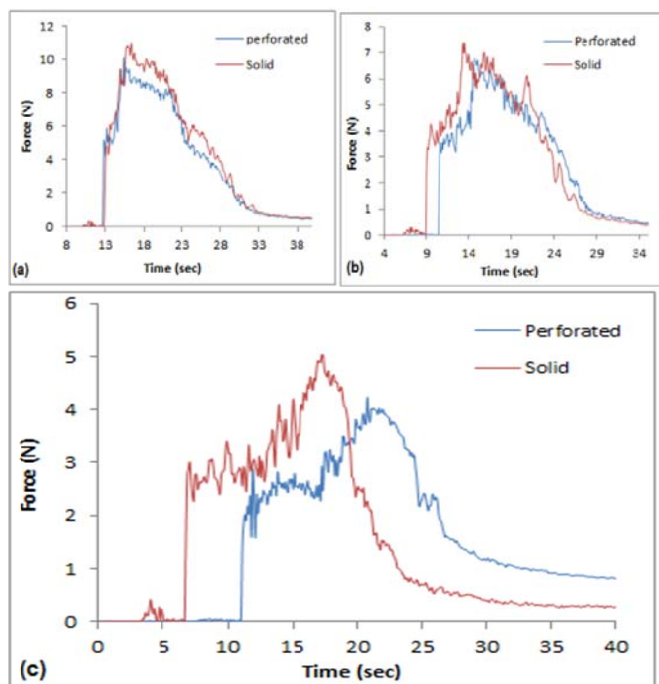
Fig. 13 Force time history for both solid and perforated girder for different reservoir depths

The main findings of this paper rest on ensuring the performance of perforated girder bridge against tsunami forces. In order to do this, approximately 16% perforations were considered within girder. The time history of forces for both solid and perforated girder bridge was presented in Fig. 13. The peak forces were taken as the maximum forces from the force time history. From Fig. 13, it has been found that substantial amount of force reduction were observed due to the use of perforations in girder. This force reduction was experienced not only in peak force but also throughout the whole time history. Table II showed the results obtained from using solid and perforated bridge girder. Another finding was that, time to attain peak forces were less for perforated girder bridge than that of solid girder bridge (Table III).

Reservoir Depth (cm)	Peak forces in Solid Girder Bridge (N)	Peak forces in Perforated Girder bridge (N)	Reductions in forces
30	11.075	9.97	10%
25	7.9	6.464	13%
20	4.67	3.8	18%

Tested were performed with perforations in the girder to observe the bridge performance under tsunami attack. For all of the selected wave heights, substantial reductions were observed due to the presence of perforations in the girder. These reductions were attributed not only at the peak value but also throughout the whole time history. The reductions in total forces due to the presence of perforations were given in Table II. For 20cm reservoir depth, the percentage of reduction was higher compared to reduction during 30cm and 25cm reservoir depth. It has been found from summary Table II that the peak forces reductions were 10%, 13% and 18% for reservoir depth 30cm, 25cm, and 20cm, respectively. The reduction of the wave attacked area in the girder was mainly responsible for the reductions in forces in the girders. Perforations in girder allow some amount of flowing water to pass through the perforations, thus contributing in force reduction. Moreover, with decreasing reservoir depth declinations of forces were increasing. This indicated that reduction in forces were more apparent for smaller wave heights. Table III demonstrated that lesser time were required for perforated girder bridge to reach the peak value than that of solid girder bridge.
